OPERATIONAL SERVICES BRANCH
ENGINEERING LABORATORY REPORT

LP165/2013

Tank Car Volume Measurements

Montreal, Maine & Atlantic Railway, Train MMA-002

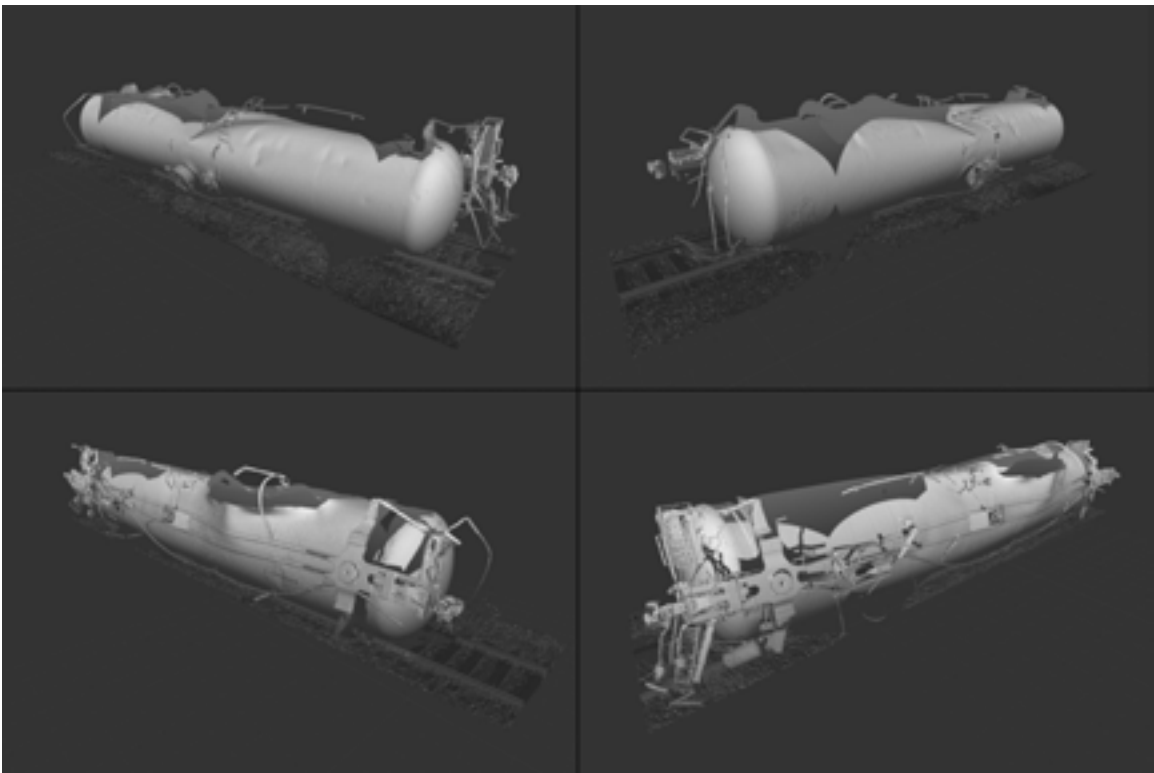
Figure 2: Oblique views of WFIX 130608 tank car laser scan visualizations

3.4.1 This tank car exhibited minor dents on the tank shell with little change in the length of the shell. There was a rupture due to a thermal tear on the right side⁴ near the A end that resulted in the expansion of the shell in this area.

3.4.2 From the B end to where the rupture started there was slight deformation in the shell with minor increases in the cross-sectional area.

3.4.3 Analysis of the tank car volume could only be performed from the B end to the start of the shell rupture. The rupture resulted in a deformed expansion of the shell so the cross-sections in this area are not representative of the actual volume of the tank car prior to the rupture. The volume in this portion of the tank car increased by 1.50% as compared to the volume of an undamaged COC L116012A tank car.

3.4.4 There was a reduction of 0.29% in the length of the tank car as compared to the length of the comparison tank car.

3.4.5 The length of the rupture was approximately 4.4 m and the surface area across the rupture was measured to be approximately 2.5 m².

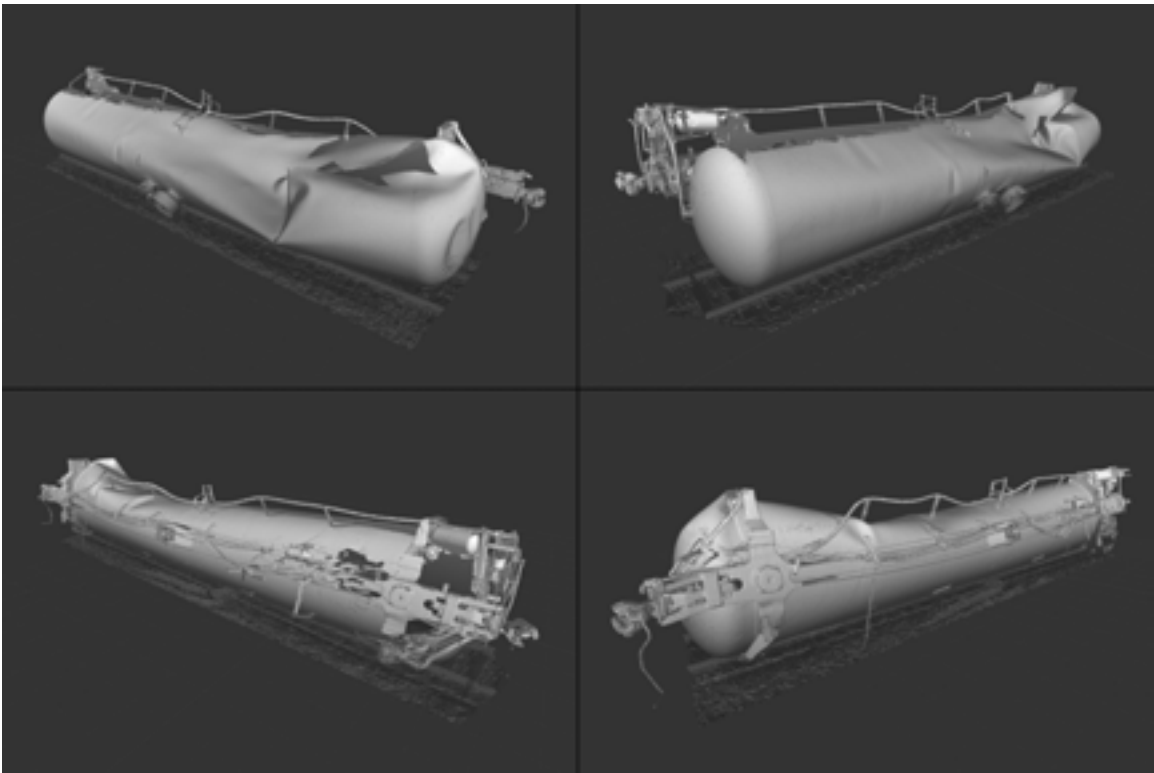
Figure 3: Oblique views of TILX 316570 tank car laser scan visualizations

3.5.1 This tank car contained a large rupture on the left side near the A end resulting in the expansion of the shell in this area. Moving from the B end towards the A end,

the tank car was compressed on the left side towards the center. The compression increased the vertical dimension of the tank reaching a maximum at the point where the rupture began at approximately 3.5 m from the center of the tank.

- 3.5.2 Analysis of the tank car volume could only be performed up until the start of the rupture. The rupture resulted in a deformed expansion of the shell so the cross-sections in this area are not representative of the actual volume of the tank car prior to the rupture. The volume in this portion of the tank car decreased by 5.52% as compared to the volume of an undamaged COC L116012A tank car.

- 3.5.3 There was a reduction of 0.77% in the length of the tank car as compared to the length of the comparison tank car.
- 3.5.4 The length of the rupture was approximately 3.9 m and the surface area across the rupture was measured to be approximately 1.1 m².

4.3 Analysis of the 3D laser scan data for car TILX 316570 indicated that the rupture in the shell was 3.9 m in length, with a surface area of about 1.1 m². The length of this car was reduced by about 0.77% as compared to an undamaged car. The portion of the tank located away from the rupture exhibited a reduction in volume of approximately 5.52% relative to an undamaged car. The cross sectional area adjacent to the rupture had decreased by about 17% relative to an undamaged car.

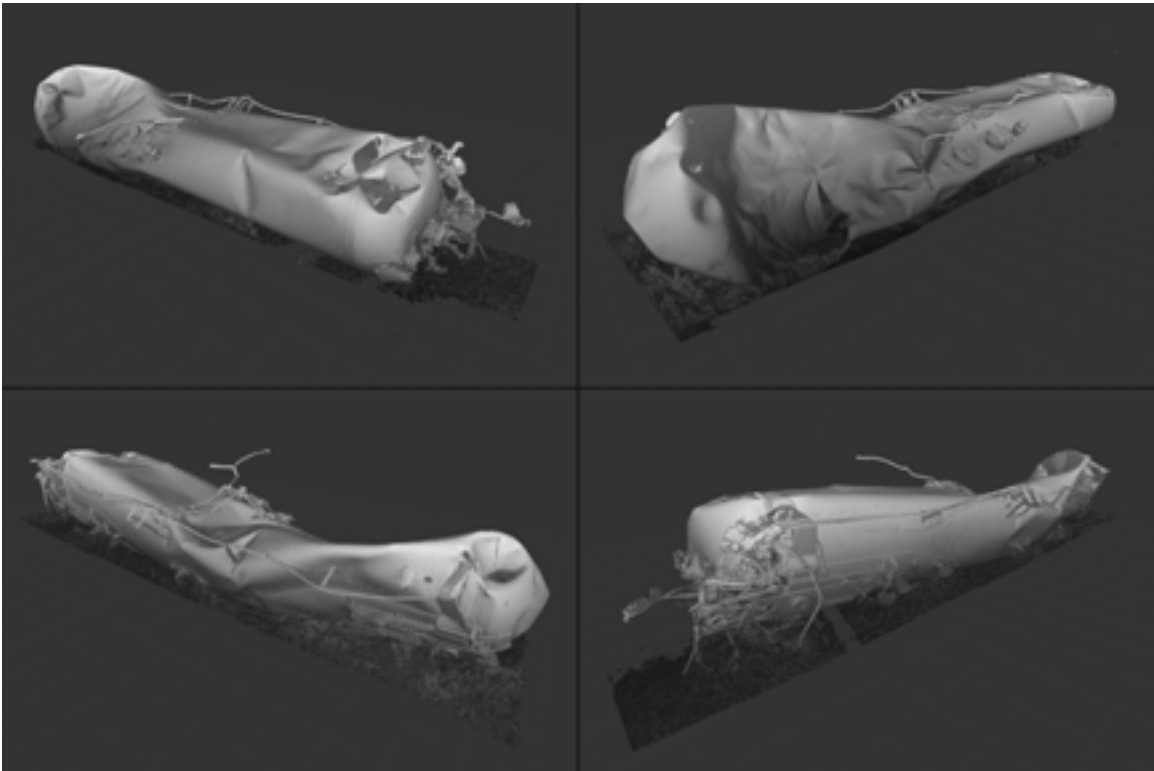
Figure 4: Oblique views of ACFX 76605 tank car laser scan visualizations

- 3.6 Tank Car ACFX 76605
- 3.6.1 This tank car exhibited extensive deformation and compression of the shell and heads. There was a large puncture in both heads, a transverse rupture in the shell, and several other shell breaches.

- 3.6.2 The volume of the tank car decreased by 39.7% as compared to the volume of an undamaged COC A841016 tank car.
- 3.6.3 There was a reduction of 2.76% in the length of the tank car as compared to the length of the comparison tank car.

- 3.6.4 The cross-sections of ACFX 76605 exhibited nearly a three-quarter reduction in area at about 1 metre from the A end of the tank car. The compression of the shell reduced the volume by more than one-third of the volume of the comparison tank car.

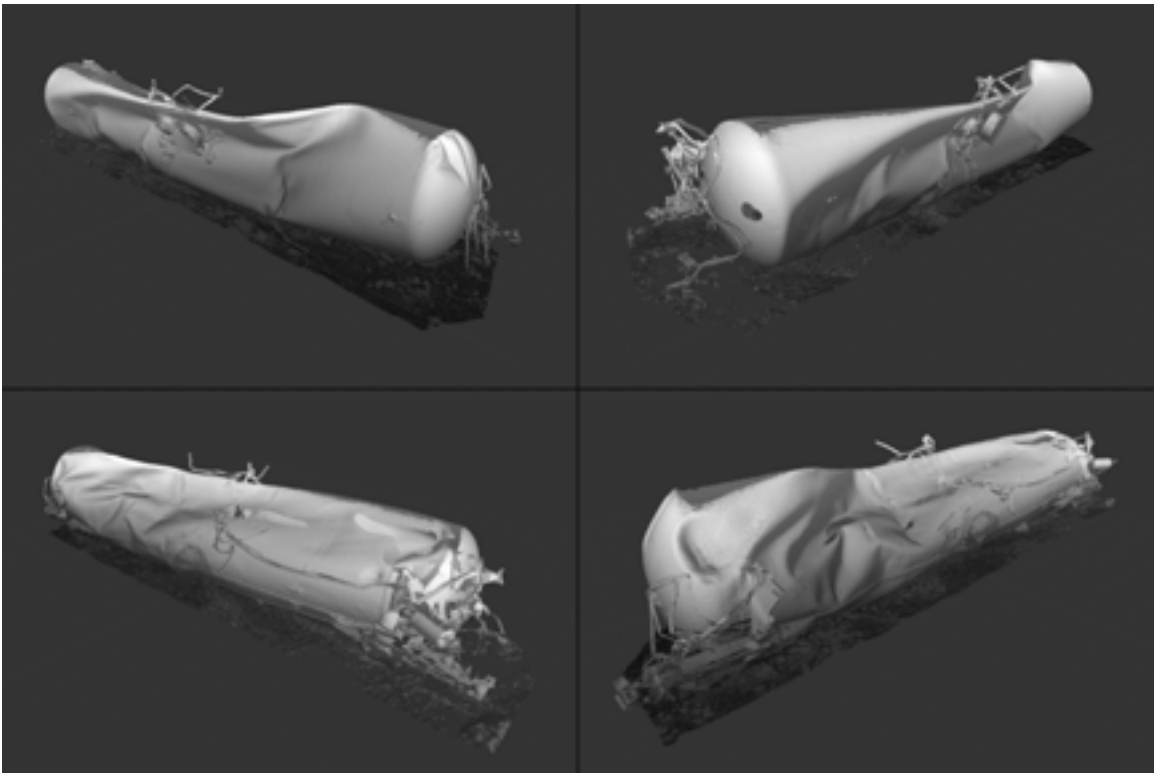
Figure 5: Oblique views of WFIX 130545 tank car laser scan visualizations

- 3.7 Tank Car WFIX 130545
- 3.7.1 This tank car was compressed on the left and right sides of the tank car. This compression pinched the shell together near the top of the tank car. There were no punctures in the heads or shell.

- 3.7.2 The volume of the tank car decreased by 26.8% as compared to the volume of an undamaged COC L116012A tank car.
- 3.7.3 There was a reduction of 1.58% in the length of the tank car as compared to the length of the comparison tank car.

- 3.7.4 The more deformed portions of the shell (for example see cross-sections 3 and 4 in Figure B-12) exhibited a significant decrease of the radius of curvature. The radius of curvature at the top of the buckle in the centre of the tank car and 2 m towards the A end are 0.10 m and 0.09 m respectively. The radius of curvature for the cross-section of the comparison tank car is 1.524 m.

- 3.7.5 There was a significant change in volume of WFIX 130545 due to the localized deformation. The cross-sections exhibited nearly a one-half reduction in area at about 2 m from the centre of the tank car towards the A end. The compression of the shell reduced the volume by almost one-third of the volume of the comparison tank car.

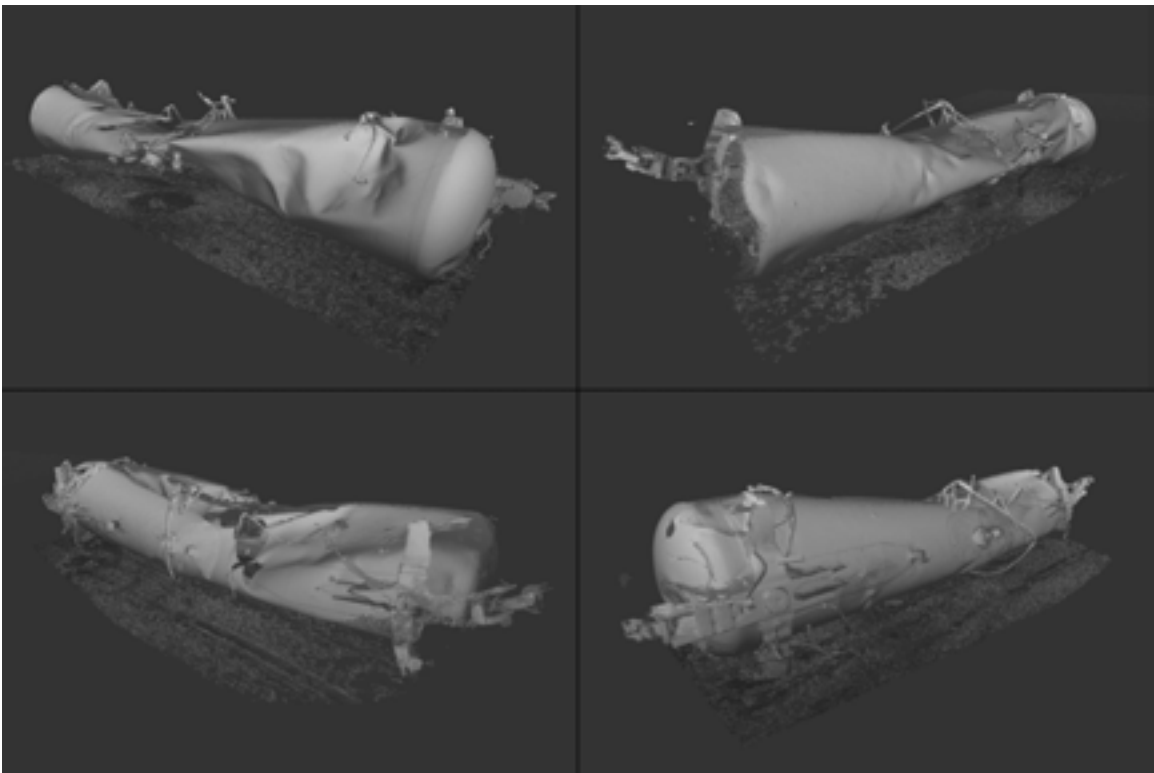
Figure 6: Oblique views of ACFX 71505 tank car laser scan visualizations

- 3.8.2 This tank car was compressed on the left and right sides near the center of the tank. The shell had a rupture near the B end. Both heads were dented with a small puncture in the B end.

- 3.8.3 The volume of the tank car decreased by 22.8% as compared to the volume of an undamaged COC A811019A tank car.
- 3.8.4 There was a reduction of 2.42% in the length of the tank car as compared to the length of the comparison tank car.

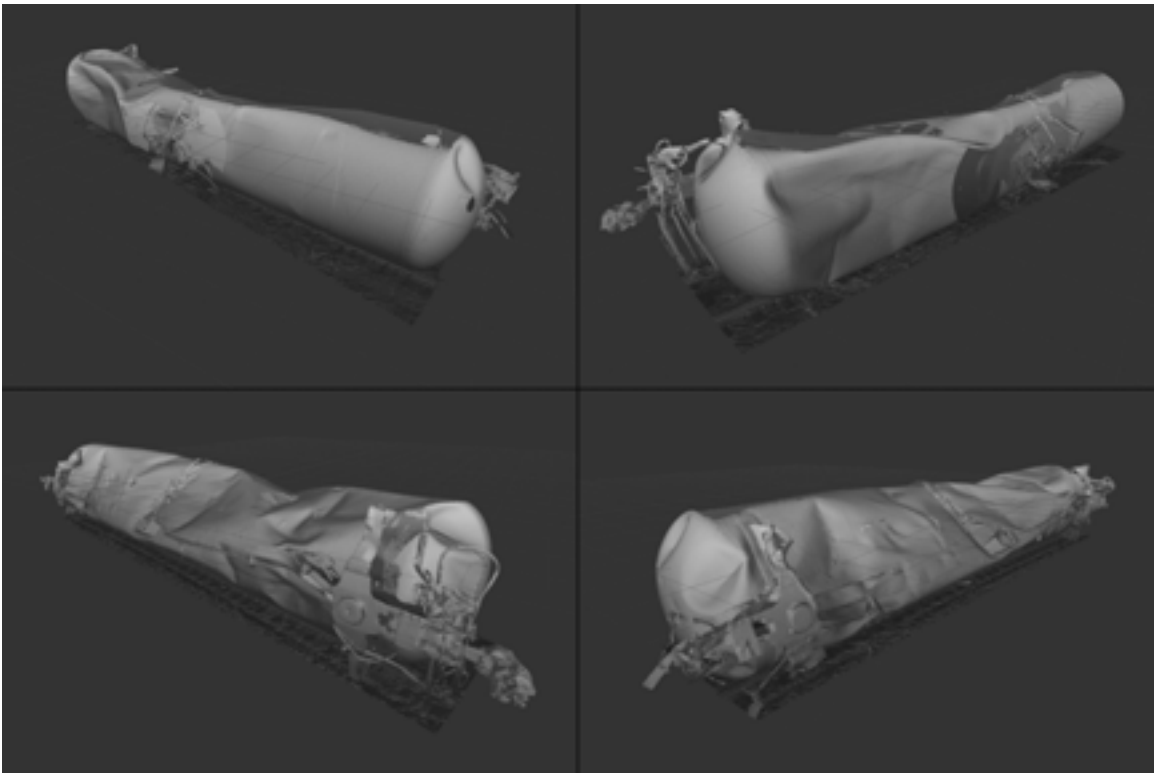
Figure 7: Oblique views of CTCX 735572 tank car laser scan visualizations

- 3.9 Tank Car CTCX 735572
- 3.9.1 The shell of this tank car was compressed on three sides (left, right, and top) resulting in a wedge shape near the center. There were dents on both the A and B ends of the tank car.

- 3.9.2 The volume of the tank car decreased by 11.2% as compared to the volume of an undamaged COC L121031C tank car.
- 3.9.3 There was a reduction of 0.60% in the length of the tank car as compared to the length of the comparison tank car.

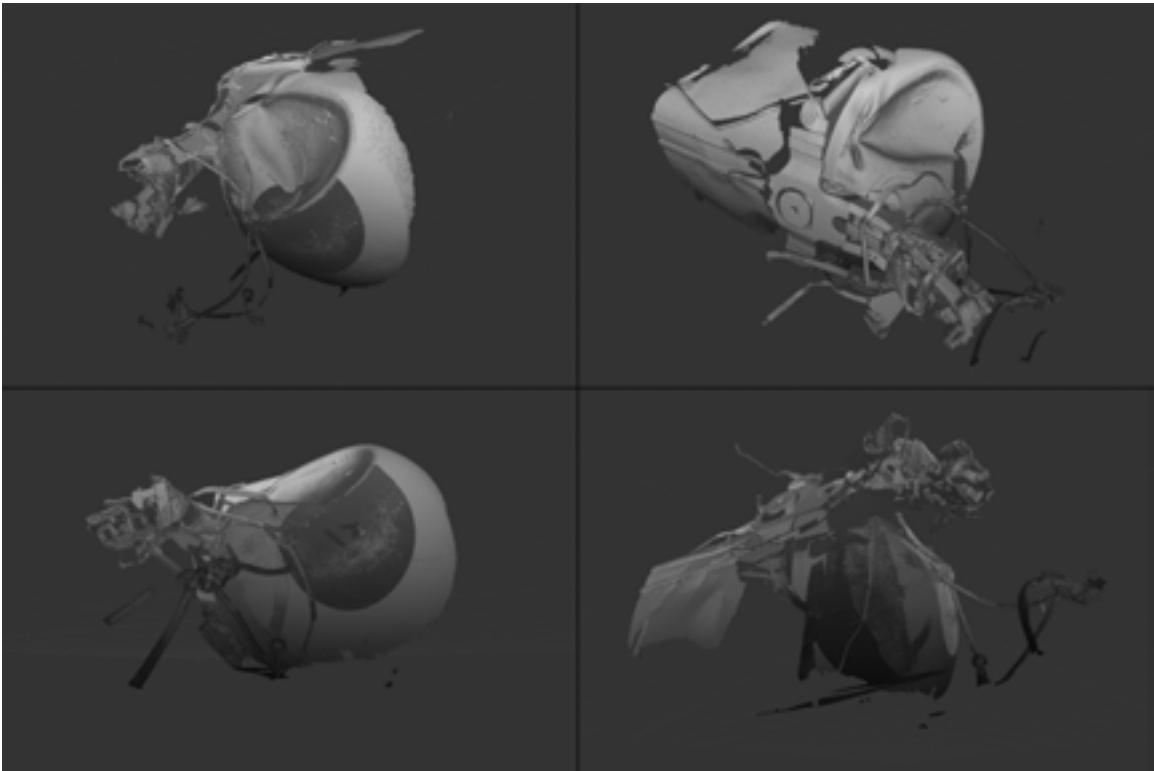
Figure 8: Oblique views of WFIX 130664 tank car laser scan visualizations

- 3.10 Tank Car WFIX 130664
- 3.10.1 Only the A end of this tank car was laser scanned with emphasis on a dent on the head of the tank and a separation at the fillet weld between the front sill pad and head.

- 3.10.2 The measured volume of the dent was approximately 0.64 m³ (169 US gallons) as compared to the surface of the undamaged COC tank car. The surface area of the dent was approximately 2.8 m² (30 ft²).

- 3.10.3 The stub sill had separated at the fillet weld between the front sill pad and the head. This crack had propagated to the body bolster pad fillet weld and into the head-to-shell weld. The lower crack was 0.50 m in length with a maximum width of 0.11 m. The upper crack was 0.25 m in length with a maximum width of 0.03 m.

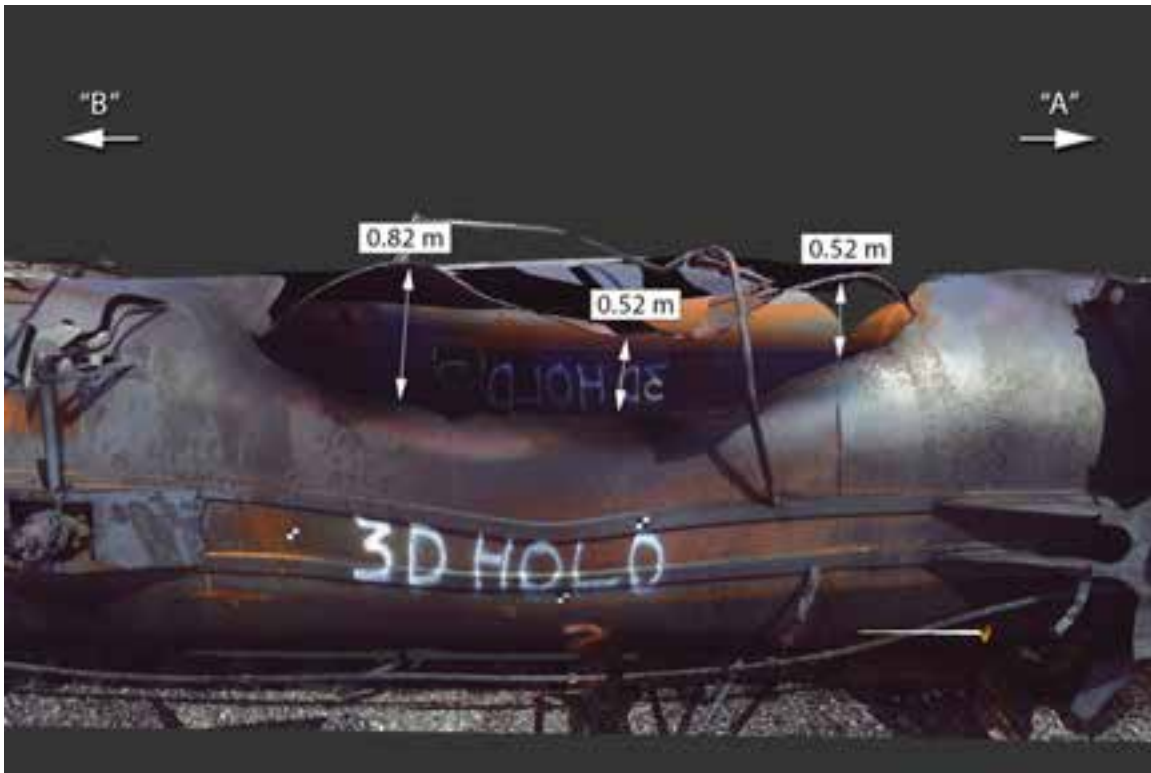
Figure B-3: Rupture along WFIX 130608 tank car

The portion of the tank car near the A end had to be discounted when measuring the volume (refer to Figure B-3). After the tank ruptured the deformation would have created a gap across the cross-section in this region, thus affecting the volume.

The separation in the rupture increased when moving from its A end extremity towards the middle. Up until half way along the rupture the separation distance was measured to be 0.52 m with some fluctuations and extended to as much as 0.82 m approaching the B end extremity. The length of the rupture was approximately 4.4 m and the surface area across the rupture was measured to be approximately 2.5 m².

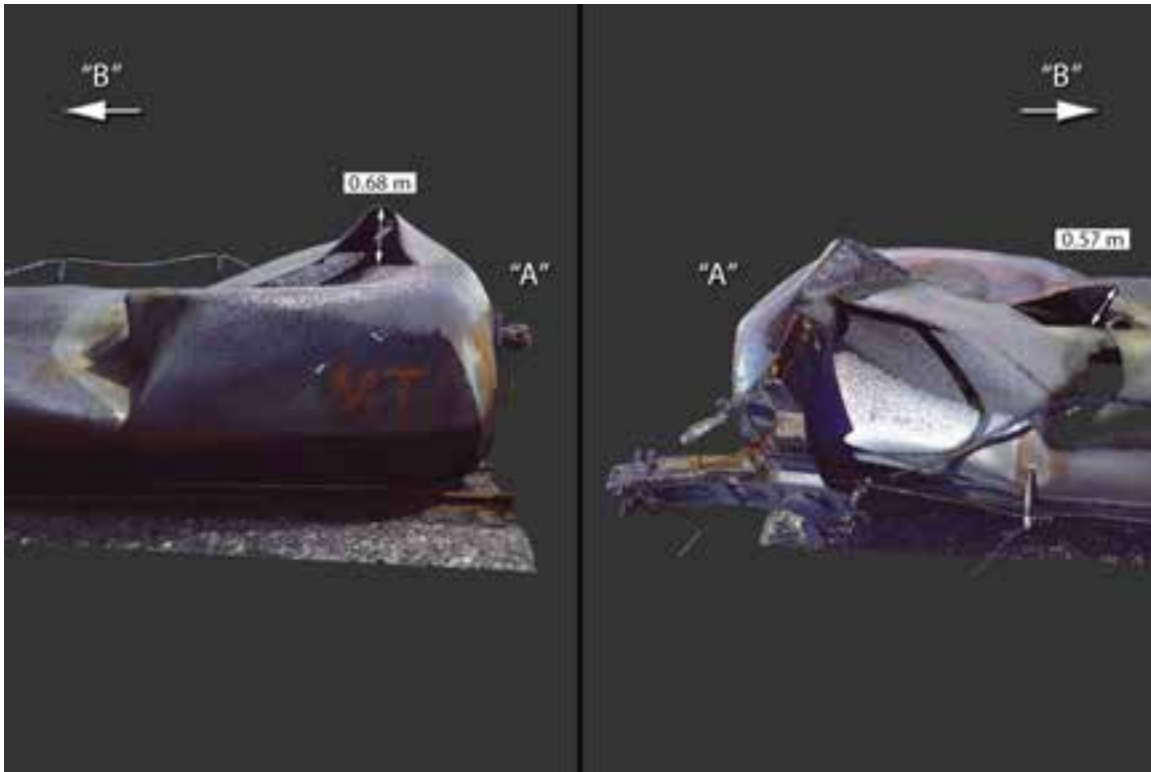
Figure B-6: Rupture along TILX 316570 tank car

The rupture on the left side of the tank car near the “A” end had to be discounted when measuring the volume in this region of the tank car (refer to Figure B-6). After the tank ruptured, the deformation would have created a gap across the cross-section in this region thus affecting the volume in this region.

There was a decrease in the tank car volume moving from the B end towards the A end. A rupture started at approximately 3.5 m from the center of the tank car moving towards the A end of the shell. The upper portion of the rupture extends beyond the deformation by 0.68 m and then switches to the lower portion that extends by 0.57 m approaching the B end. There is a buckle in the top portion of the tank that extended upward due to the compression in the left side of the tank. Following the rupture the cross-section of the tank returns to the original shape near the B end of the tank. The length of the rupture was approximately 3.9 m and the surface area across the rupture was measured to be approximately 1.1 m².

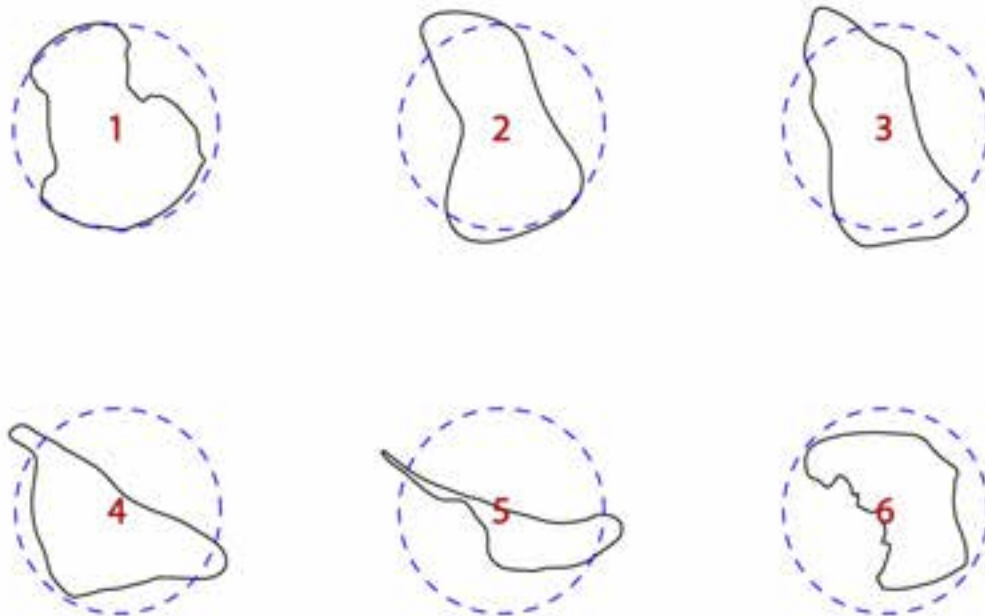
Figure B-8: Labelled cross-sections for tank car ACFX 76605 with cross-sections for an undamaged COC A841016 tank car represented as dashed outline

The cross-sections of ACFX 76605 exhibited nearly a three-quarter reduction in area at about 1 metre from the A end of the tank car. The compression of the shell reduced the volume by more than one-third of the volume of the undamaged tank car.

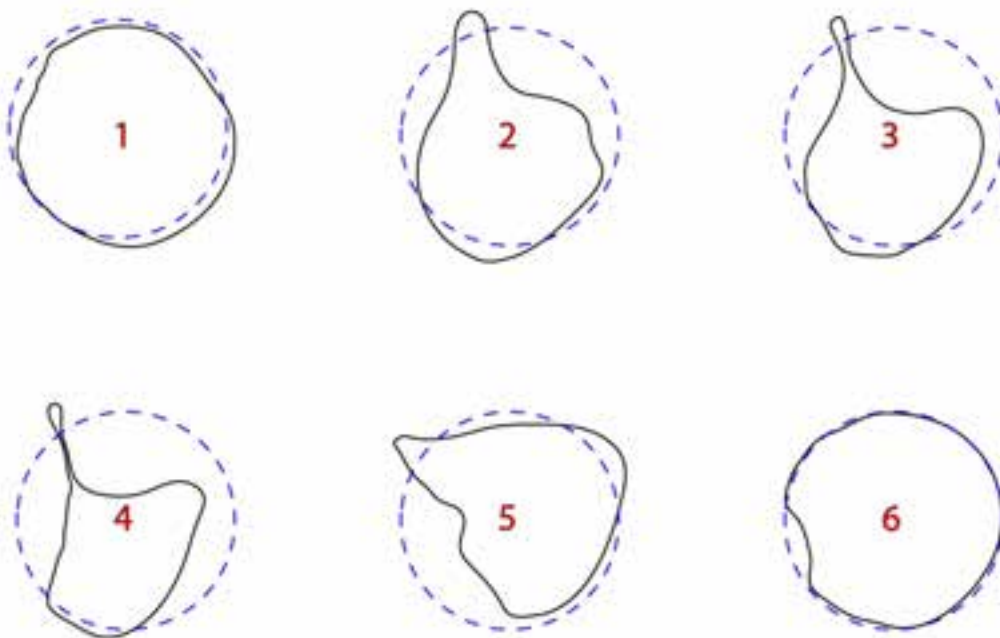
Figure B-10: Labelled cross-sections for tank car WFIX 130545 with cross-sections for an undamaged COC L116012A tank car represented as dashed outline

There was a significant change in volume of WFIX 130545 due to the deformation. The cross-sections exhibited nearly a one-half reduction in area at about 2 m from the centre of the tank car towards the A end. The compression of the shell in turn reduced the volume by almost one-third of the volume of the comparison tank car.

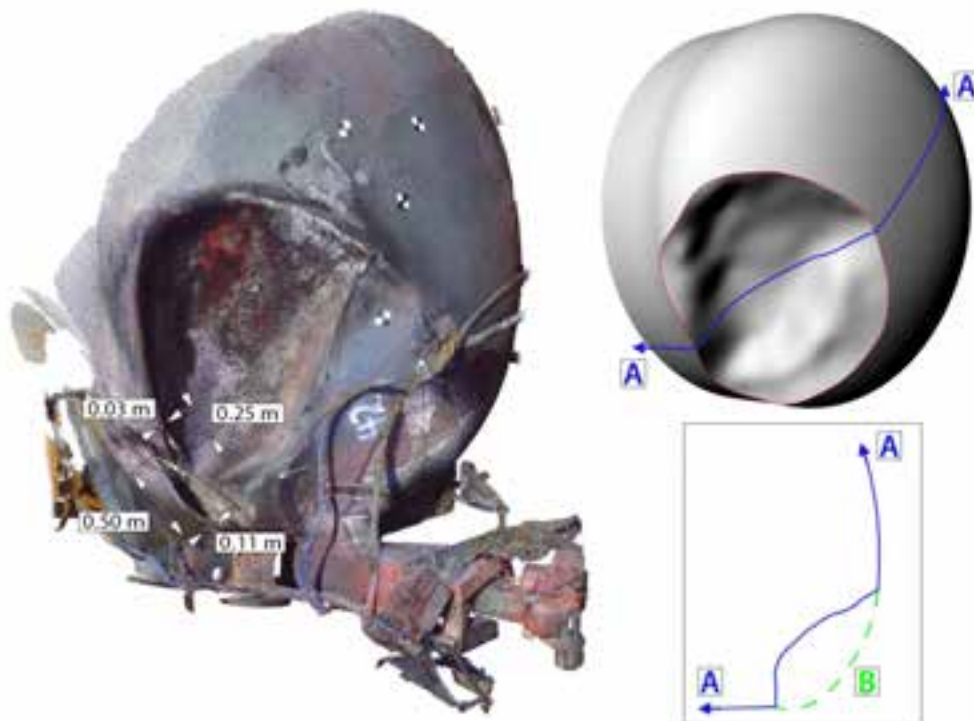
On the A end of WFIX 130664 there was a large impact dent (refer to Figure B-15). To measure the volume of the dent a 3D model was built of the tank head for the undamaged COC L116012A tank car. The curvature of the point cloud data was applied to the 3D model to cut out a section representative of the impact dent. The measured volume of the dent was approximately 0.64 m³ (169 US gallons). The surface area of the dent was approximately 2.8 m² (30 ft²).

Figure B-15: Point cloud data for WFIX 130664 A end (left) showing the impact dent as compared to the reconstructed surface (right) used to measure volume of the dent. Profile A-A shows the cross-section along the impact dent with curve B as the profile of the COC L116012A intact shell

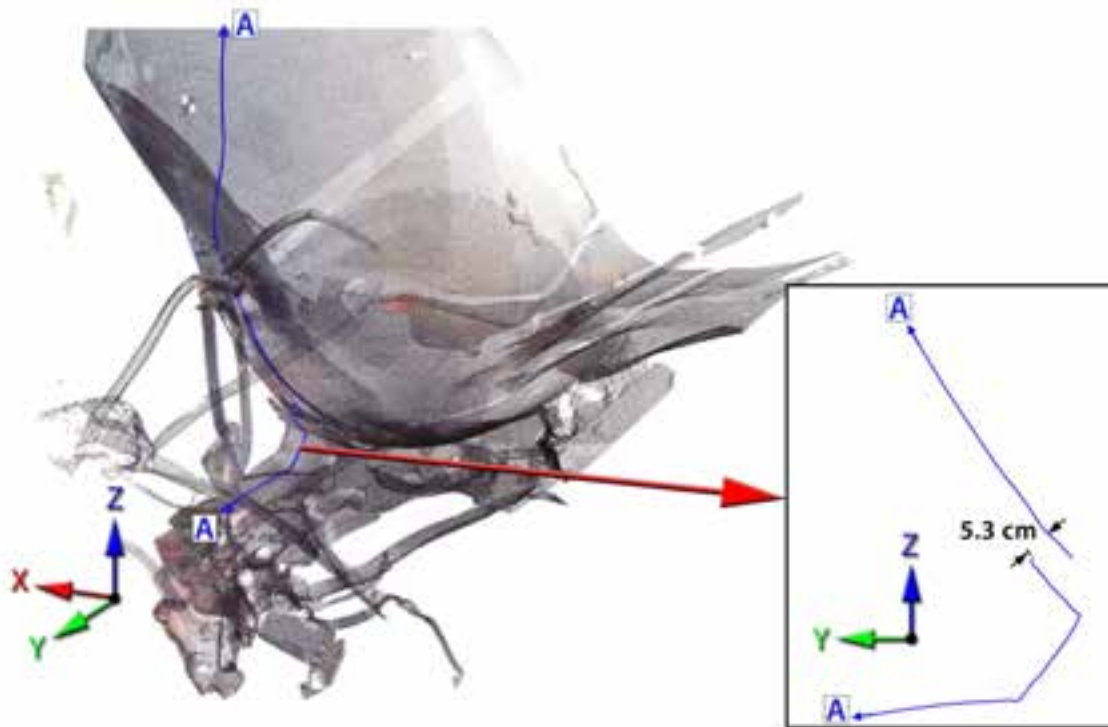
Along the centerline of the tank car the gap between the front sill pad and the head was measured to be approximately 5.3 cm (refer to Figure B-16). The separation of the front sill pad was greater along the top edge and became smaller as it approached the lower portion of the front sill pad closer to the stub sill (refer to Figure B-17).

Figure B-16: Oblique view of point cloud for tank car WFIX 130664 showing A end with cross-sectional profile exhibiting front sill pad separation

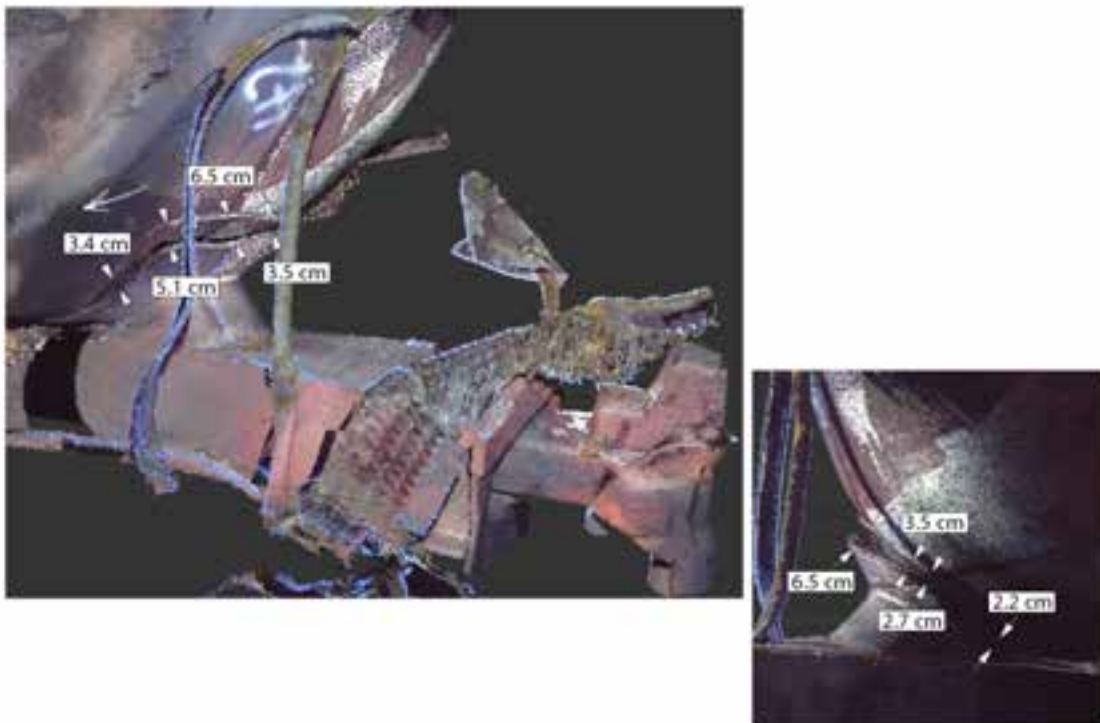
The stub sill of WFIX 130664 had separated at the fillet weld between the front sill pad and the head. This crack had propagated to the body bolster pad fillet weld and into the head-to-shell weld. The lower crack was 0.50 m in length with a maximum width of 0.11 m. The upper crack was 0.25 m in length with a maximum width of 0.03 m.

Figure B-17: Right & left oblique views of WFIX 130664 stub sill showing front sill pad separation
