OPERATIONAL SERVICES BRANCH
ENGINEERING LABORATORY REPORT

LP233/2013

Locomotive Electrical Examination

Montreal, Maine & Atlantic Railway, Train MMA-002

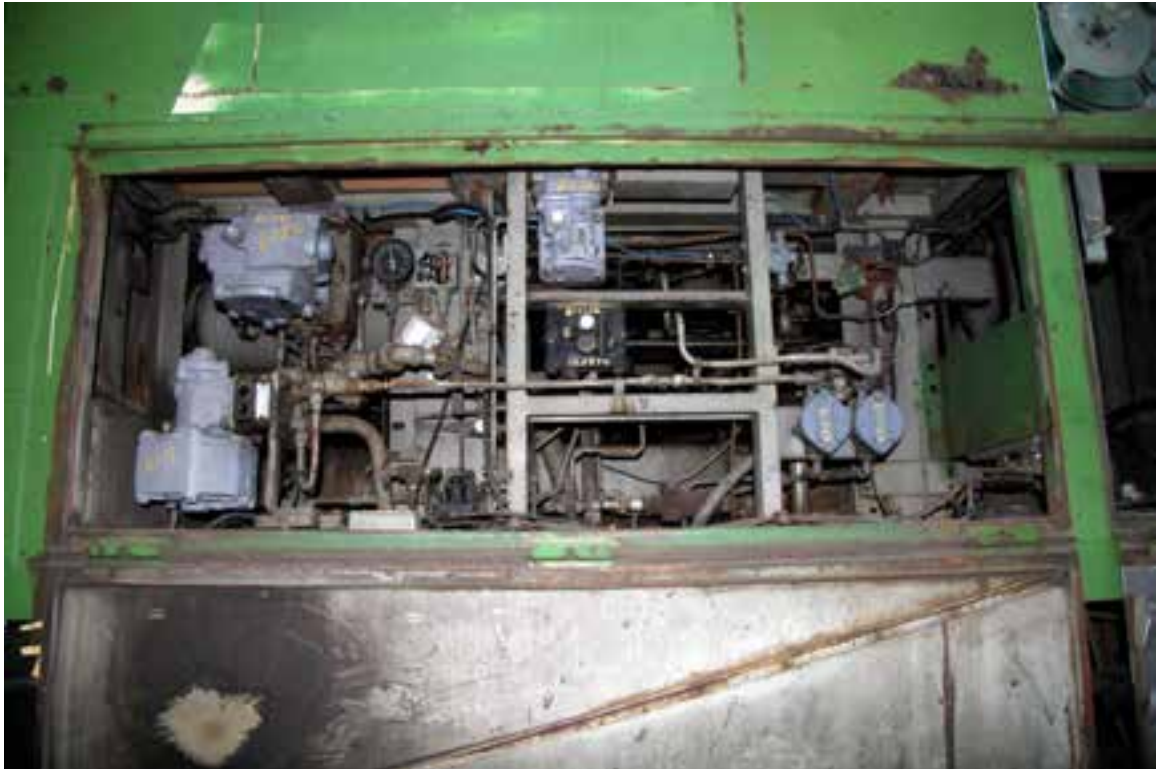
Figure 1: Locomotive 5017's airbrake compartment

- 2.6.1 The examination of locomotive 5017 (Figure 1) showed that the OSV was electrically powered as per the original manufactured arrangement through the wire labelled “80PC” which was connected inside a junction box. The RSC was directly connected to the hot side of the battery. The wire for the “Brake Test” (Figure 2) circuitry was physically and electrically connected to the same terminal as the control signal for the RSC (Figure 3); the protective box in which the terminal was located had a cover that was pushed to the side and only held on by one screw.

- 2.6.6 Testing showed that the OSV was always powered by the battery and thus did not vent for any of the test conditions.

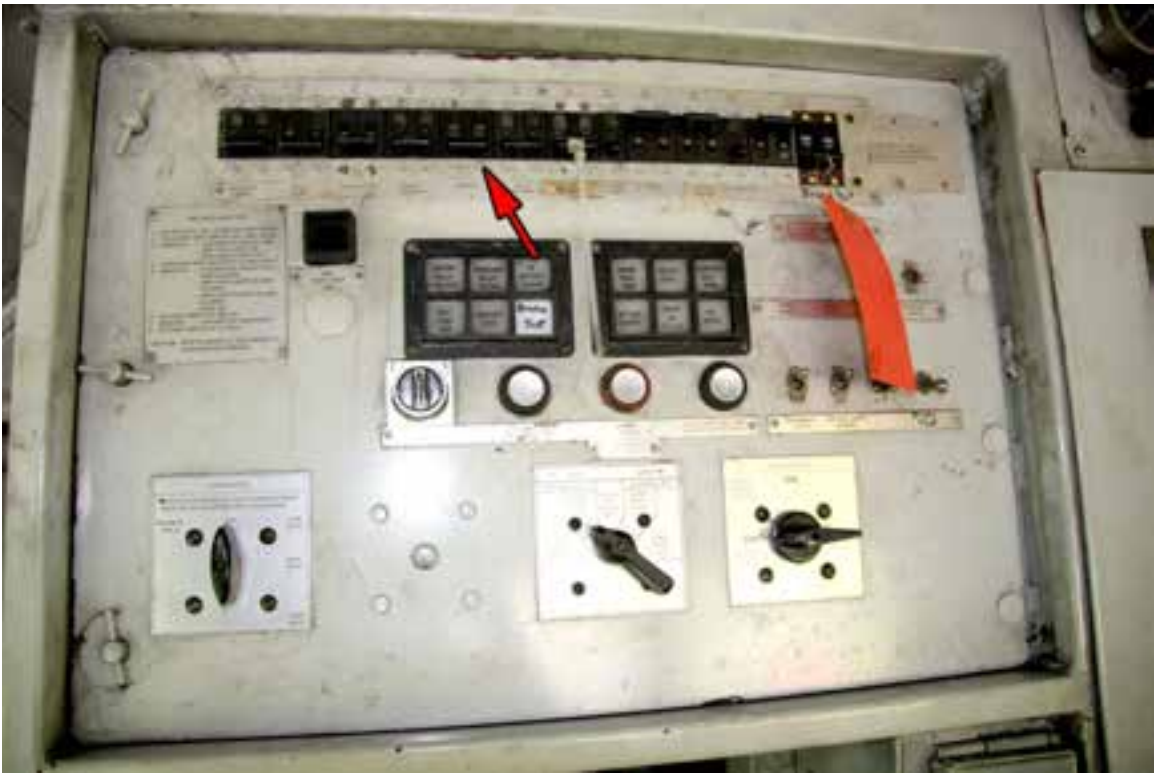
Figure 4: Control circuit breaker in locomotive cab

- 2.6.3 The control circuit breaker (Figure 4) was placed in the “OFF” position; none of the valves vented and there was no penalty braking application.

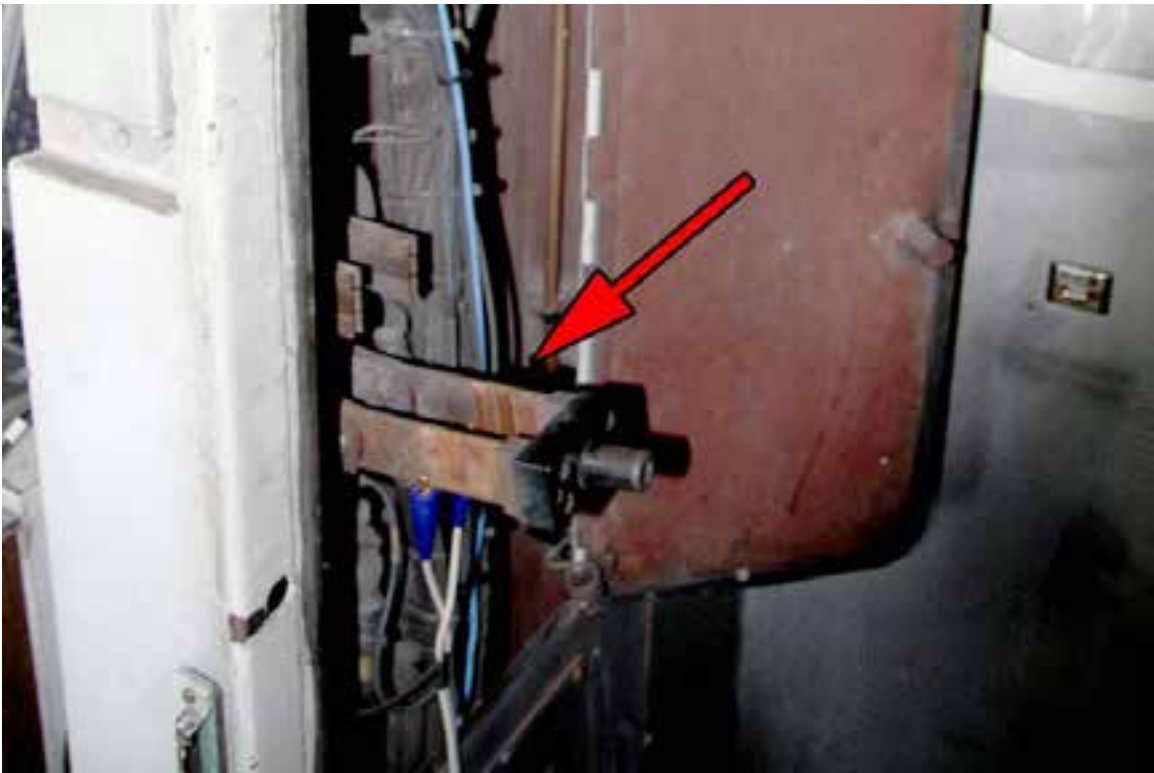
Figure 5: Main electrical cut-off switch

- 2.6.4 The main electrical cut-off switch (Figure 5) was opened; none of the valves vented and there was no penalty braking application.
- 2.6.5 The control circuit breaker was opened and the main electrical cut-off switch was placed in the “OFF” position; none of the valves vented and there was no penalty braking application.

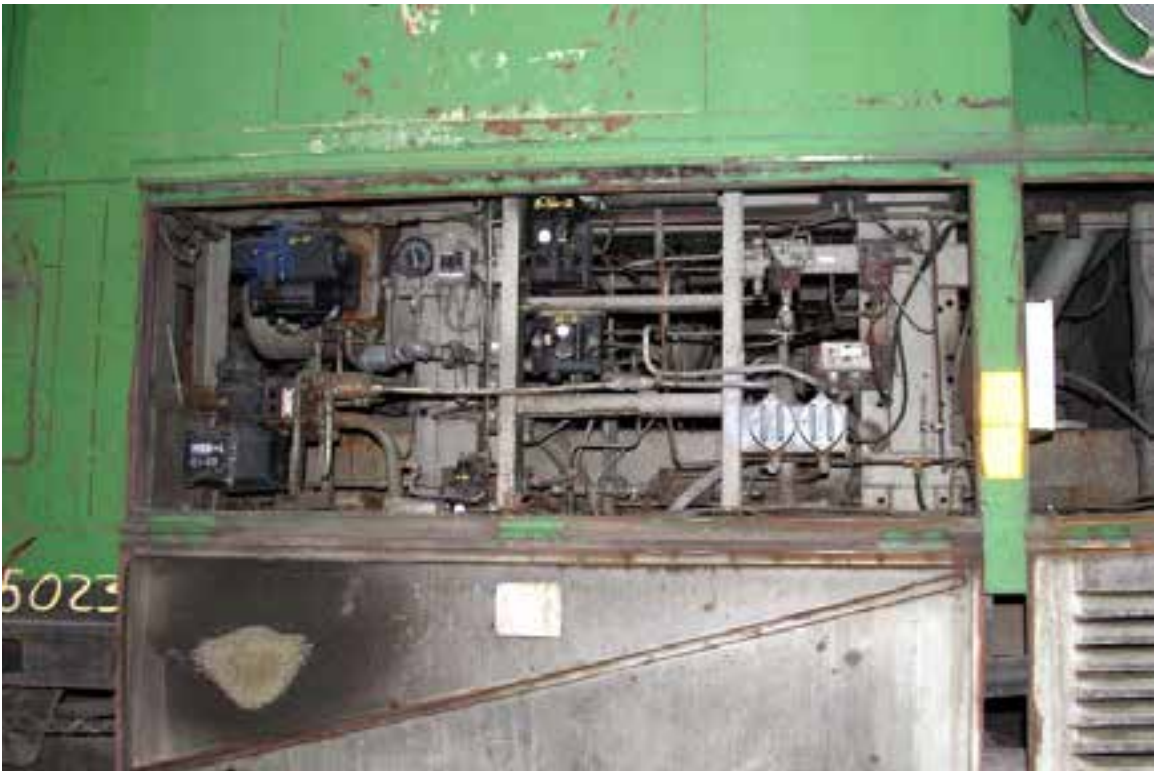
Figure 6: Locomotive 5023's airbrake compartment

- 2.7.1 The examination of locomotive 5023 (Figure 6) showed that the OSV was electrically powered as per the original manufactured arrangement through the wire labelled “80PC”; the wire was connected outside of the junction box. The RSC was directly connected to the hot side of the battery. The wire for the “Brake Test” circuitry was electrically connected to the same terminal as the control signal for the RSC but physically separate (Figure 7); there was no protective box around the terminals. The OSV cut-off was closed as found but was opened for the testing.

- 3.7 Locomotive 5023 had a unique condition somewhere within its systems that would keep voltage applied to the OSV's solenoid regardless of the circuit breaker state. When the circuit breaker was switched "OFF", the voltage dropped, but was still sufficient to keep the solenoid from changing states preventing the OSV from venting. Although the exact source of the voltage was not identified, it was determined that it was related to the speed indicator system as when the speed indicator was removed, the voltage would drop to 0 VDC. The issue was not the speed indicator itself but something in the system as when a known good speed indicator was installed in the locomotive the voltage level jumped back up again.

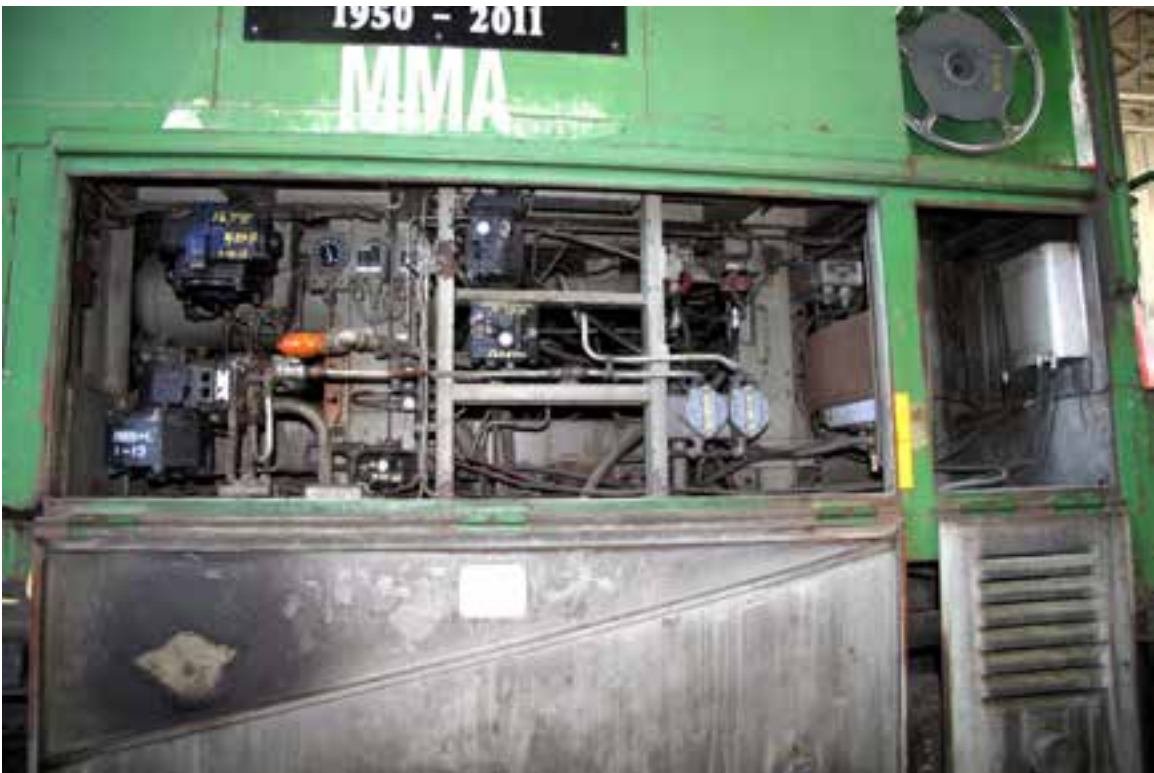
Figure 8: Locomotive 5026's airbrake compartment

- 2.8 Locomotive 5026
- 2.8.1 The examination of locomotive 5026 (Figure 8) showed that the wire labelled “80PC” was disconnected and the end was taped over. The OSV was electrically powered through the Pulse system. The RSC was directly connected to the hot side of the battery. The wire for the “Brake Test” circuitry was physically and electrically connected to the same terminal as the control signal for the RSC (Figure 9); the protective box in which the terminal was located did not have a cover. The OSV cut-off was noted to be in the open position.

- 3.8 Locomotive 5026 performed as expected, producing a penalty brake application for all test conditions.
