AVIATION INVESTIGATION REPORT

A00P0199

HAZARDOUS SITUATION—ATC IRREGULARITY

VANCOUVER AREA CONTROL CENTRE

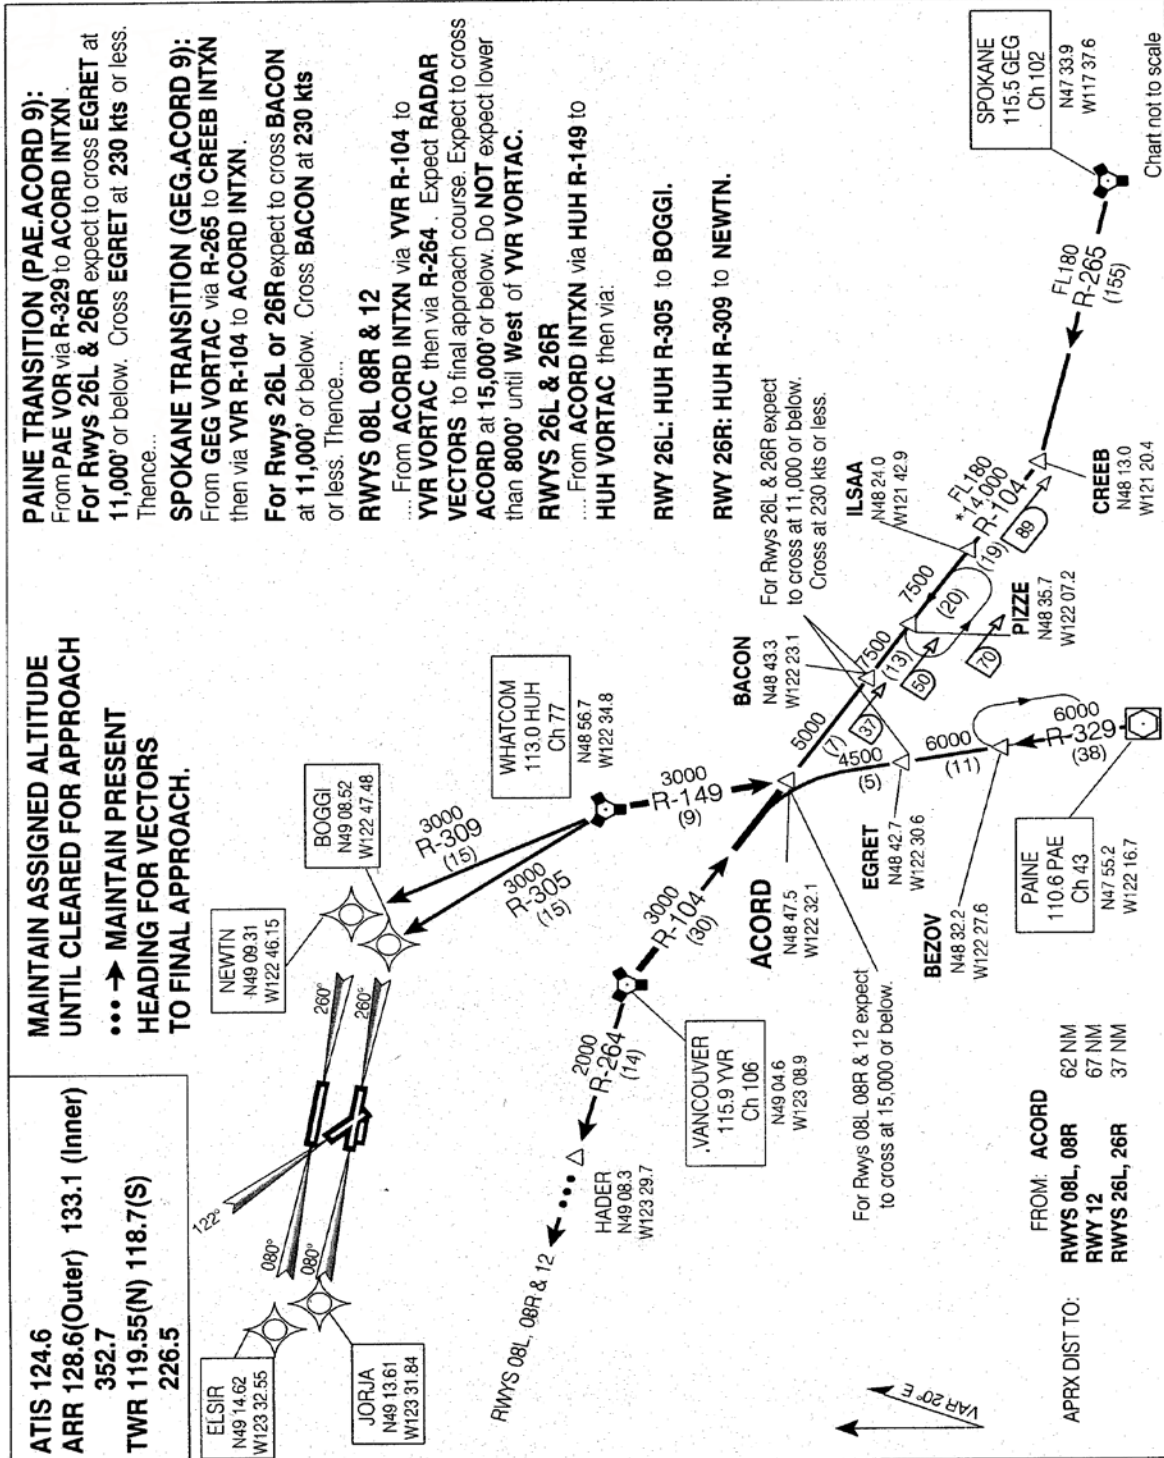
Appendix A—CAP Acord Nine Arrival Chart

The Acord 9 arrival chart does not specify that an aircraft may be vectored to the north of the airport, neither does it provide information regarding back-up procedures or high terrain. This absence of information reduces aircrews’ abilities to maintain their own situational awareness. Issuing vectors in areas restricted by terrain will continue to result in a risk of controlled-flight-into-terrain accidents unless the vectors are formalized to ensure standardization and the incorporation of safety defences, including dissemination of pertinent information to pilots.

1. The Acord 9 arrival chart does not indicate that an aircraft may be vectored to the north of the airport toward high terrain. This absence of information could reduce flight crew preparedness and situational awareness as a defence regarding their position in relation to the terrain.
2. The Acord 9 arrival chart and the approach plate for Runway 08L do not depict a navigational limitation to the north of the airport to ensure that aircraft do not stray into a high-terrain area. Without this information readily available, the defence of back-up procedures to increase a flight crew's situational awareness is compromised.
3. There is no operational minimum safe-altitude warning system to provide a technical back-up warning for controllers when an aircraft flies into an area of higher terrain.

On 17 August 2001, the TSB forwarded Aviation Safety Information Letter A010018 (“Vancouver Acord Star Procedures”) to Nav Canada. The letter points out the increased risks associated with the use of unpublished procedures and the lack of relevant pilot navigation information regarding the crossover procedure on the Vancouver Acord arrival chart. In response to this letter, Nav Canada has revised the Vancouver Acord Star procedure. As of 20 September 2001, two procedures became effective: the Acord Star for runways 08R, 08L, and 12 and a new procedure, the Whatcom Star, for runways 26L and 26R. The Acord Star now contains a cautionary note to pilots regarding high terrain to the north of the Pitt Meadows (YPK) VOR 260° radial and depicts the location and frequency of the YPK VOR and the 260° radial. The revised procedures were incorporated into the 01 November 2001 issue of *Canada Air Pilot*.

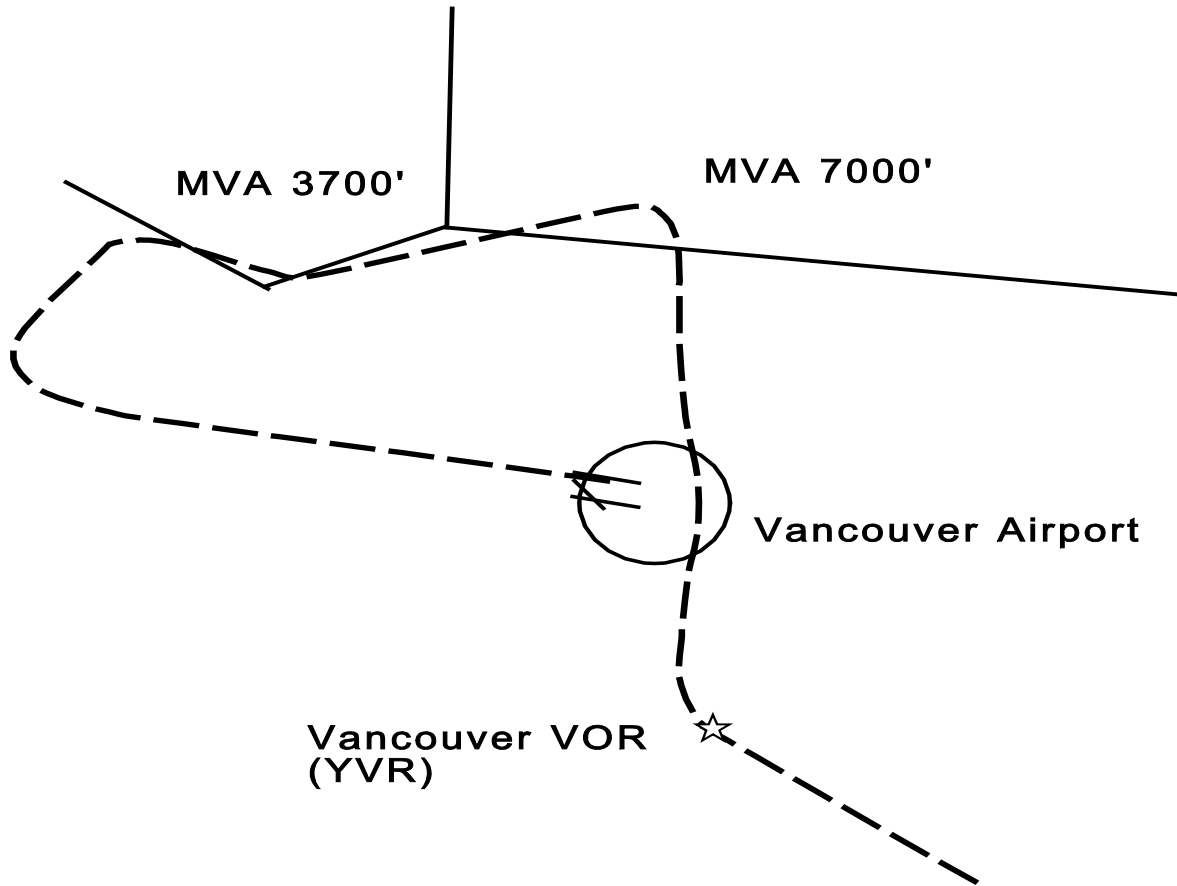
Appendix B—Radar Track and Vancouver Airport Area

The trainee vectored QXE260 overhead the airport via an assigned heading of 340° from the Vancouver VOR, with a descent to 5000 feet. This heading resulted in the aircraft tracking toward higher terrain north of the airport, at an altitude that would be below the progressively higher MVA for that area. Controllers can and do issue a heading of 320° or less from overhead the Vancouver VOR to ensure that an aircraft remains west of the 7000-foot MVA area.

The OJI and the trainee then became involved with the coordination of two other aircraft that were on vectors for Runway 08L. Both controllers were focused on discussing these aircraft to the extent that they forgot QXE260. They had not used a reminder or memory aide, such as a cocked flight progress strip, projected track line, halo, request for position reports from the flight crew, or alternate instructions to the flight crew. The coordinator's warning to the OJI drew the attention of the two controllers back to QXE260 as it approached the boundary of the higher MVA area. The trainee issued a quick series of instructions to QXE260, first to turn left to 240°, then to 180°, and then to climb to 7000 feet immediately. The trainee did not use the phraseology published in *Air Traffic Control Manual of Operations* for issuing a safety alert to the aircraft. QXE260 penetrated the 7000-foot MVA area by approximately 3 nautical miles as the aircraft turned to the westbound heading.

Vancouver Area Control Centre (ACC) issued Operations Bulletin 00-186 immediately after this occurrence. The bulletin indicated that if controllers use the centre-field crossover for flights from the south, aircraft shall not normally be cleared below 7000 feet until observed (on radar) in the downwind turn. If further descent is required on the northbound heading before issuing the downwind turn, the aircraft is to be instructed to intercept the Pitt Meadows VOR 260° radial to ensure that the aircraft does not stray into a high-terrain area.
