AVIATION INVESTIGATION REPORT

A01H0002

LOSS OF SEPARATION

NAV CANADA
GANDER AREA CONTROL CENTRE
SYDNEY, NOVA SCOTIA, 23 NM SE
05 MARCH 2001

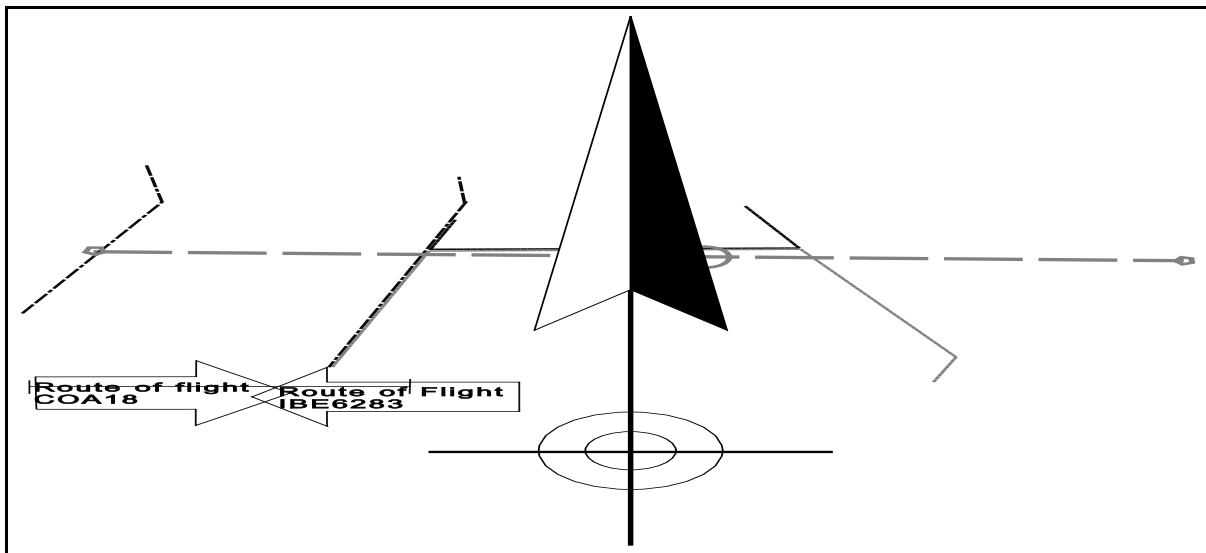
COA18 had been cleared at flight level (FL) 330 through Moncton and Gander Area Control Centre (ACC) controlled airspace on an eastbound route from TUSKY intersection to Torbay VOR (very high frequency omnidirectional RADIO range) navigation aid before entering oceanic airspace. (see Figure 1.) When the Moncton ACC controller solicited a ride report from COA18, the crew advised that they were experiencing continuous light turbulence (chop). Ten minutes later, COA18 advised that the flight was now in continuous light chop, with occasional moderate chop. Based on previous reports of a smoother ride at FL350, the controller offered that altitude to COA18 with a turn off course to accommodate traffic. COA18 requested to maintain its present course at FL330 until clear of conflicting traffic. At 1339:03 Newfoundland standard time (NST)¹ the Moncton ACC controller cleared COA18 to climb to FL350. The change in altitude was not passed to Gander ACC immediately, nor did the Gander/Moncton Agreement specifically require controllers to do so. FL350 was not an appropriate altitude for the direction of flight. Controllers use the term “wrong way” for internal communications with other air traffic control (ATC) sectors to describe this situation. At 1351:46, COA18 was verbally handed off from Moncton to Gander ACC control. The Moncton ACC controller advised the Gander ACC controller of the aircraft’s flight level (FL350), the fact that it was a
