AVIATION INVESTIGATION REPORT

A0100164

IN-FLIGHT COLLISION

20 JUNE 2001

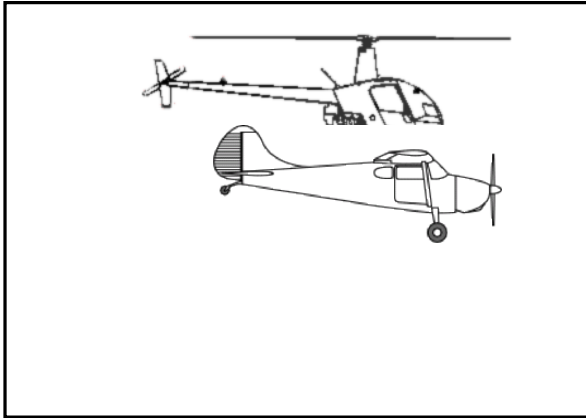
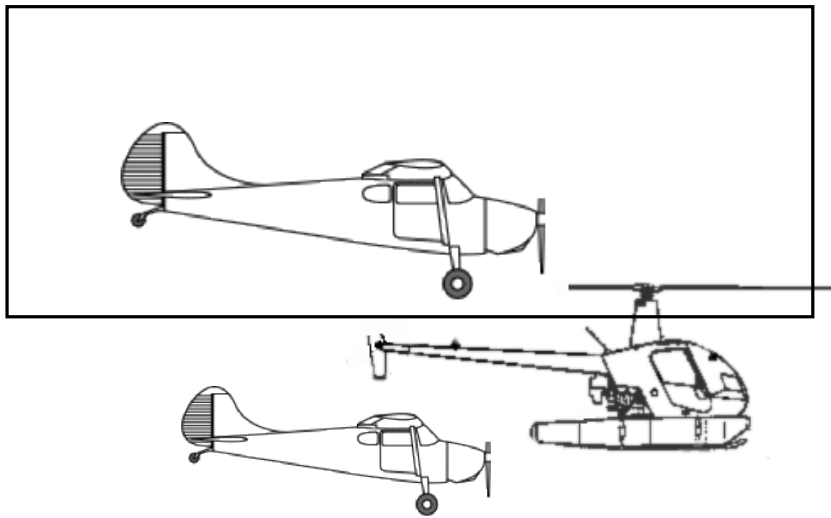
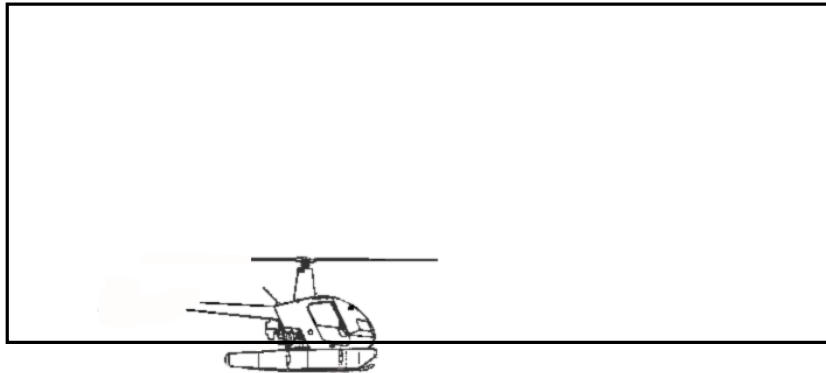
*Appendix A—Impact Sequence*

As the helicopter came into the Cessna pilot's field of vision, it was slightly above at the pilot's 11 o'clock position, at extremely close range. Collision was imminent, and although the Cessna pilot initiated a climbing right-hand collision-avoidance turn, he was unable to gain positive separation. The helicopter tail rotor struck the under side of the Cessna's engine cowl, and the tail-rotor blades broke. Simultaneously, the helicopter's retreating main-rotor blade struck the top left side of the Cessna's engine cowl, and the blade separated from the

main-rotor system. The helicopter became uncontrollable and pitched forward to an inverted attitude. This pitching movement caused a bending moment of the remaining main-rotor blade. The blade flexed downward and severed the tail boom from the main body of the helicopter. The helicopter then descended to the ground and was destroyed by impact forces.
