AVIATION INVESTIGATION REPORT

A0100210

CONTROLLED FLIGHT INTO TERRAIN

CESSNA 182 D-EDOG

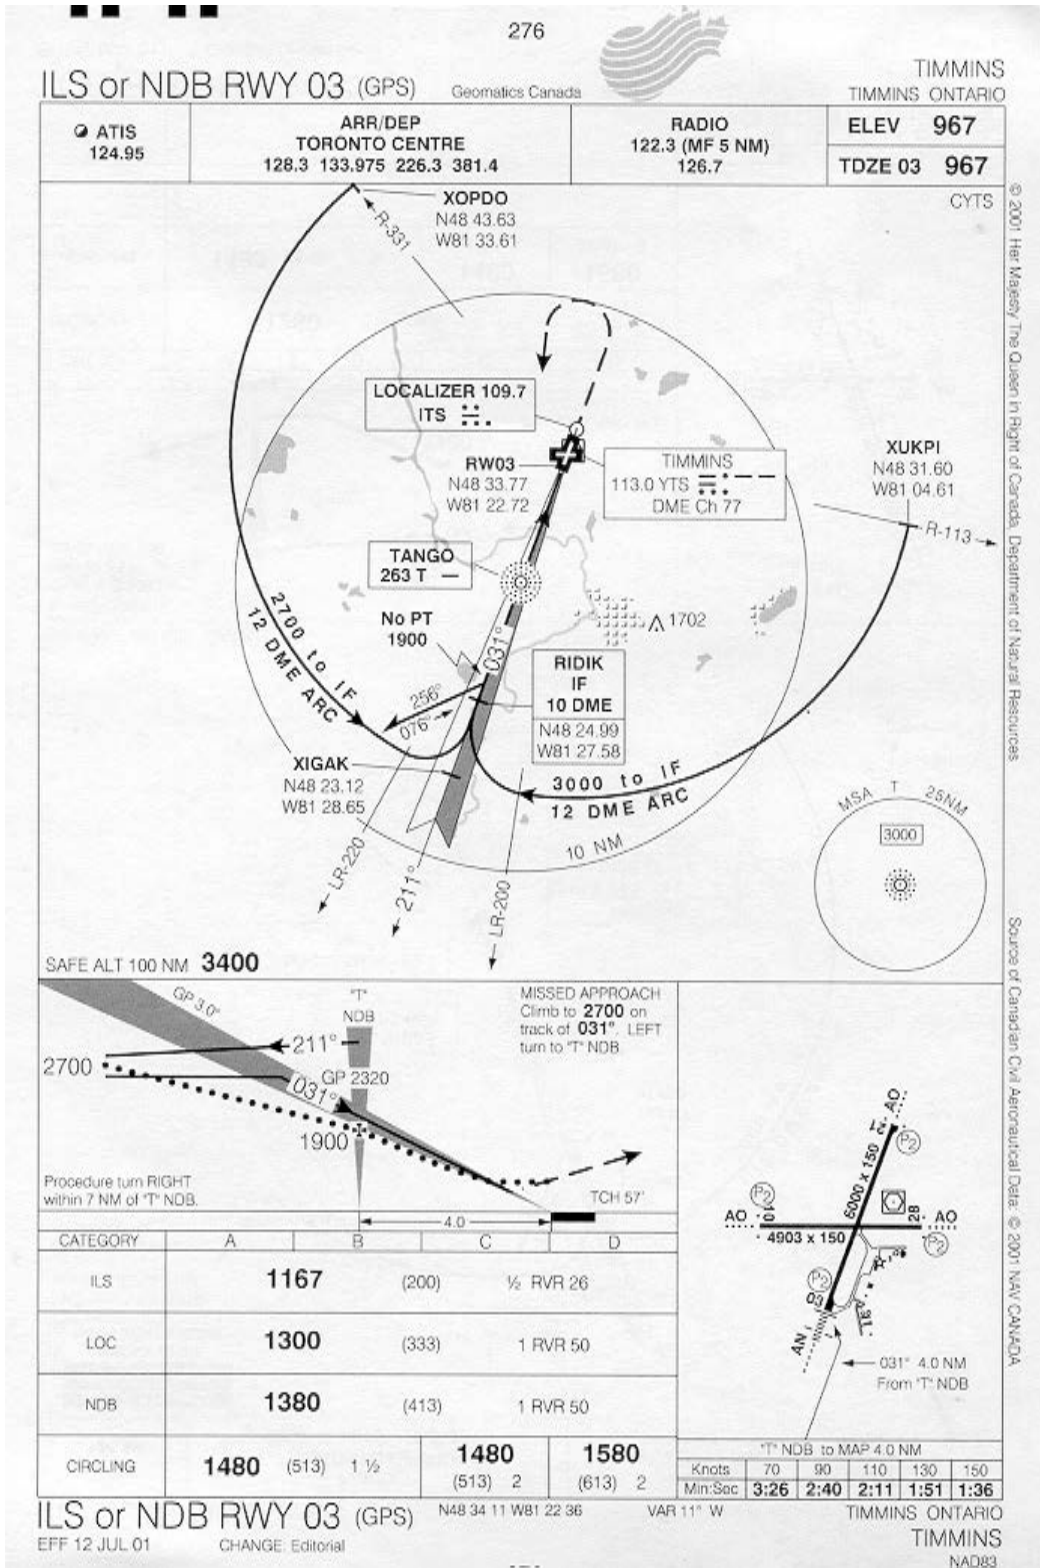
Appendix A—ILS or NDB RWY 03 (GPS) Approach

Runway 03 in Timmins has two IFR approaches: an ILS or non-directional beacon (NDB) (GPS) approach (see Appendix A) and a VOR (GPS) approach. The minimum descent altitude (MDA) for the NDB approach was 413 feet above ground level (agl). The MDA for the VOR approach was also 413 feet agl, but only if the aircraft has a serviceable NDB or DME; without an NDB or DME, the MDA was 733 feet agl.
