AVIATION INVESTIGATION REPORT

A01Q0053

LOSS OF SEPARATION

27 MARCH 2001

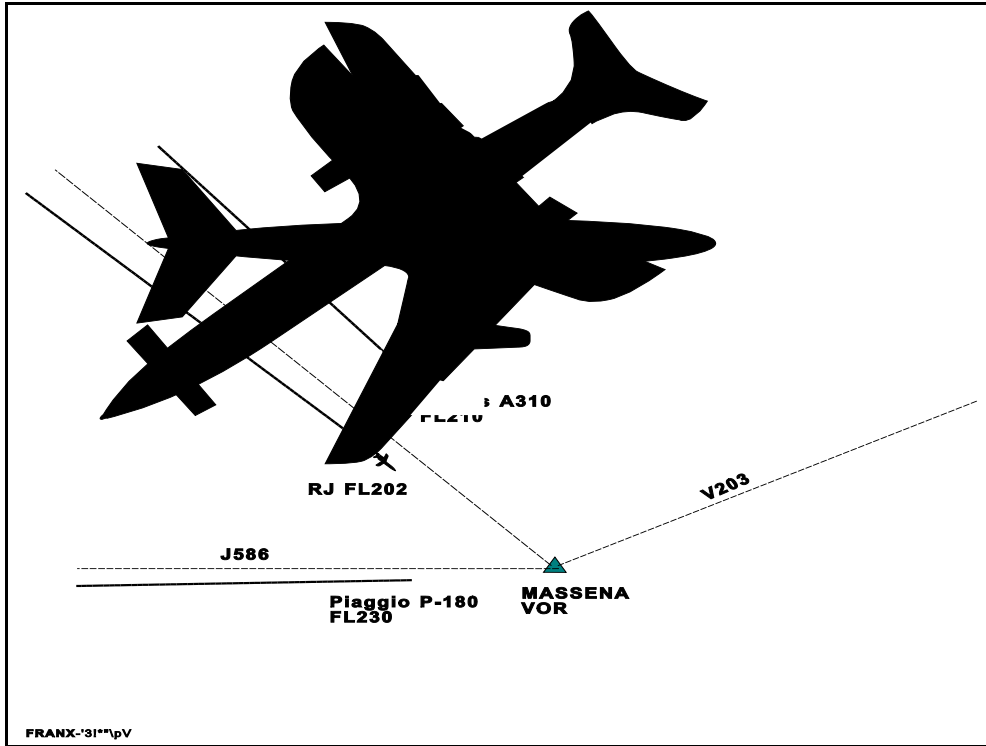
The captain misheard the clearance from the Valley controller and requested confirmation that the clearance was to climb to FL300. As well, he repeated what he thought was the instruction to turn right to a heading of 170° (30° right). The Airbus began a right turn but then reversed when the Valley controller repeated the instruction to turn left 30°. By the time the captain was able to reverse the turn, the aircraft had turned through approximately 20° and closed to 3.7 nm from the RJ. At the time, the aircraft were separated vertically by approximately 800 feet (Appendix A, Figure 1).

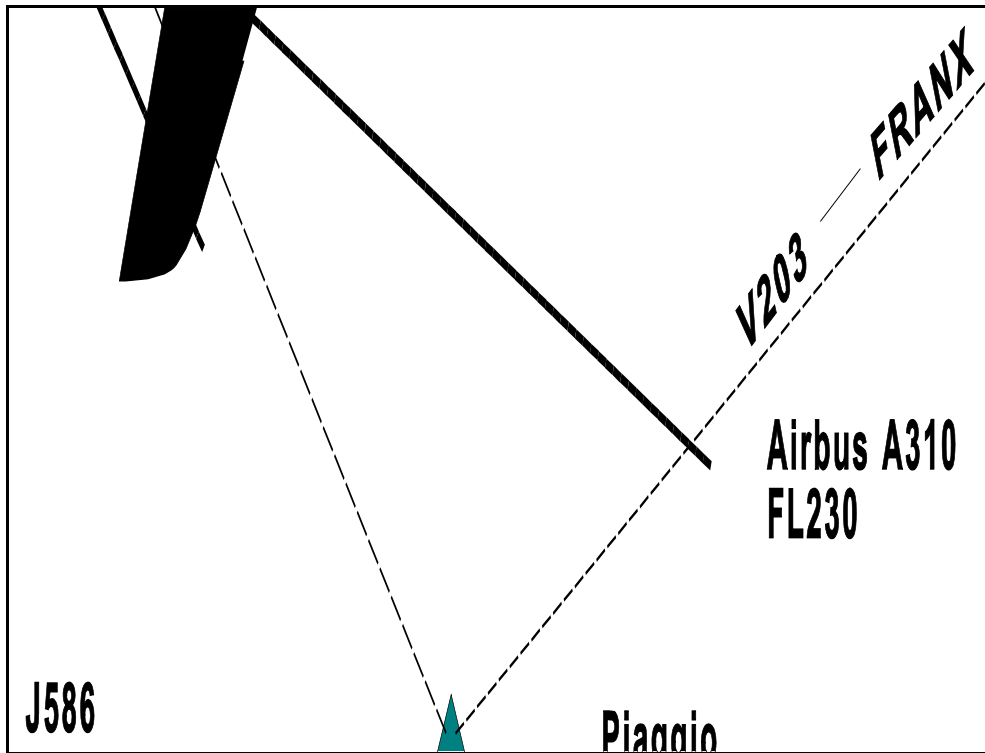
of (to the right of) the Airbus. The OJI issued an instruction to the Airbus to turn right immediately to a heading of 080°. Without waiting for a reply, the OJI then issued an instruction to the Piaggio P-180 to turn right to a heading of 150° immediately. This instruction was followed by a third transmission from the OJI, the first part of which was to the Piaggio P-180 repeating the instruction to turn right to a heading of 150° and continuing without interruption to the Airbus to turn left to a heading of 060°. The crew of the Airbus stayed on their heading of 110°, and the Piaggio P-180 crew turned right. The two aircraft approached to within 3 nm while at the same flight level (Appendix A, Figure 2). The OJI did not issue a safety alert using the phraseology recommended in ATC MANOPS.
