AVIATION INVESTIGATION REPORT

A01Q0122

RISK OF COLLISION

18 JULY 2001

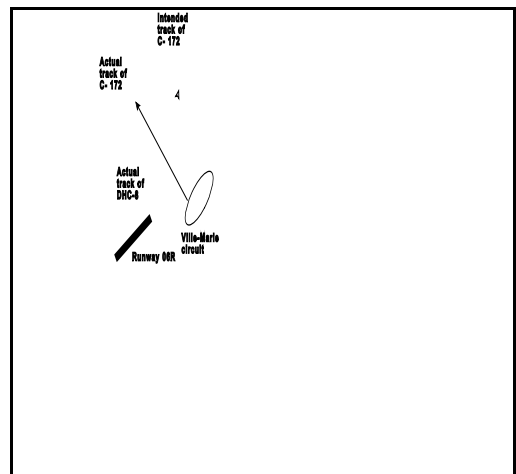
Intending to watch the fireworks at the La Ronde amusement park on Sainte-Hélène Island, Quebec, a pilot rented a Cessna 172N, owned by Cargair Ltd. Around 2150 eastern daylight time,¹ the Cessna, with the pilot and three passengers on board, took off from Mascouche Airport on a sightseeing flight over Montréal under visual flight rules (VFR). Before entering the Dorval control zone, the pilot established communications on the Dorval tower frequency and was identified by radar. He received clearance to fly over Montréal and follow the Ville-Marie sightseeing circuit, maintaining an altitude of 1700 feet above sea level (asl). The Ville-Marie circuit is oval-shaped and allows aircraft to fly over the city while remaining south of the departure paths of Dorval / Montréal International Airport runways 06R and 06L. The circuit extends about 8 nautical miles (nm) from northeast to southwest. The southwest end is closest to the airport, 4 nm east of the Runway 24L threshold (the end of Runway 06R). (See Figure 1).

Besides showing that the Cessna's Mode C was transmitting altitudes that varied from its actual altitude by more than 300 feet, radar data also revealed that the Cessna, from the time it left the circuit, maintained a heading of about 300° instead of the northerly heading assigned to it by the tower. Figure 1 indicates that the Cessna crossed the flight path of the DHC-8 sooner than expected, allowing less time for the DHC-8 to reach a higher altitude than the Cessna, which had been instructed to maintain 1500 feet asl.

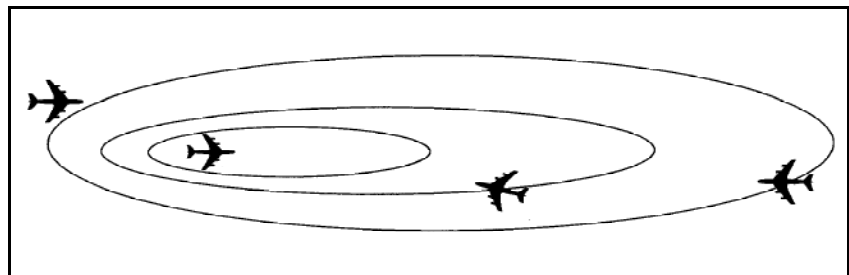
The return signal is tracked by the TCAS, allowing it to predict the track of an aircraft. The TCAS is designed to prevent other aircraft from entering a collision area. (See Figure 2.) The TCAS defines a collision area as a three-dimensional airspace whose dimensions vary according to the closure rate. If an aircraft is on a track that will lead it inside the collision
