AVIATION INVESTIGATION REPORT

A01W0129

LOSS OF SEPARATION

Nav Canada
Edmonton Area Control Centre
Edmonton, Alberta
31 May 2001

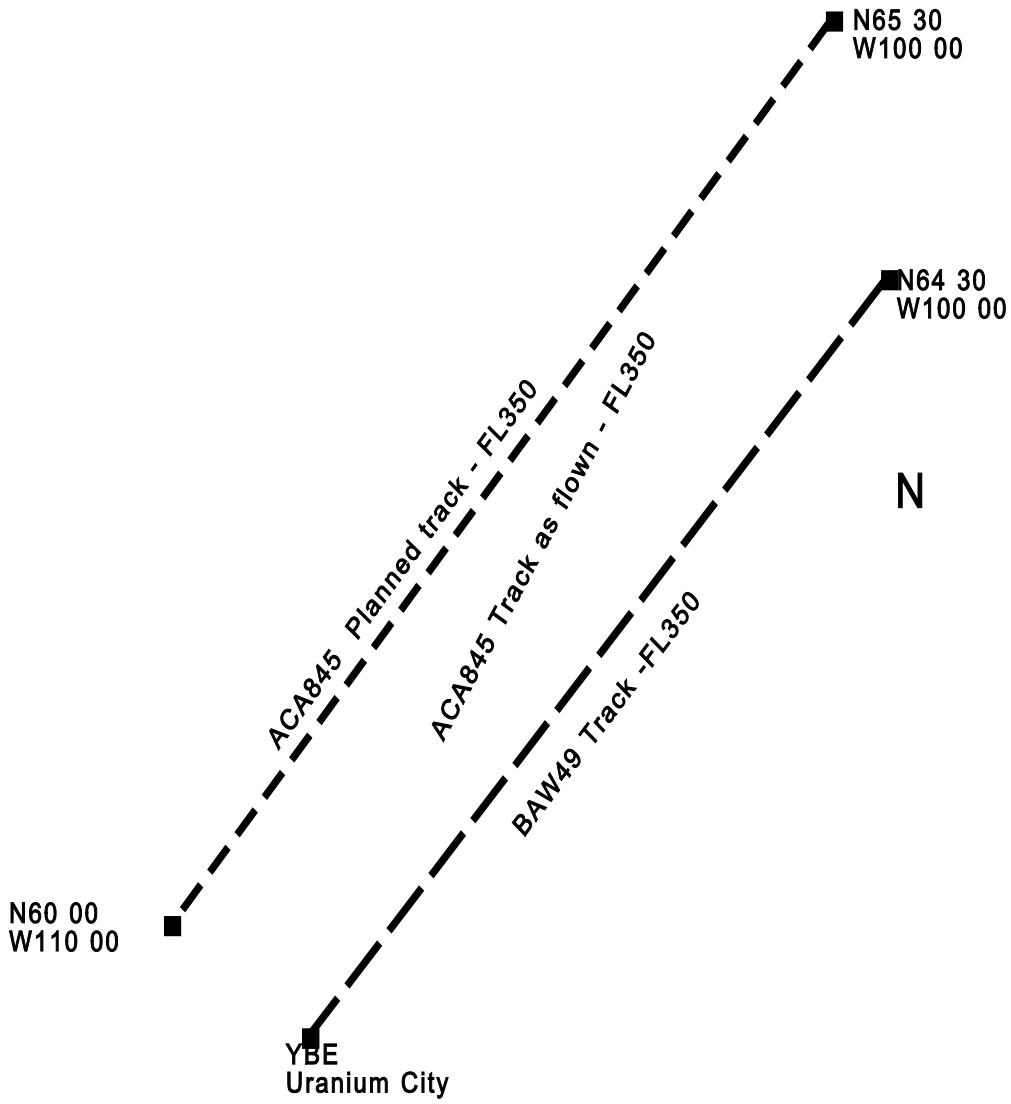
Appendix A—Aircraft Tracks

ACA845 proceeded from 6530N100W direct to TORON as it had been cleared. BAW49 was on a converging track from 6430N100W to Uranium City (YBE), Saskatchewan. Both aircraft observed each other on the traffic alert and collision-avoidance system (TCAS) and visually. The flight crew of ACA845 contacted BAW49 directly because the two aircraft were out of the Franklin sector's VHF radio range, and it was evident that the

aircraft were going to cross paths. ACA845 paralleled BAW49's flight for approximately five minutes until they were able to contact the Bison sector controller directly via the assigned VHF frequency.

ACA845 contacted the Bison radar controller at 1945 and advised that they were deviating to the right for traffic and that they had been heading direct to TORON. When the controller asked ACA845 to verify that they were proceeding to 60N110W as their next reporting point, ACA845 replied that they had been cleared direct to TORON from 6530N100W. ACA845 was then cleared to maintain FL370, and separation was regained.

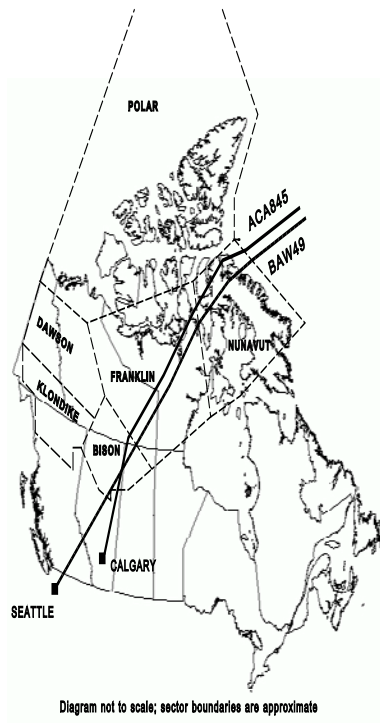
Appendix B—Sector Boundaries and Original Flight-Planned Tracks

The north high specialty of Edmonton Area Control Centre (ACC) consists of five sectors that use procedural (non-radar) separation standards and one sector (Bison) that provides procedural and radar control. (See Appendix B.) Aircraft in the procedural control areas are separated by assigning specific routes and altitudes for the aircraft to fly. Confirmation of separation is provided by periodic position reports, which are typically passed by flight crews every 10° of longitude or over mandatory reporting points. Depending on the location of the aircraft, these reports are received by the controllers in one of two ways. In the Far North, reports are routed through very high frequency (VHF) or high frequency (HF) remote communications outlets (RCOs) to Arctic radio specialists in North Bay, Ontario. The information is then relayed to the Edmonton controllers via landlines. Further south, flight crews provide position reports via VHF RCOs that are directly accessible by Edmonton controllers.

specialty was handling mostly westbound traffic from Europe headed for the western parts of North America. (See Appendix B.)
