AVIATION INVESTIGATION REPORT

A01W0269

CONTROLLED FLIGHT INTO TERRAIN

CESSNA 208B C-GGUH

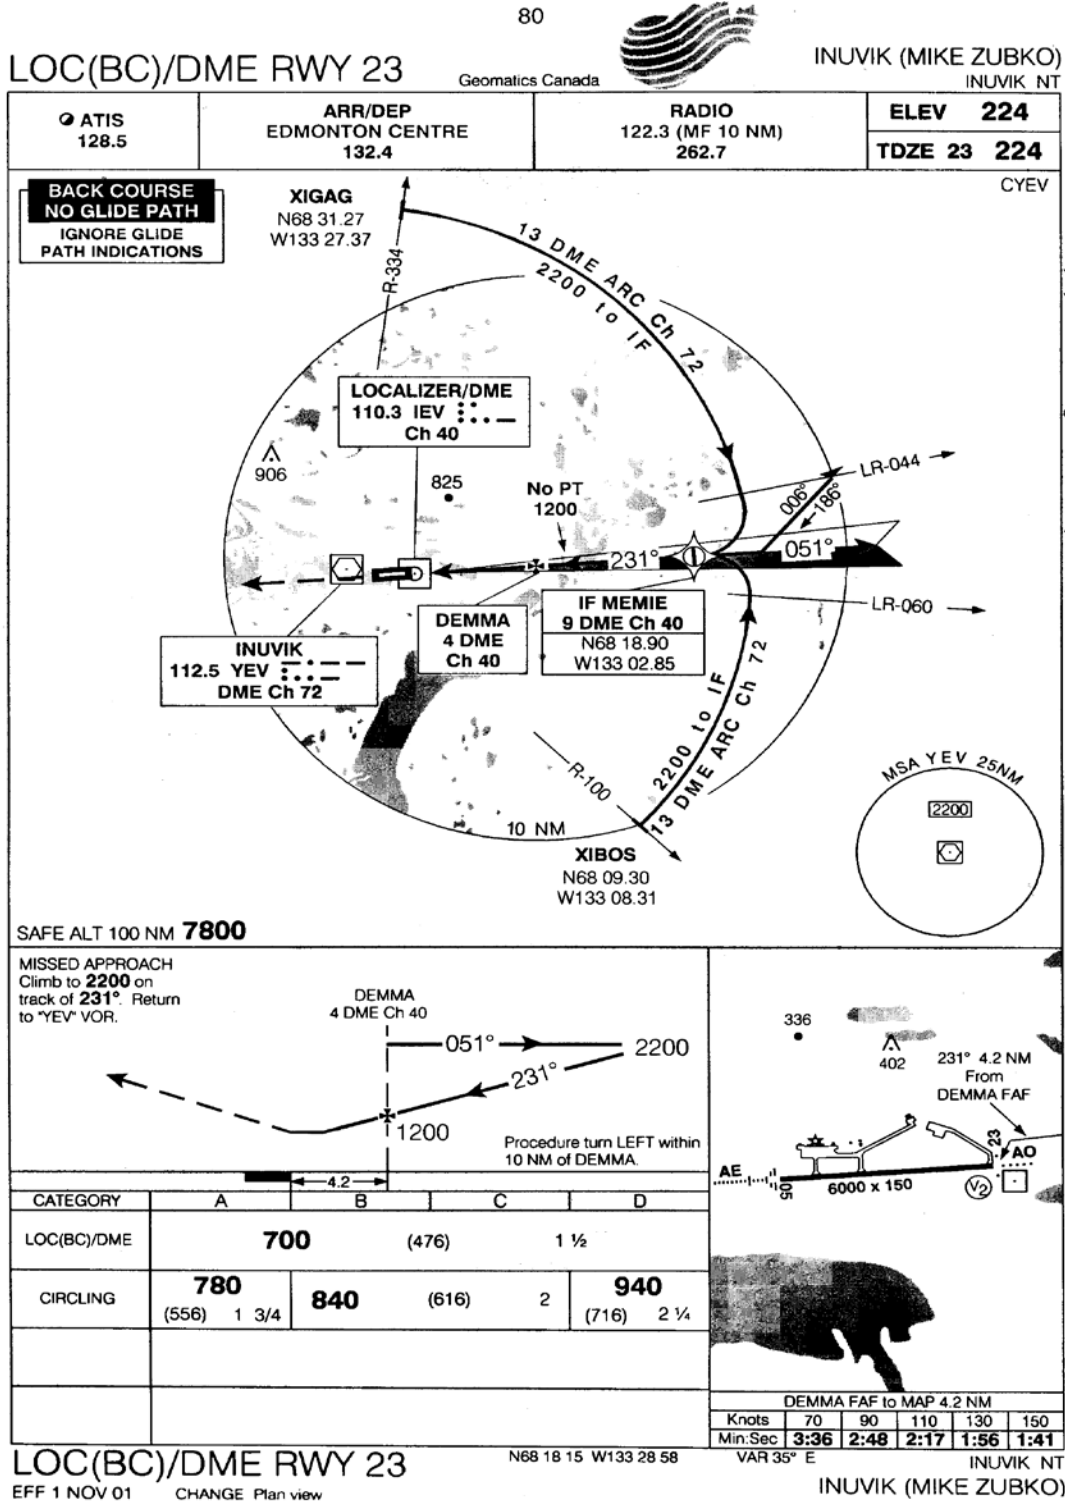
Appendix A — Approach Chart, Inuvik (Mike Zubco) Airport

On initial contact with the ACC, the pilot was cleared to the Inuvik 330° radial at 20 DME (distance measuring equipment) to maintain 3000 feet asl in controlled airspace. When the aircraft was at 26 DME, the ACC controller cleared C-GGUH to Inuvik Airport for an approach. The pilot was then instructed to call Inuvik FSS. When in contact with the FSS, the pilot indicated his intention to conduct an instrument approach to Runway 23. Subsequent traffic developments in the airport area made it necessary for the ACC controller to specify an approach for C-GGUH, and the pilot was again asked to call the ACC. The ACC controller cleared C-GGUH to Inuvik Airport for a straight-in localizer back-course DME Runway 23 approach via the 330° radial to intercept the 13 DME arc transition. When the pilot re-established contact with the FSS, the aircraft was at 2200 feet asl, 21 DME from the VOR. The minimum sector altitude (MSA) for this approach 25 nm or less from the Inuvik VOR is 2200 feet asl. (See Appendix A).

Radar returns from C-GGUH recorded by the Department of National Defense, North Bay, indicate that C-GGUH was never established on any part of the approach for Runway 23. The aircraft overflew the 13 DME position by about three nautical miles, while approximately on the 330° radial, then made a turn to the southeast. After two to three miles on this track, the aircraft turned southward. Four nautical miles further on, the aircraft struck the ground. The radar recording did not include altitude information.
