AVIATION INVESTIGATION REPORT

A02P0007

AIR PROXIMITY - RISK OF COLLISION

08 JANUARY 2002

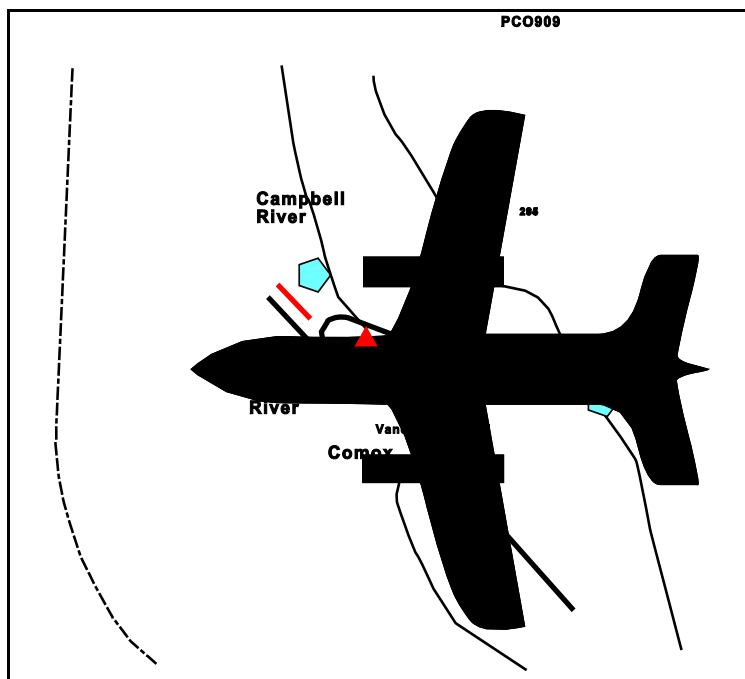
at the Campbell River airport. Therefore, left-hand circuits applied. Under the existing level of air traffic service being provided by the Campbell River FSS, the crew of PCO909 arriving VFR from the east—the upwind side—had two standard arrival options. They could join straight-in on the final leg, or they could cross the airport at mid-field and turn left to join the left downwind leg<sup>4</sup> on the west side of the airport. After reporting on a right base leg for Runway 29, PCO909 maintained an altitude of 800 feet and continued on a track of about 265 degrees directly to the airport. At about 3 nm from the airport, the crew reported that they were below low cloud and were turning back out to the ocean—no direction of turn was given—and confirmed they were clear of the approach. During this manoeuvre, however, the left turn brought PCO909 onto the localizer for Runway 29 in a direction opposite to the approach path on which GLR689 was established.

GLR689 had descended into cloud and was within 5 nm of the airport when the crew responded to the TCAS resolution advisory (RA). During these manoeuvres, the crew of each aircraft established visual contact with the other. Both aircraft climbed through 1300 feet asl at the same time, in opposite directions, with spacing between the two aircraft increasing through 0.6 nm. The cloud tops at the time were at about 1200 feet asl.
