AVIATION INVESTIGATION REPORT

A02P0021

IN-FLIGHT ENGINE NOSE DOME DETACHMENT

BOEING 737-200 C-FAWJ

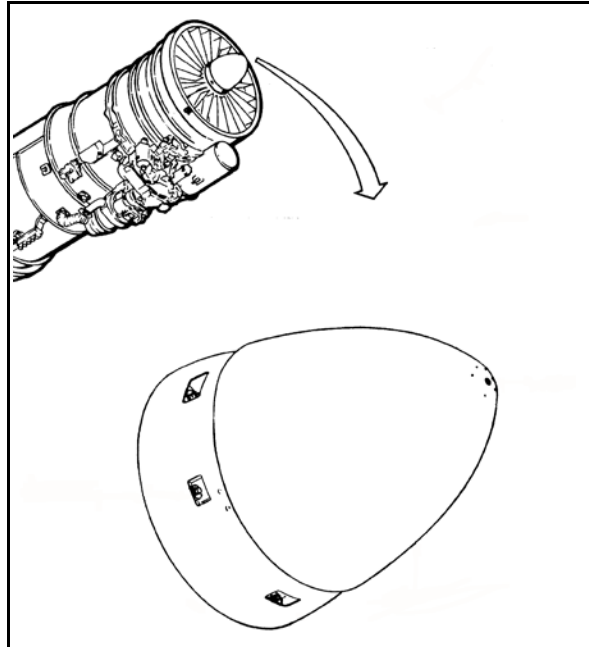
After the engines were shut down, maintenance personnel found that the extended nose dome assembly (see Figure 1) of the No. 2 engine had detached and jammed into the engine inlet guide vanes. The nose dome had broken away from the magnesium engine accessory support to which it is normally attached with four nuts. The nuts are threaded onto steel studs on the accessory support. Examination found that the four nuts had remained attached to the studs, but that the studs had pulled out from the accessory support, and a section of the support near the number-three stud was missing. The nose dome showed secondary impact damage and deformation as a result of contact with the inlet guide vanes. This damage included deformation of the tip, separation of one of the acoustic panels and partial delamination of another, and deformation of the aft edge of the nose dome.

1. The studs from the front accessory support had pulled out and remained with their respective nuts in the nose dome assembly. The attachment points of the nose dome were subsequently removed and then sectioned to extract the stud/nut assemblies intact. The coarse thread of stud number one was heavily smeared with significant damage to the thread crests. The coarse thread of studs number two, three and four were filled with material from the front accessory support. The surface of the pulled-out front accessory support material on studs two and four appeared smoother than that of the material in the thread of stud number three. Also, stud number three was slightly bent.

2. The thread in stud boss number one had been completely removed to the depth of the stud engagement and the bore appeared somewhat polished. The thread in stud bosses two and four were similar in that, although the thread had been removed, the thread roots were still distinguishable, and the surfaces where the crests had been removed showed some rub damage. The thread in stud boss number three showed only partial crest removal.

3. Longitudinal sections taken from the front accessory support at stud bosses one and three were mounted for metallurgical analysis. Examination of the mounted sections showed that nine thread crests had been sheared off in each case, with axial deformation consistent with stud pull out. The fracture faces of the sheared thread from stud boss number one were more planar than those of stud boss number three suggesting that: a) stud boss number one had failed earlier than stud boss number three and had been working for some time and b) stud boss number three failed in a combined angular/axial fashion. Longitudinal sections taken through studs one and two were mounted for metallurgical analysis. Significant thread crest damage was observed on the first four threads of stud number one. Flow lips observed either side of the affected thread crests are consistent with rotational interaction with a harder material. Direct Rockwell hardness testing of the stud material averaged 29 Rockwell (HRC) for both studs examined. These results are typical for this particular application and within the specified hardness range of 26-32 HRC.

The findings of the TSB Engineering Branch report suggest that the coarse thread of stud number one was significantly damaged prior to installation in the thread of the stud boss. Installation of stud number one resulted in damage to the thread of stud boss number one. Eventually, the remaining thread material in stud boss number one could no longer maintain the required hold down stress, failed in shear, and began to work in the stud boss, polishing the bore as observed.

The loss of clamping force at stud number one resulted in a disproportionate load on studs two and four. Eventually, the stud boss thread holding studs two and four in the front accessory support weakened and failed in shear, again followed by some working in the bore, generating the rub damage observed. Finally, the total hold down clamping force provided by studs one,

two and four was insufficient to resist the applied loads, and the nose dome levered stud number three out of the front accessory support, bending stud number three and breaking off stud boss number three in the process.

The damage to stud number one was most likely a result of rotational engagement with a harder material. As the front accessory support is manufactured from a cast magnesium alloy, which is a significantly softer material than the stud material, and there are no threaded inserts in the front accessory support, stud number one could not have been damaged during installation. Damage as a result of previous installation in a heli-coil repaired stud boss was initially suspected; however, the symmetrical nature of the thread crest damage to the stud and the large number of affected thread crests suggests that this was not the cause. Possible scenarios which would lead to the type of thread damage observed on the stud include rotation of the stud while held in a vise or rotation of locking pliers around the threads of the stud.

WestJet Airlines is carrying out a fleet-wide campaign to replace all engine accessory supports (part number 633759) with modified accessory supports that have strengthened stud bosses. The modified accessory supports have the threaded stud bosses reworked and stainless steel inserts installed in accordance with MTU Maintenance Canada technical order 72-21-01-01.
