AVIATION INVESTIGATION REPORT

A02P0096

LOSS OF CONTROL AND COLLISION WITH TERRAIN

BELL 206L4 C-FVEF (HELICOPTER)

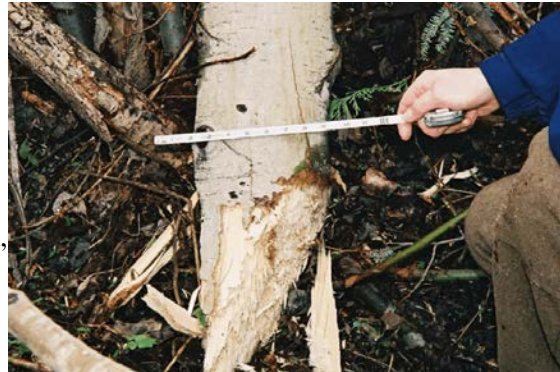
The main rotor blades were badly damaged and broken, and the damage indicates that rotor blades were coned upwards and at a high pitch angle when they broke. Many trees, ranging from a couple of inches to about 10 inches in diameter, were cleanly cut by the main rotor blades (see Figure 4 – many were cut on acute angles, and several trees were cut twice). The tree damage and blade damage indicate that main rotor rpm and energy was significant when the helicopter first entered the trees. The damage to the tail rotor blades and vertical fin is less, and characteristic of lower tail rotor rpm and energy. No indication of rotational scoring was found on any of the tail rotor drive shaft components, signifying that the damage to the tail rotor system occurred when the tail rotor blades were almost stopped.
