AVIATION INVESTIGATION REPORT

A04A0111

LOSS OF CONTROL - COLLISION WITH TERRAIN

AEROSPATIALE AS-350D C-GVHB

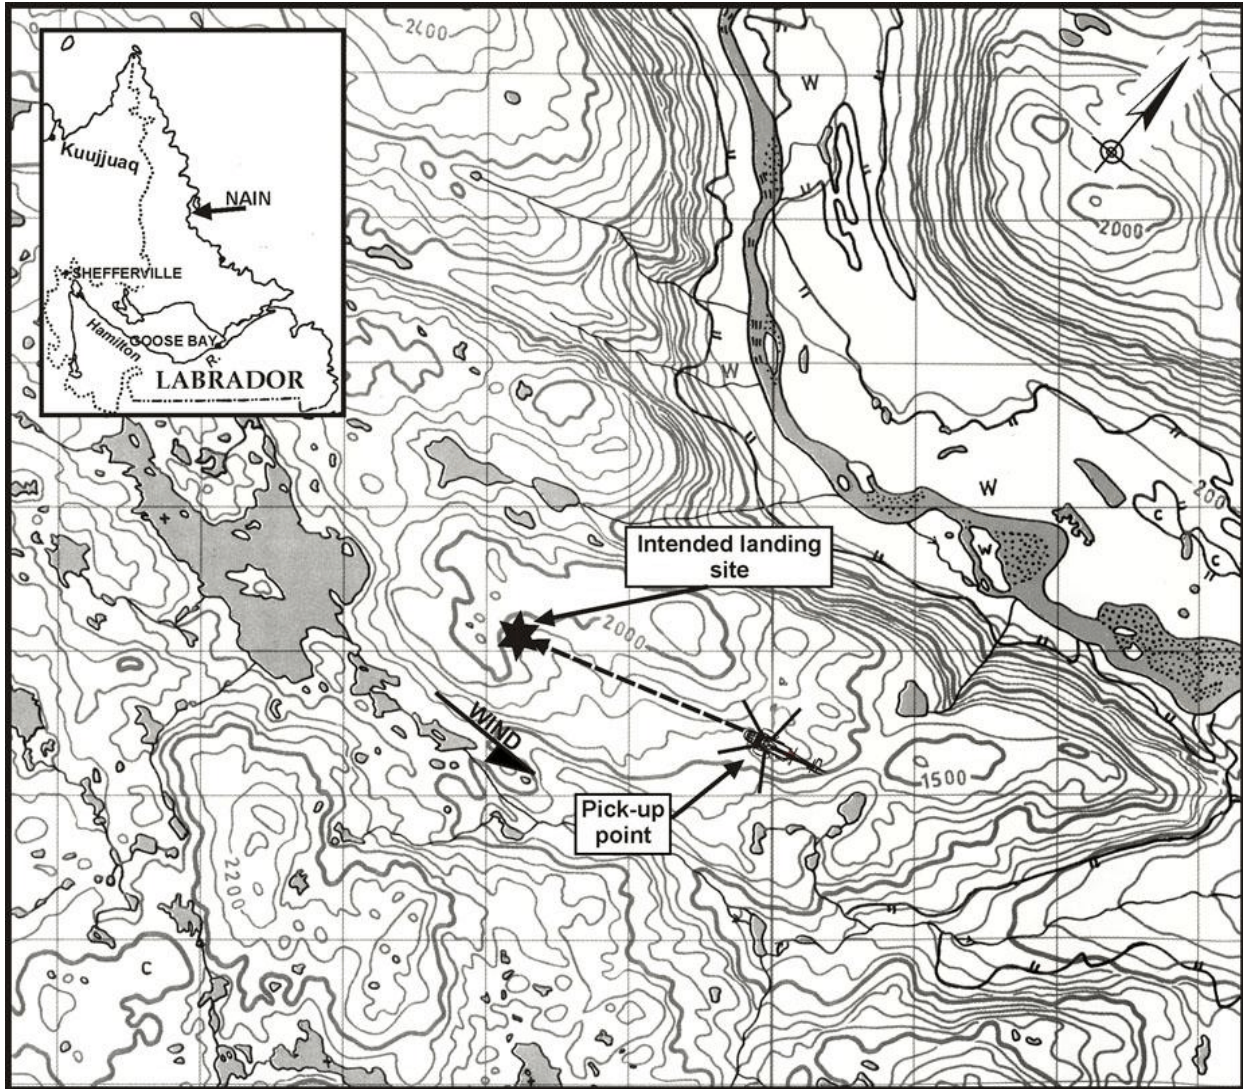
Appendix A – Site Map

The intended landing site was on the west side of the same ridge, approximately 300 feet higher in elevation than the previous site. The western edge of the ridge was L-shaped with the base of the L oriented north-south, and the stem oriented east-west. The base of the "L" was on the west side of the stem (see Appendix A). The top of the ridge line was 2100 feet asl and the landing site was located at an elevation of 1900 feet asl in the bowl formed by the two sides of the L. The prevailing winds were from the west and crossed the ridge at an angle of 90 degrees. The approach was flown directly into the centre of the bowl, without a reconnaissance pass.
