## AVIATION INVESTIGATION REPORT

A04P0047

### RISK OF COLLISION ON THE RUNWAY

NAV CANADA  
VANCOUVER TOWER  
VANCOUVER INTERNATIONAL AIRPORT,  
BRITISH COLUMBIA  
03 MARCH 2004

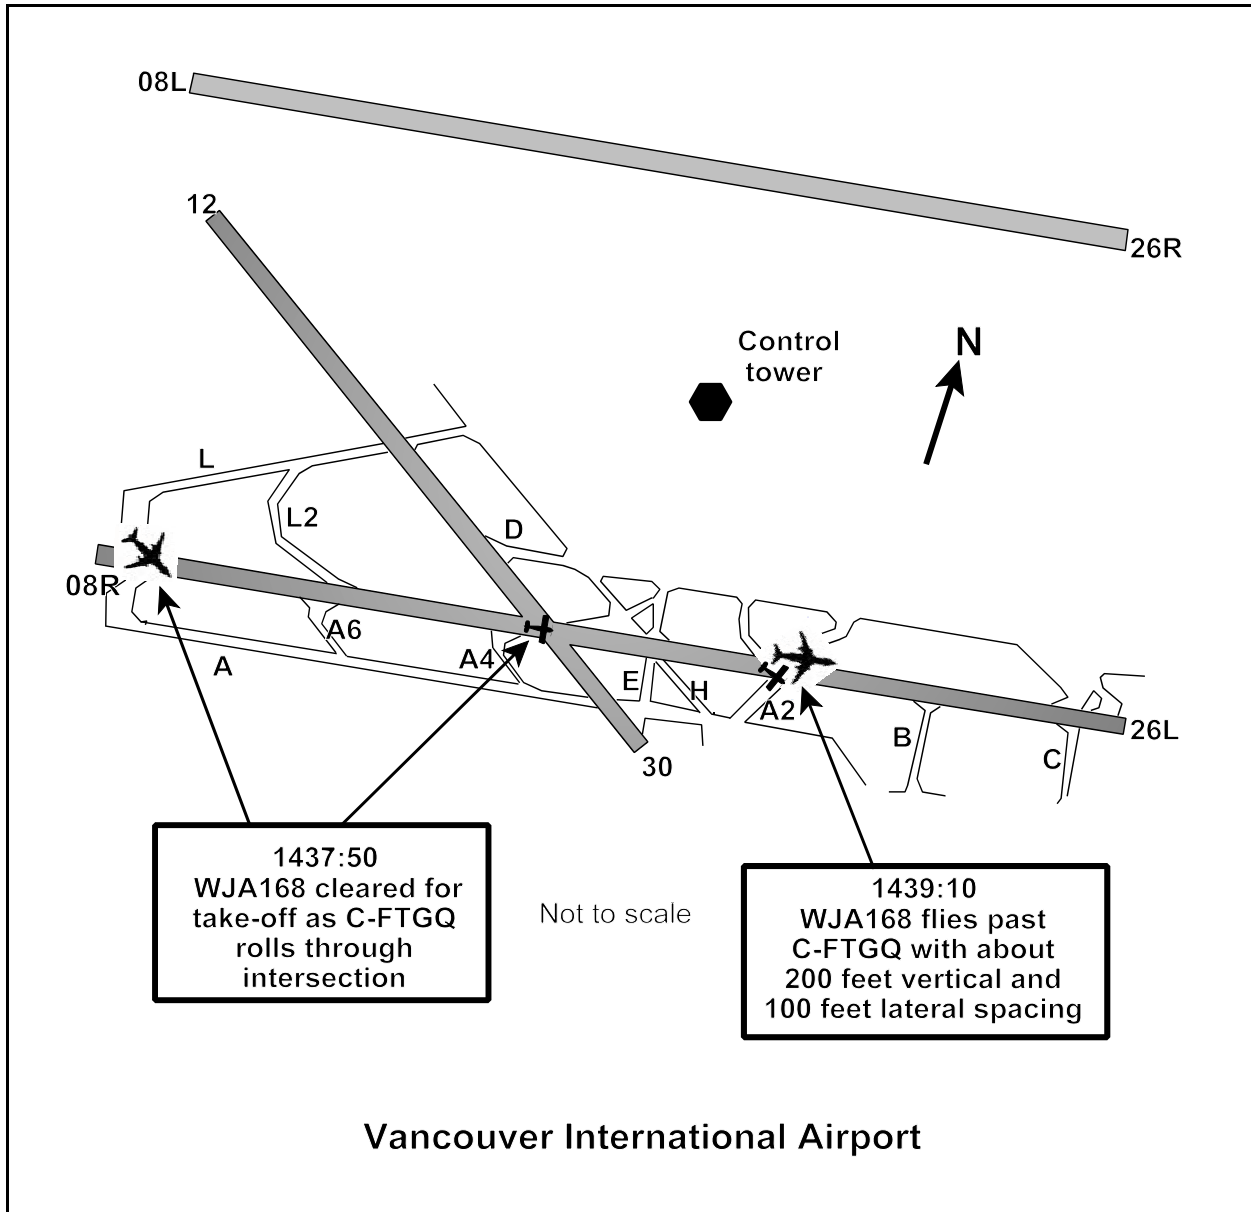
# Appendix A – Near Miss Between WJA168 and C-FTGQ

After WJA168 had passed 80 knots on the take-off run, the pilot flying saw a light ahead near the side of the runway. He alerted the pilot not flying, and both pilots looked for the source of the light. On hearing the TS controller instruct an aircraft to expeditiously vacate the runway, the pilot flying saw the Cessna. Assessing the situation, he determined that there was sufficient room to continue the take-off and avoid the other aircraft, rather than abort the take-off at high speed thus risking a collision on the runway. WJA168 rotated at approximately 145 knots just beyond the intersection of Runway 12. A replay of the airport surface detection equipment (ASDE) radar showed that WJA168 passed approximately 100 feet to the left of the Cessna at an estimated height of approximately 200 feet. At the time, the Cessna was still on the runway at the entrance to Taxiway A2.
