AVIATION INVESTIGATION REPORT

A04P0153

AIR PROXIMITY – SAFETY NOT ASSURED

VANCOUVER INTERNATIONAL AIRPORT,

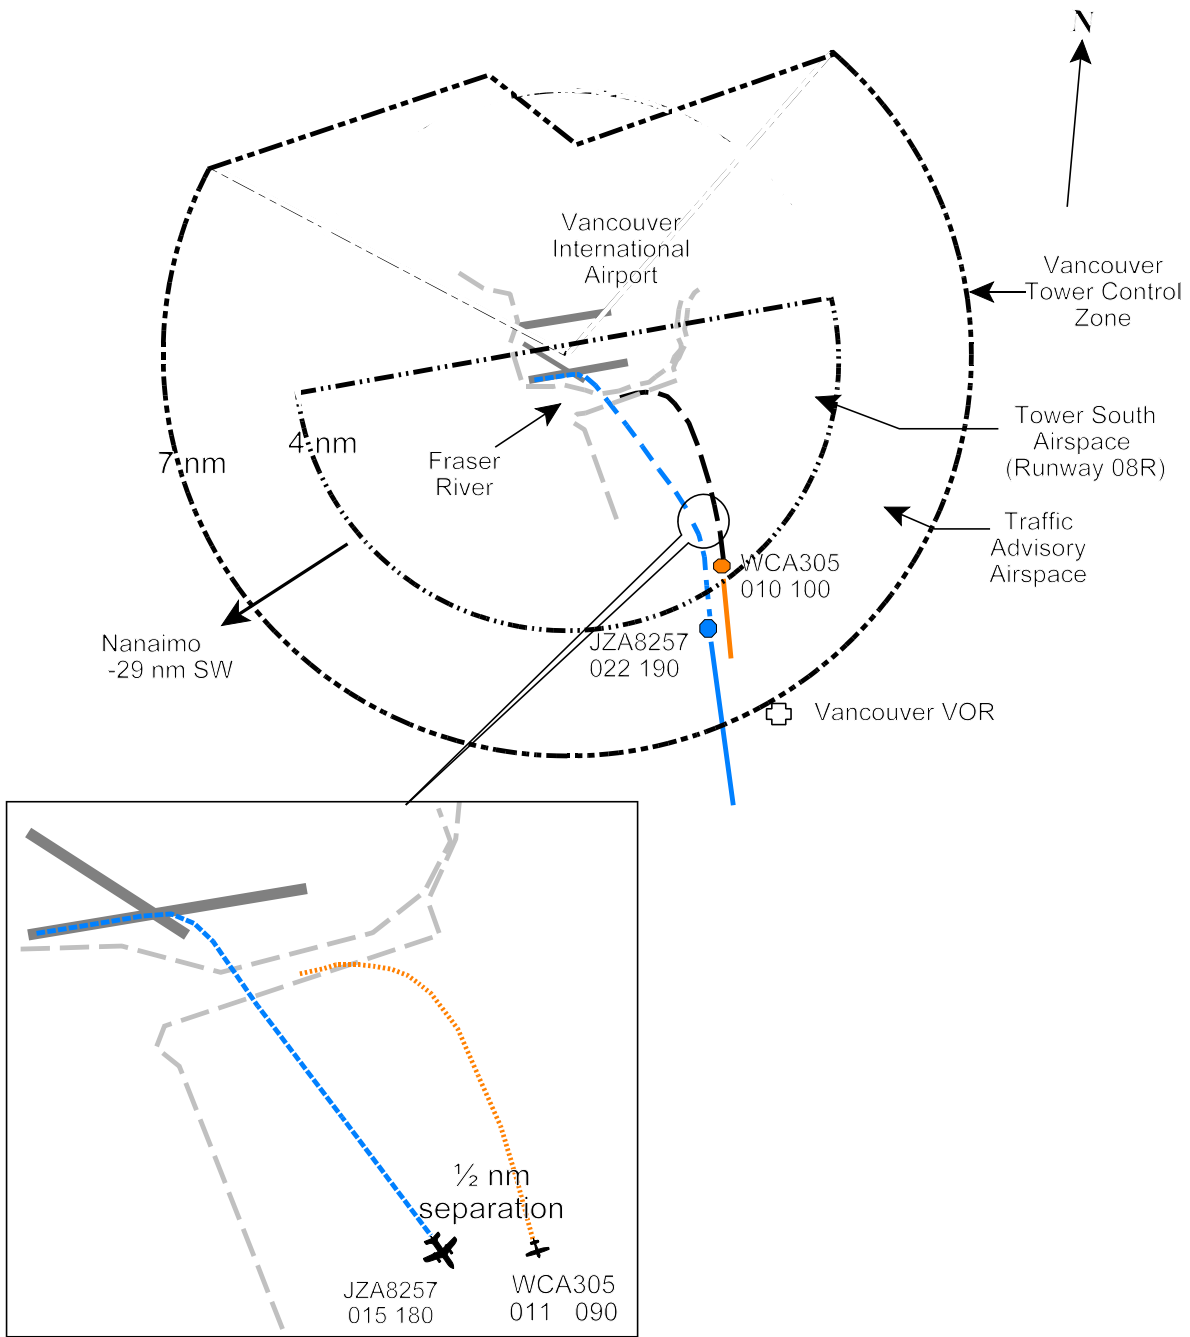
Appendix A – Area Diagram

At 0818:47, the two aircraft reached their closest proximity laterally, approximately ½ nm. At this point, they were separated only 400 feet vertically and safety was not assured.

JZA8257 sights WCA305 and turns right to avoid
