## AVIATION INVESTIGATION REPORT

A04Q0196

## LANDING BESIDE THE RUNWAY

**PIPER PA-31-350 C-GBYL**

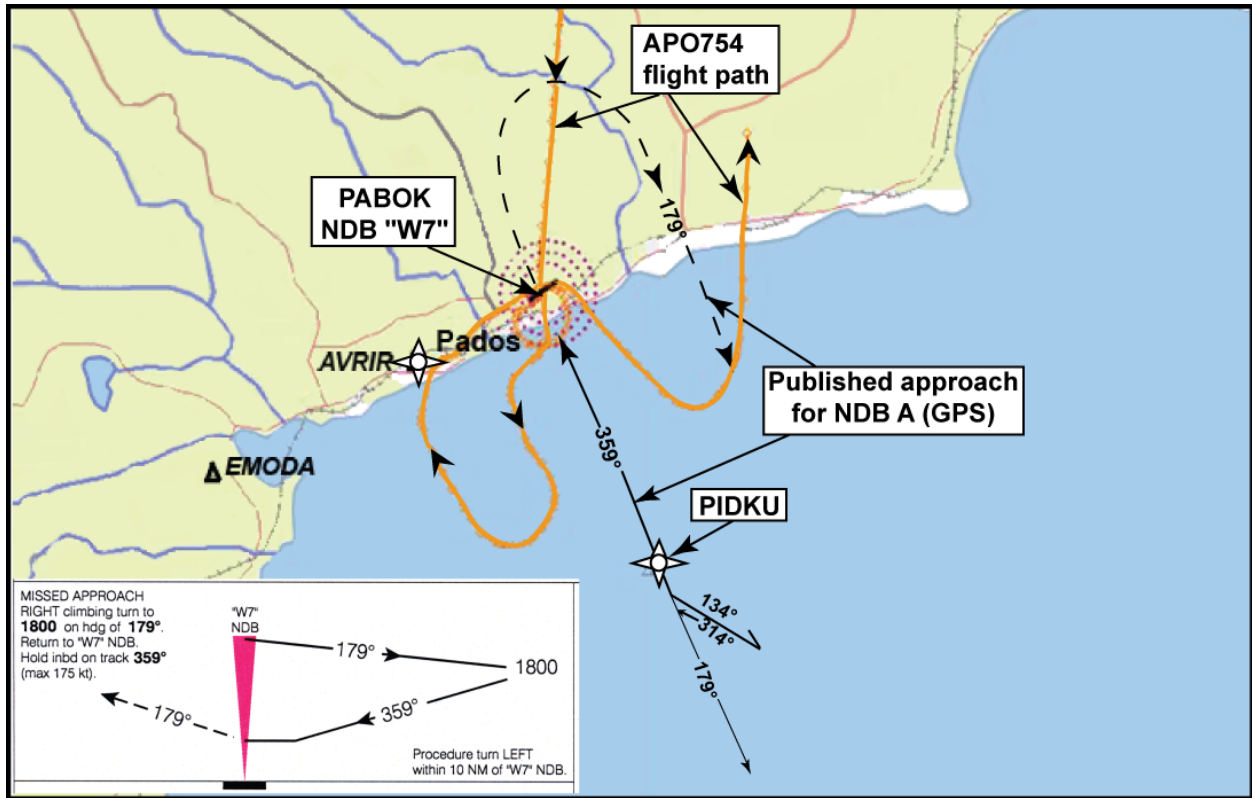
## Appendix A – Approach to the Du Rocher-Percé Aerodrome (Pabok)

1. Upon his arrival at Du Rocher-Percé, the pilot executed an improvised instrument approach, which suggests the use of a global positioning system (GPS) although neither the pilot nor the aircraft was certified for a GPS approach.
2. On the first approach at Gaspé, the pilot did not follow the published missed approach procedure, which reduced the obstacle clearance.

The following illustrates the aircraft's flight path compared with the published NDB A (GPS) approach path.

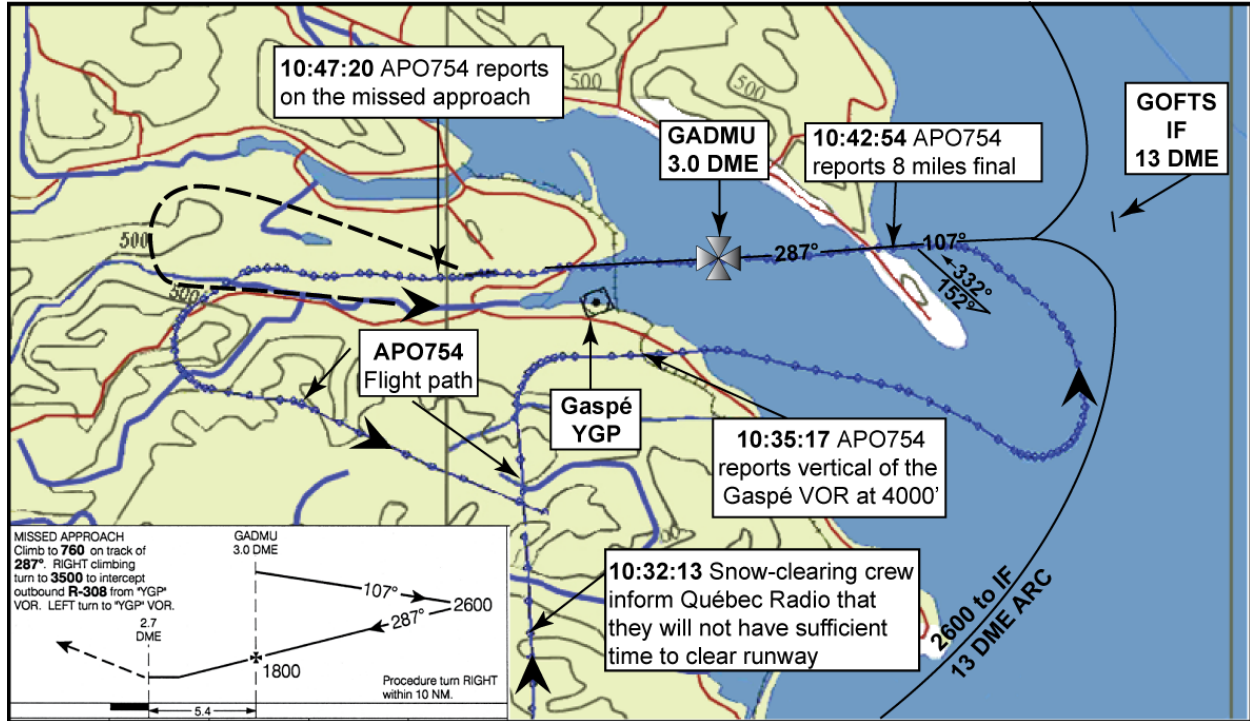
## Appendix B – First Approach to the Gaspé Airport

Because he could not see the runway, the pilot executed a missed approach but did not follow the missed approach procedure published on the approach chart he was using. Although the published procedure is designed to allow a missed approach safely away from the higher ground on the runway centreline, the pilot maintained the runway heading before turning left and proceeding southeast.

The following illustrates the aircraft's flight path during the first approach to the Gaspé Airport compared with the LOC (BC)/DME RUNWAY 29 approach path.

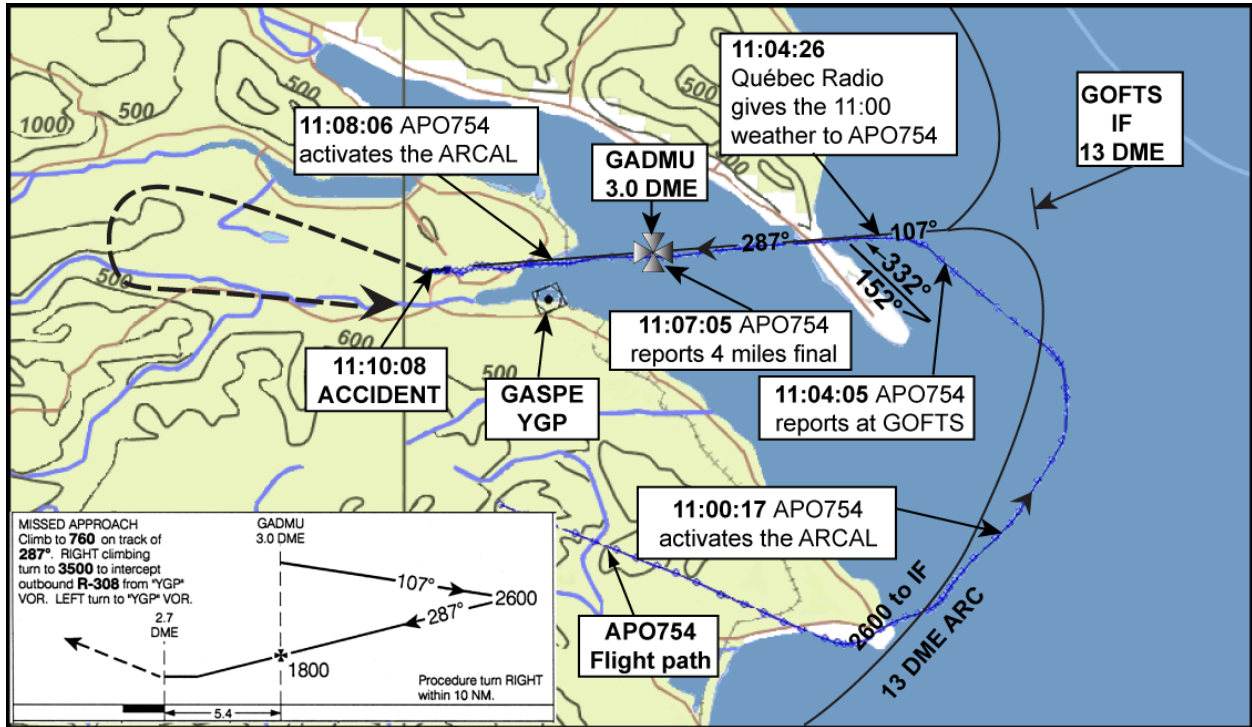
## Appendix C – Second Approach to the Gaspé Airport

Once the pilot finally saw a row of runway lights, he mistook the left row of lights for the right row. Since only one row of runway lights was visible, it was impossible for him to confirm the exact position of the runway and he should have initiated the missed approach procedure. For an undetermined reason, he assumed that the runway was below the aircraft even though he could not see the left row of lights, and he decided to land.

The following illustrates the aircraft's flight path during the second approach to the Gaspé Airport compared with the LOC (BC)/DME RUNWAY 29 approach path.
