## AVIATION INVESTIGATION REPORT

A05A0161

**WING CONTACT WITH RUNWAY DURING LANDING**

**BOEING 737-700 C-GWJF**

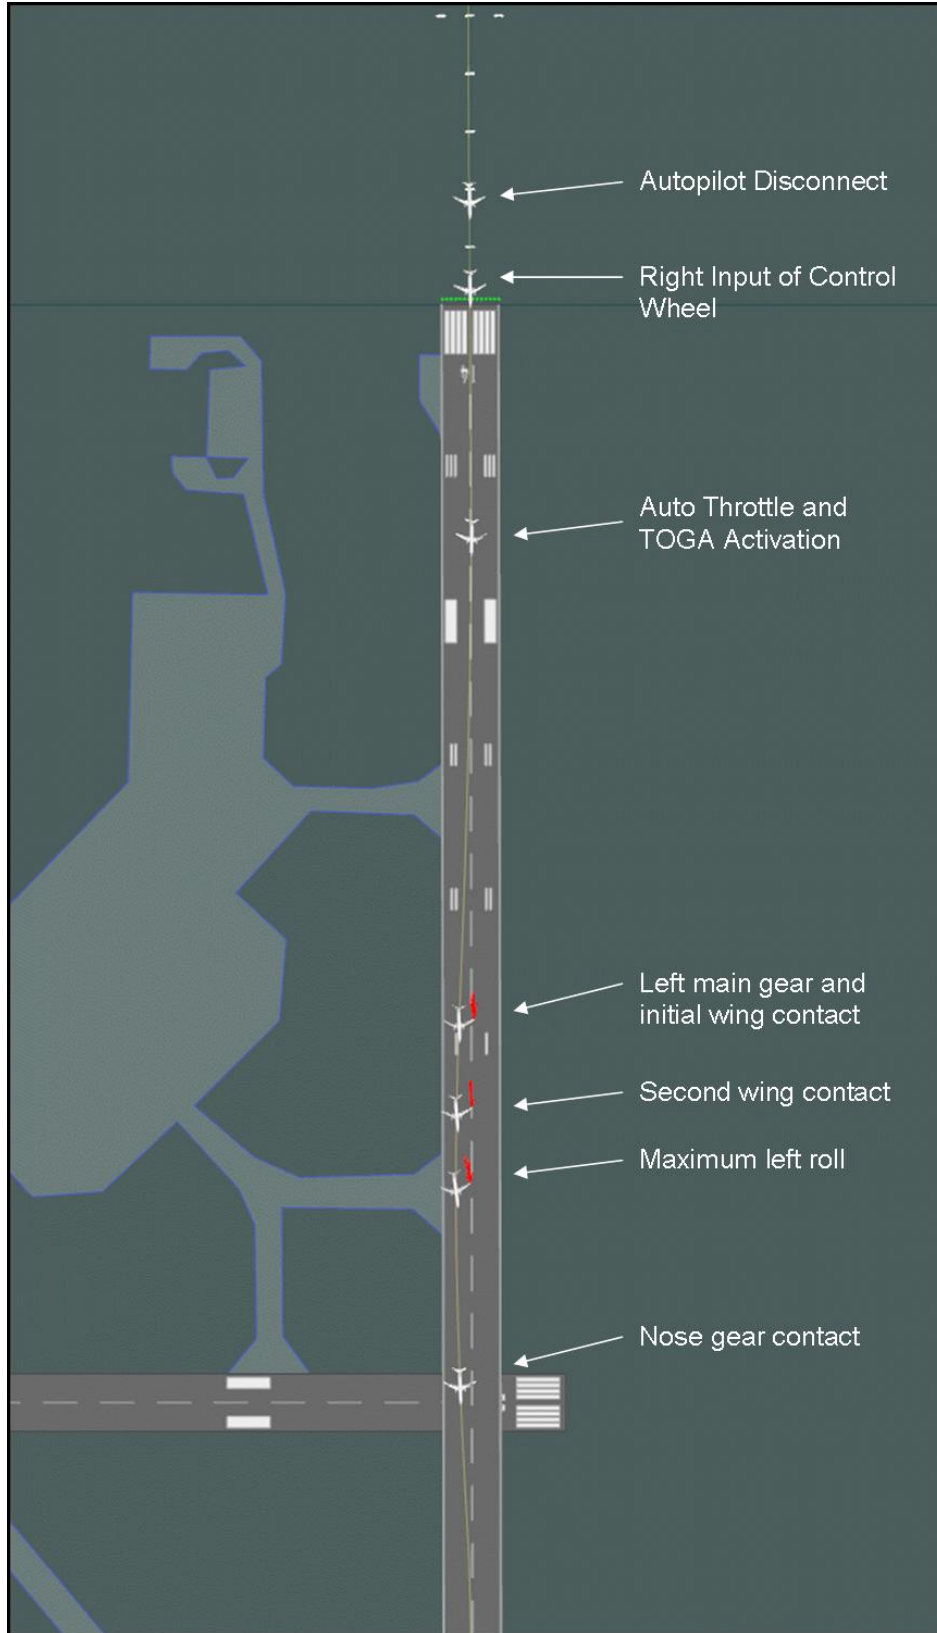
*Appendix A – Sequence of Events Illustration*

The aircraft remained aligned with the runway and on the ILS glide path until, at 67 feet agl,<sup>3</sup> the PF disconnected the autopilot. Immediately after, the PF unintentionally rotated the control column approximately 30 degrees clockwise towards right-wing-down, and also moved it slightly aft. This resulted in the aircraft rolling to the right and levelling off. The aircraft went above the glide path, and deviated three degrees from the runway heading to a heading of 147 degrees.

At 22 feet agl, the PF unintentionally depressed the take-off/go-around (TOGA) switch on the throttles instead of the auto-throttle disconnect switch. This was followed by immediate selection of the auto-throttle disconnect. The operator's standard operating procedures (SOPs) require that the auto-throttles be disconnected at no lower than 50 feet agl. The aircraft deviated to the right of the runway centreline. The PF attempted re-alignment using rapid and aggressive left and right control wheel movement. The captain gave verbal instructions to descend and turn left almost immediately after the deviations from the approach path, indicating that he had sufficient visual cues to correctly assess the aircraft's displacement.

The aircraft touched down firmly on the left main landing gear at about 2500 feet from the runway threshold, between the centreline and the right edge of the runway, with 16 degrees of left bank. Concurrently, the left wing contacted the runway surface for approximately one-half second. The left main landing gear strut then extended to nearly full length, and the left bank increased to 18 degrees. The wing contacted the runway again for approximately two seconds, and simultaneously, the aircraft heading deviated left to 136 degrees, or 8 degrees left of the runway heading.
