**AVIATION INVESTIGATION REPORT
A05F0025**

HYDRAULIC FLIGHT CONTROL MALFUNCTION

**VANCOUVER ISLAND HELICOPTERS
EUROCOPTER AS 350 B2 (HELICOPTER) C-GNMJ
KAMARANG, GUYANA
06 FEBRUARY 2005**

Report Number A05F0025

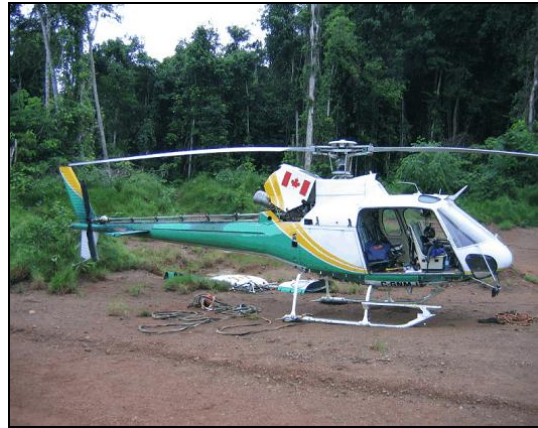
The helicopter was substantially damaged by the hard landing. During the two ground collisions, the left skid tube was fractured but remained intact, still providing support for the helicopter. The hard landing caused the tail boom to whip down, and formed a small kink in the skin, just aft of the main fuselage attachment frame (tail boom junction frame) (see Photo 1).

Photo 1. C-GNMJ after the hard landing

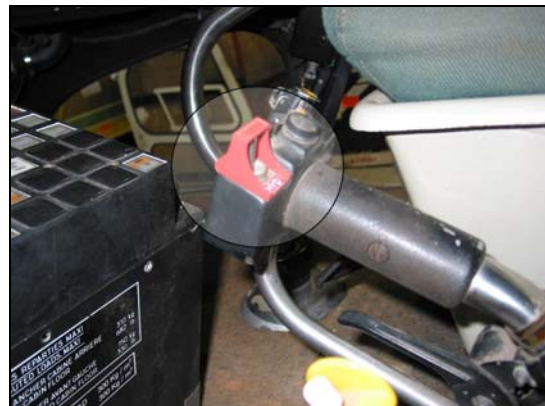
Photo 2. Hydraulic cut-off (HYD CUT OFF) switch

The collective HYD CUT OFF switch (Honeywell part number 12TW1-3) is a double-pole, double-throw (DPDT) toggle switch, which is attached to six insulated, flexible-strand wires that pass inside the collective lever itself. By design, the wires are soldered to the switch terminals and appropriately insulated. The HYD CUT OFF switch was disassembled by the TSB, and discrepancies that indicate a pre-existing condition that may have prevented normal switch function were noted. This switch is electrically protected by the hydraulic circuit fuse, which was noted to be intact during the examination. A continuity check and a functional test of the HYD CUT OFF switch were conducted, and discrepancies were noted.

The accident switch was poorly soldered and missing the insulating material. No indication of arcing was found on the terminals, but the switch contacts inside the sealed switch case were contaminated with dirt and dust. Bench-testing of the switch found no functional anomaly at that time. The detailed examination and testing of the switch found that the wire connections were cold-soldered, which is a soldering technique flaw. However, the connections were solid and exhibited electrical continuity.

Research conducted after the accident reveals several recent failures of this particular collective HYD CUT OFF switch (part number 12TW1-3). Furthermore, the failures were not confined to in-service switches, but also occurred to new switches supplied directly from helicopter manufacturer spare parts inventories. The TC Service Difficulty Report (SDR) database records instances where the switch operated intermittently or incompletely (that is, not all expected functions occurred).

The TSB Engineering Laboratory examined some of these failed switches, and determined that the 12TW1-3 switch is underrated for its present application in the AS 350 B2 (TSB Engineering Laboratory report LP 123/2005).

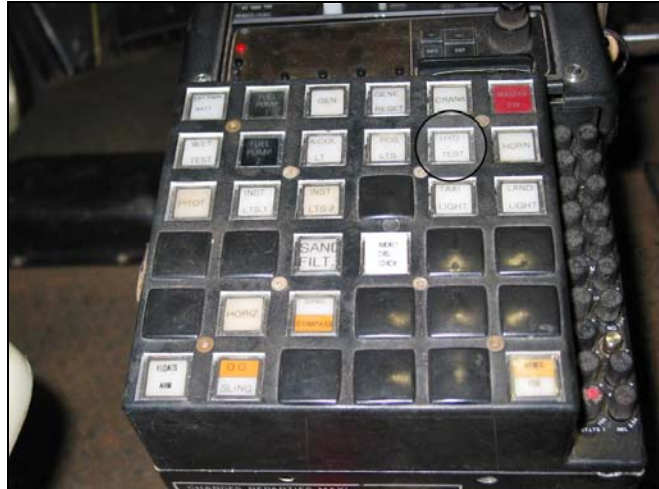
Photo 3. Hydraulic test (HYD TEST) switch

Immediately after the accident, the position of the HYD TEST switch was recorded as being in the normal OFF position. Had this switch been depressed, the klaxon horn would have sounded immediately; it did not sound until the pilot retarded the throttle and the main rotor rpm decayed.
