AVIATION INVESTIGATION REPORT

A05O0146

ENGINE POWER LOSS

CESSNA 185F C-GAXK

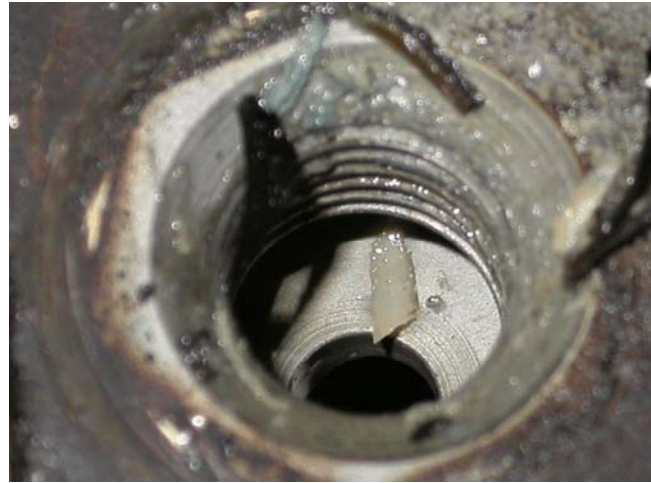
The EDP was examined for damage and wear that may have contributed to the abnormal pump operation. The bypass valve was removed from the vapour separator, and the ball and spring were removed from the EDP. A piece of foreign material, later determined to be thread sealant, was lodged between the ball and its seat (see Photo 1). This was the only abnormality noted. Teledyne Continental Motors (TCM) confirmed that any contaminant lodged between the ball and its seat would unseat the ball and allow fuel to flow through the bypass valve. This would cause a reduction in fuel pressure, which in turn would result in a loss of engine power. Selecting the auxiliary fuel pump on would provide a higher fuel pressure, which would allow the engine to run normally.

Photo 1. Piece of thread sealant in valve seat

The piece of foreign material lodged between the ball and the seat within the bypass valve of the EDP resulted in inadequate fuel pressure for normal engine operation unless the auxiliary fuel pump was on.

1. A piece of thread sealant lodged in the bypass valve of the engine-driven fuel pump created a reduction of fuel pressure, preventing normal engine operation.
2. A poor electrical connection within the auxiliary fuel pump resulted in intermittent operation of the pump. When the pilot re-selected the pump to provide additional fuel pressure to the engine, it did not operate.

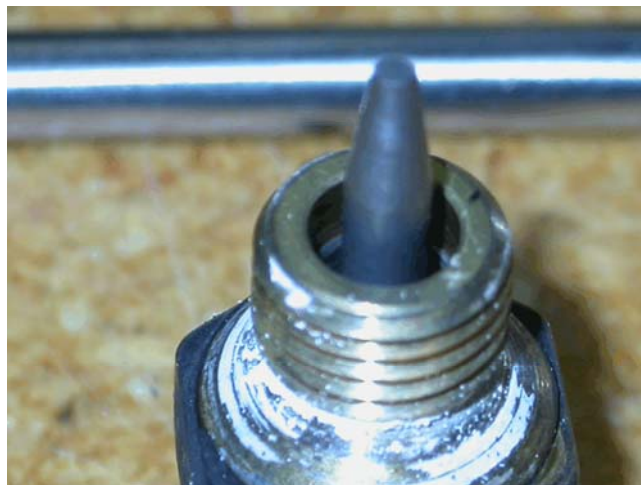
Photo 2. Fitting with excess thread sealant

was determined that the two sealants were not chemically identical. Furthermore, the beige sealant was not soluble in fuel and remained in a solid state even after it was immersed in fuel for several days. The amount and distribution of the beige sealant indicated that an excessive amount was applied to the threads on the fuel pump components (see Photo 2).
