## AVIATION INVESTIGATION REPORT

A05O0147

### COLLISION WITH WATER

CESSNA A185F SEAPLANE C-FHOP

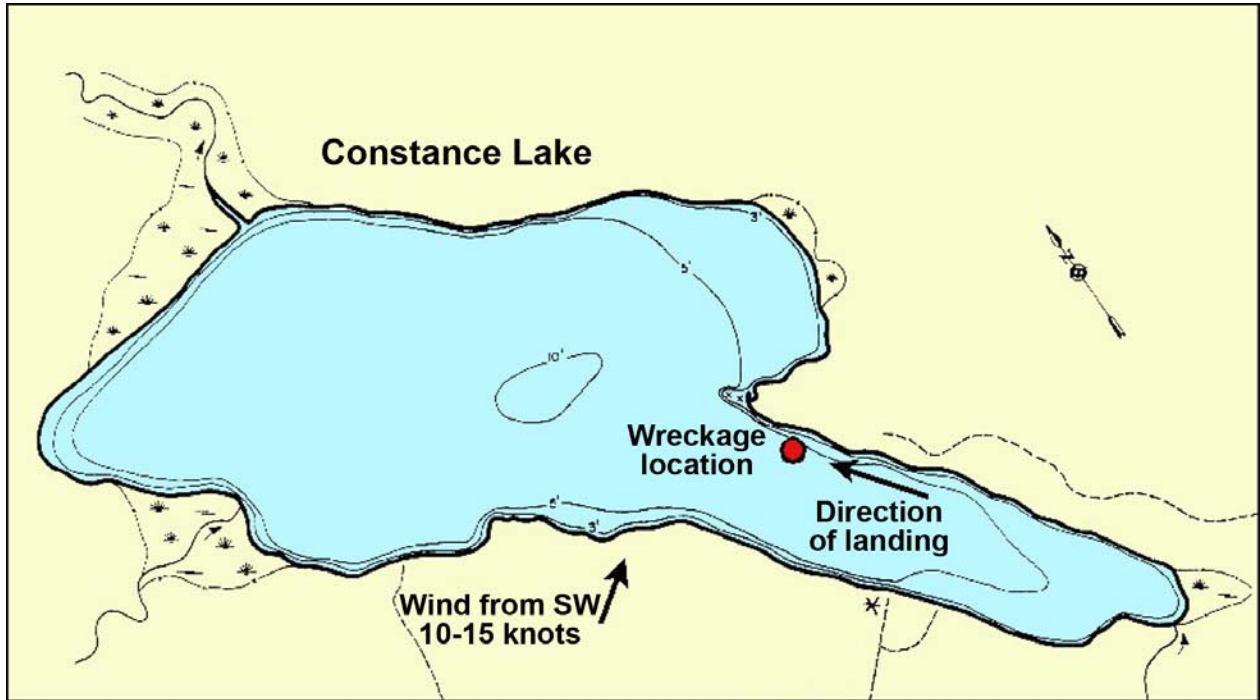
*Appendix A – Site Diagram – Constance Lake, Ontario*

At approximately 1050 eastern daylight time, the aircraft cartwheeled on the lake, travelling in a northwesterly direction and adjacent to the north shore of the eastern section of the lake. The aircraft came to rest inverted in the lake with most of the aircraft visible. It floated approximately 500 feet east, then came to rest on the bottom of the lake, with only the bottom of the floats visible. Some local residents attempted a rescue, but they were unable to get the pilot out of the aircraft. The pilot had manoeuvred himself into the right seat, but he was unable to exit the aircraft and he drowned.
