AVIATION INVESTIGATION REPORT

A05P0032

SETTLING WITH POWER – ROLL-OVER

TASMAN HELICOPTERS LTD.
BELL 212 (HELICOPTER) C-GEEC
SPEARHEAD GLACIER, BRITISH COLUMBIA
11 FEBRUARY 2005

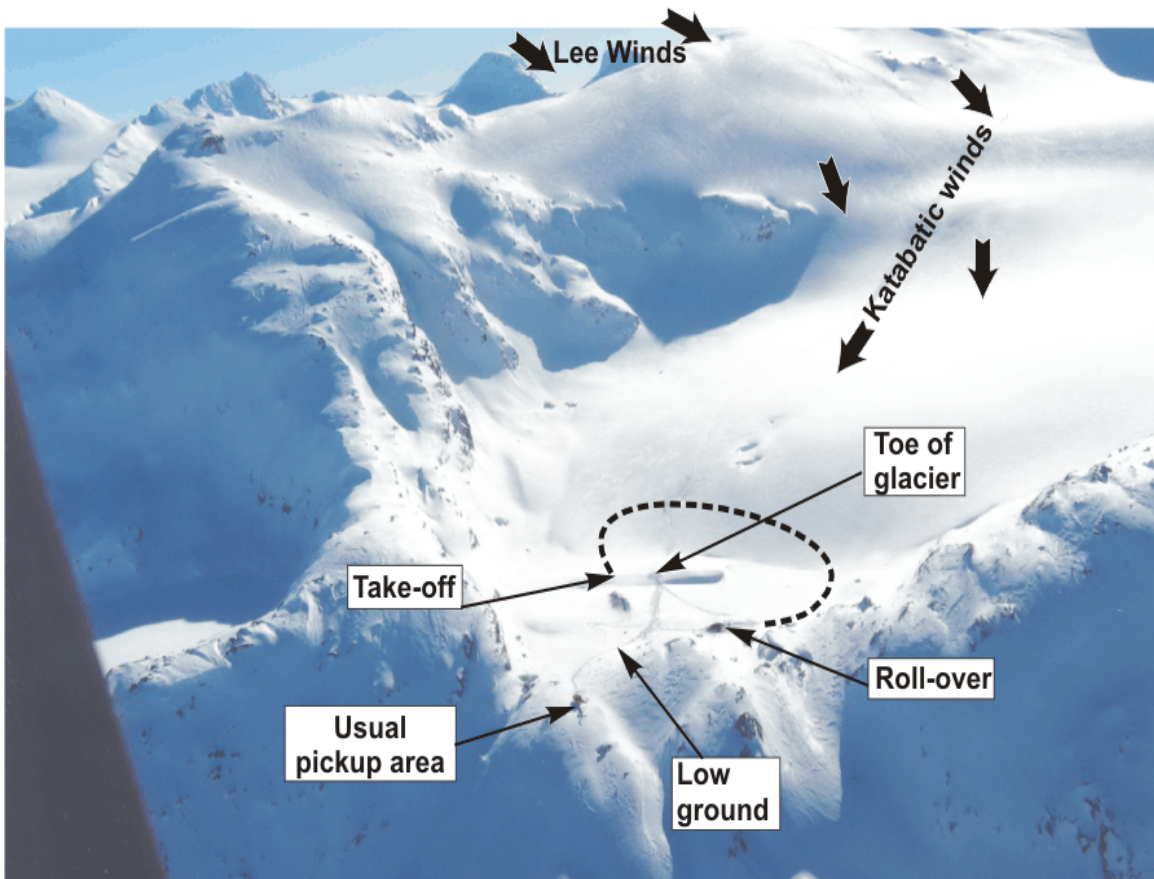
Appendix A – Accident Flight Diagram

It is quite likely that, during the day, as a temperature inversion existed, katabatic winds formed over the glacier and they were pulsing downhill. Given the gross weight of the helicopter at take-off, the close proximity to the glacier and the strong downflowing winds, the helicopter was not able to climb high enough to clear the surrounding terrain. When the pilot turned away from the lower ridge, the helicopter was settling with power in downflowing wind, and the pilot could not arrest its descent. When the helicopter settled onto the snow, still moving forward, it struck a snow drift, dug in, and rolled over.

The photograph was taken soon after the accident. It shows the Spearhead Glacier and the conditions.
