AVIATION INVESTIGATION REPORT

A05Q0008

COLLISION WITH TERRAIN

EUROCOPTER AS-350 BA (HELICOPTER) C-FHBG

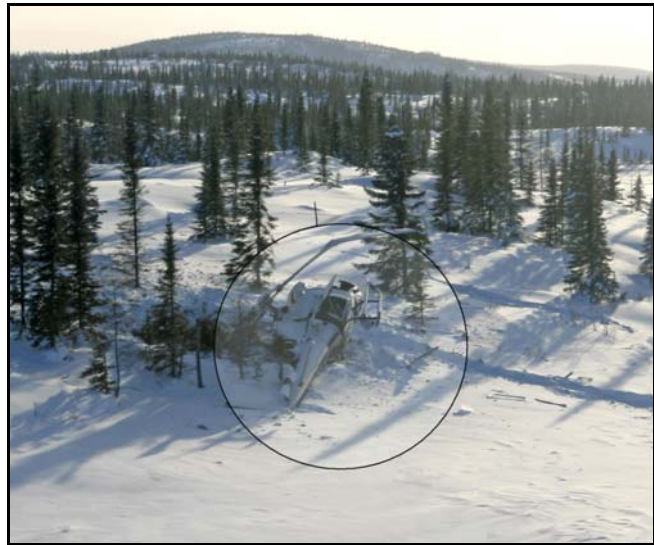
The accident occurred at the edge of a wood and beside a lake, on terrain that was sloped about 20 degrees (Photo 1). After the accident, the helicopter was lying on its left side with the rotor mast pointing up the slope. The cockpit roof had been torn off. There were blade impact marks on the forward portion of the headliner, the pillar between the windshields and the front door frames. All damages were attributed to instantaneous overload. The transmission was torn away, and the main rotor blades and rotor hub exhibited damages consistent with the aircraft rolling onto its side.

Photo 1. Aircraft wreckage and accident site

1. The pilot did not notice that the slope of the landing area exceeded the maximum roll angle allowable for this aircraft because the existing white-out conditions deprived him of depth perception. The helicopter rolled onto its left side in a dynamic rollover.
2. The pilot did not perceive the lateral movement of the helicopter because the snowball effect and the ice on the aircraft's windows prevented him from seeing external references.
