**AVIATION INVESTIGATION REPORT  
A05W0109**

**INADVERTENT STICK SHAKER AT HIGH ALTITUDE**

**AIR CANADA JAZZ  
BOMBARDIER CRJ705 C-FBJZ  
LETHBRIDGE, ALBERTA, 41 nm SE (COUTS INTERSECTION)  
10 JUNE 2005**

Report Number A05W0109

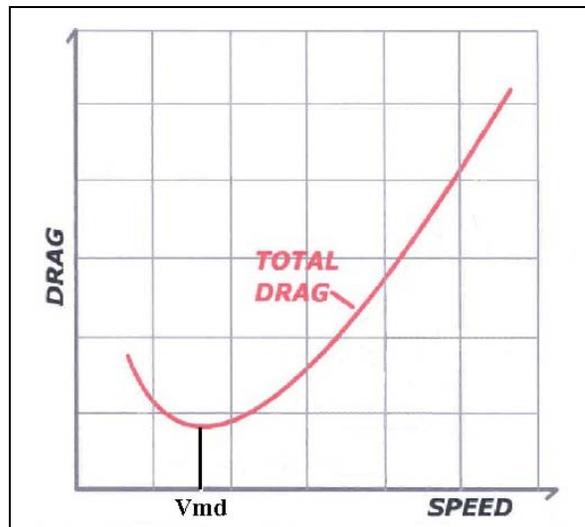
Minimum drag speed ( $V_{md}$ ) is defined as the speed at which aircraft total drag is at a minimum, requiring minimum thrust for level flight. This speed is associated with the endurance speed. At a constant altitude, progressive reduction in true airspeed below  $V_{md}$  results in a concomitant increase in total drag, which results in a further deterioration of airspeed. Therefore, airspeed values below  $V_{md}$  can result in negative stability (see Figure 1). Should cruise airspeed become less than  $V_{md}$ , speed restoration can be accomplished by increasing engine power, by initiating a descent, or a combination of both.

Figure 1. Drag versus speed (adapted from Air Canada Jazz training module)

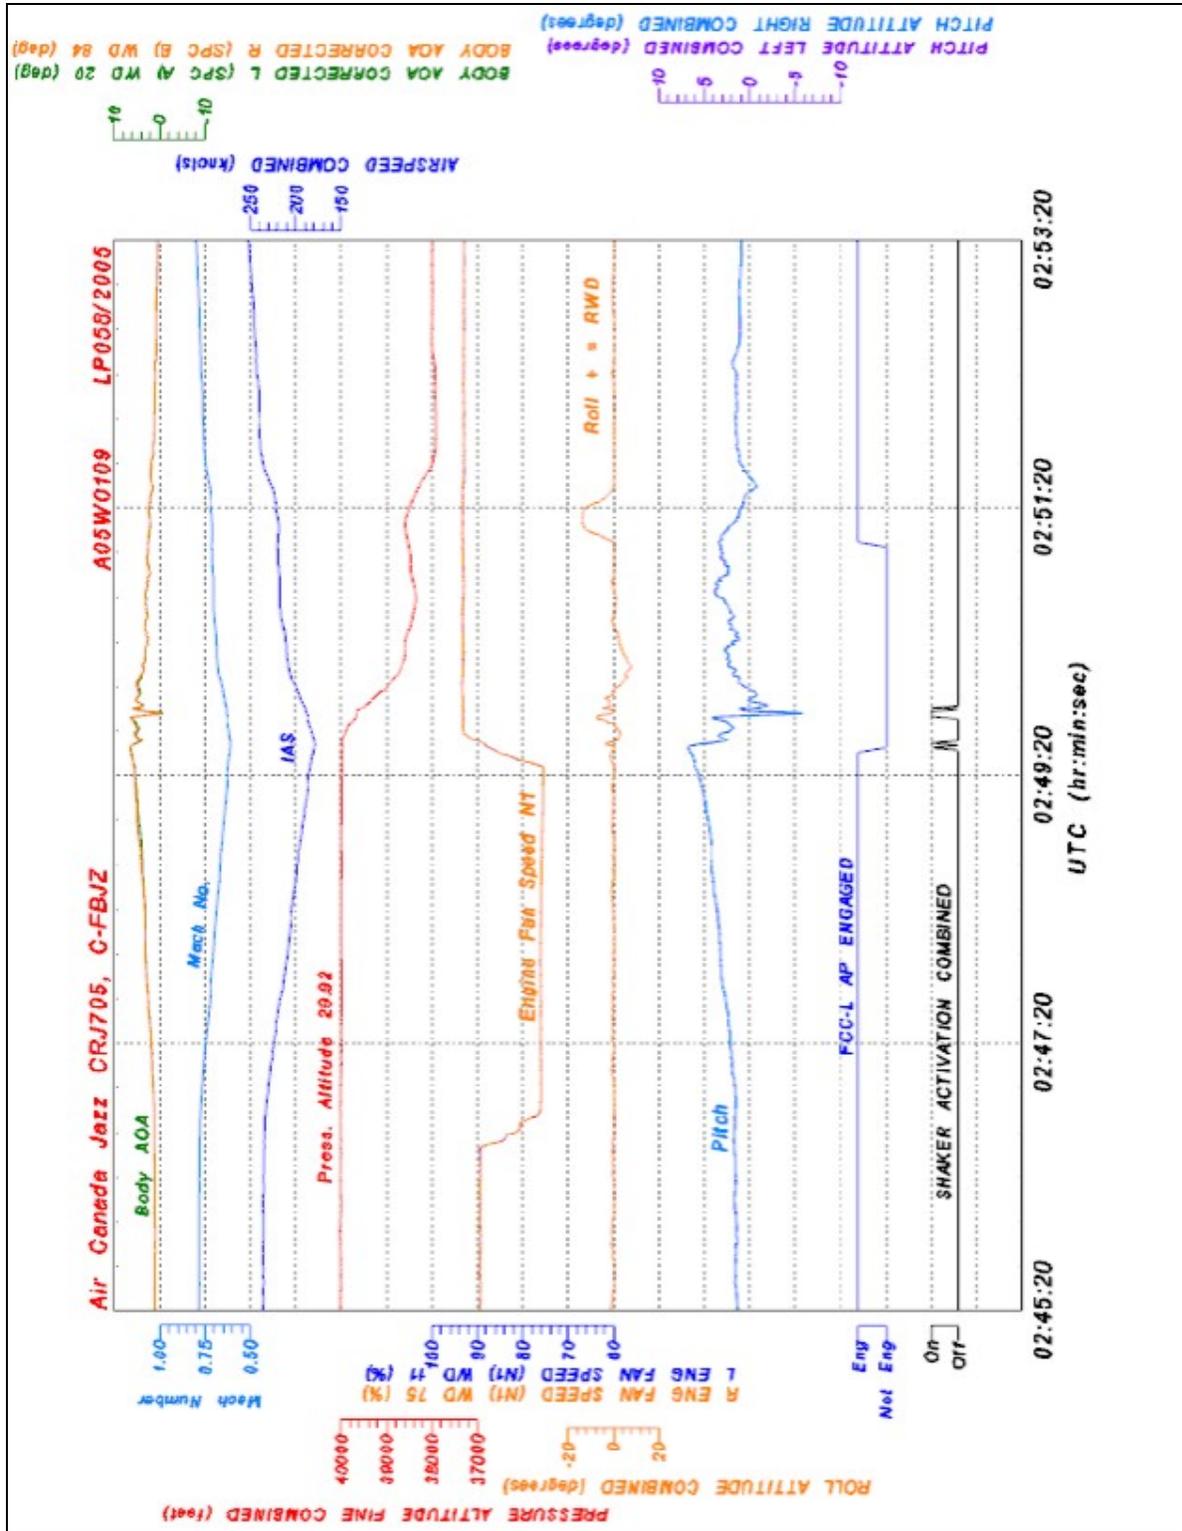
# Appendix A – Digital Flight Data Recorder Plot – Event Overview

noticed the speed dropping below 0.70M and warned the captain. The captain responded by advancing the thrust levers. The aircraft continued to decelerate with increasing nose-up pitch attitude while maintaining FL 400. The captain then began programming a descent in the flight control computer (FCC) vertical speed mode. Immediately thereafter, as the airspeed decreased to 0.61M (180 knots indicated airspeed (KIAS)), the stick shaker activated and the autopilot disengaged. Both pilots pushed the control yoke forward to reduce the pitch attitude, which resulted in a descent and an increase in airspeed. This was followed by the crew returning the aircraft to a pitch-up attitude, with an increase in body angle of attack and G.<sup>4</sup> A second stick shaker activation occurred 11 seconds after the first. Buffeting and roll oscillations of about 10 degrees accompanied the stick shaker events. The pitch attitude was further reduced and the airspeed recovered to 0.82M (250 KIAS). The altitude stabilized briefly at FL 386 before the crew coordinated with ATC, a further descent to FL 380 due to conflicting traffic. (See Appendices A and B for digital flight data recorder plots.)
