## AVIATION INVESTIGATION REPORT

**A06A0114**

### **COLLISION WITH OBSTACLE DURING TAKE-OFF**

**PROVINCIAL AIRLINES LIMITED  
de HAVILLAND DHC-6 TWIN OTTER C-FIZD  
PORT OF GOOSE BAY DOCK, HAPPY VALLEY  
GOOSE BAY, NEWFOUNDLAND AND LABRADOR  
06 NOVEMBER 2006**

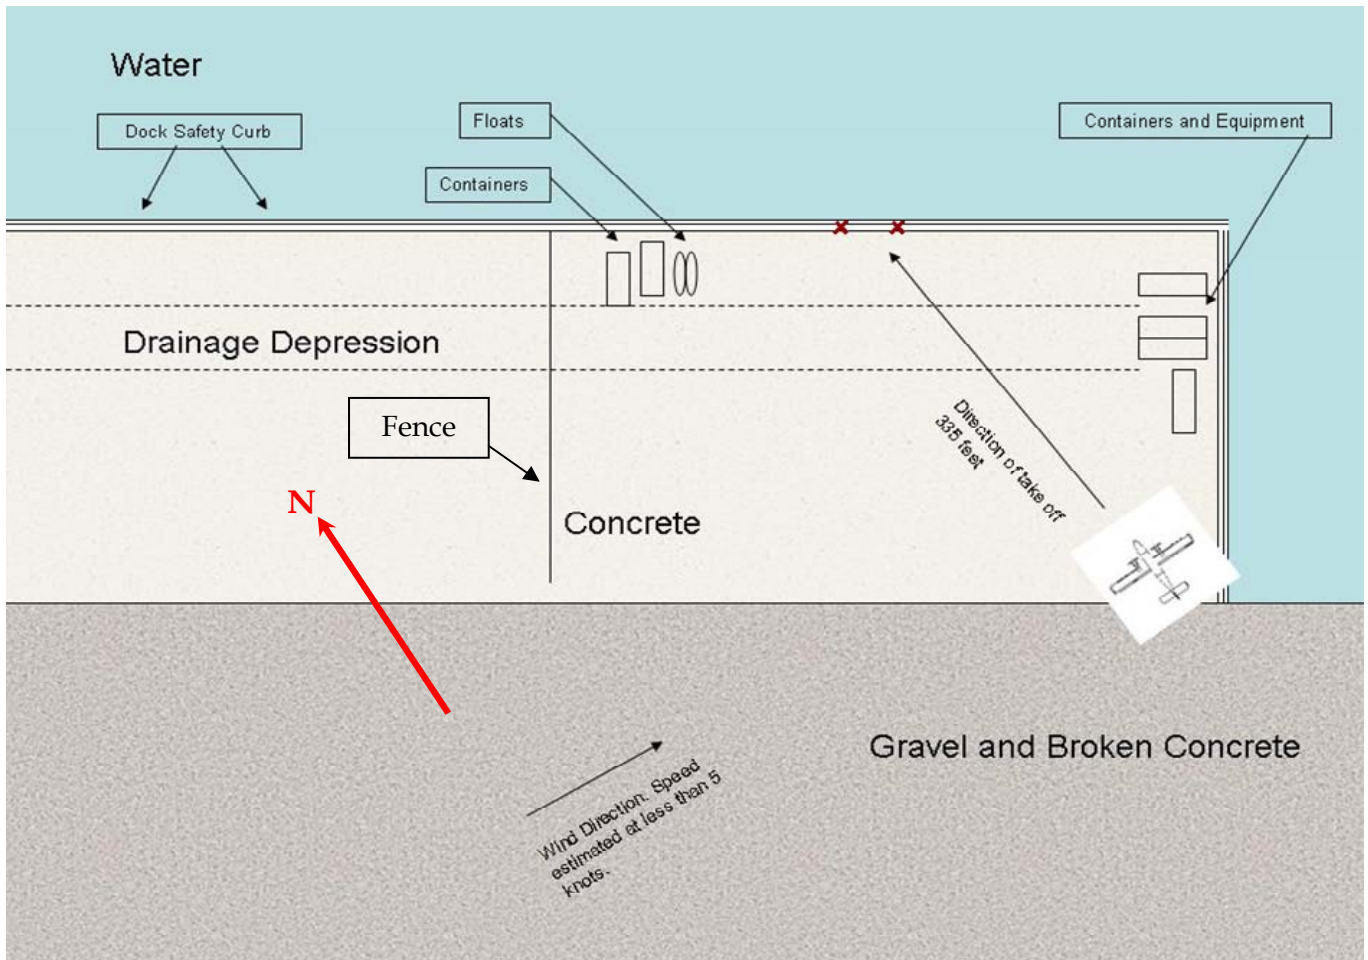
# Appendix A – Take-Off Run – Plan View

The orientation of the concrete-surface dock is northwest to southeast (see Appendix A). There is a dividing chain-link fence at the midpoint of the dock running perpendicular to the dock edge. There is a 14-inch-high wooden safety curb, made of wood beams measuring 12 inches by 12 inches, surrounding the outside perimeter of the dock. Approximately 105 feet from the water side, in the direction of the take-off, there is a depression approximately 60 feet wide and 1.5 feet deep in the surface of the dock, running parallel to the edge or 45° to the direction of take-off.

The pilots then taxied the aircraft on the dock to allow for the maximum take-off run available, taking into account the wind speed and direction and obstacles on the dock. The obstacles comprised equipment parked at the southeastern end of the dock and containers and aircraft floats sitting on the southeastern side of the chain-link fence. The take-off run chosen was from the south corner of the concrete surface toward the water edge of the dock, in a northerly direction, approximately 45° to the dock orientation (see Appendix A).

The right main landing gear struck the wooden safety curb at the perimeter of the dock, and the left main gear struck and severed a partially decomposed 10-foot section of the curb. The aircraft became airborne and the flight continued to Goose Bay.

1. The take-off length available on the dock was shorter than estimated. This, in combination with the reduction in take-off performance due to the effect of the dock depression, resulted in the landing gear striking the wooden safety curb.
2. The right main landing gear collapsed on landing as a result of damage incurred when the gear struck the wooden safety curb.
