AVIATION INVESTIGATION REPORT
A06F0014

MISALIGNED TAKE-OFF

AIR CANADA
AIRBUS A319-114 C-FYKR
LAS VEGAS, NEVADA
30 JANUARY 2006

Report Number A06F0014

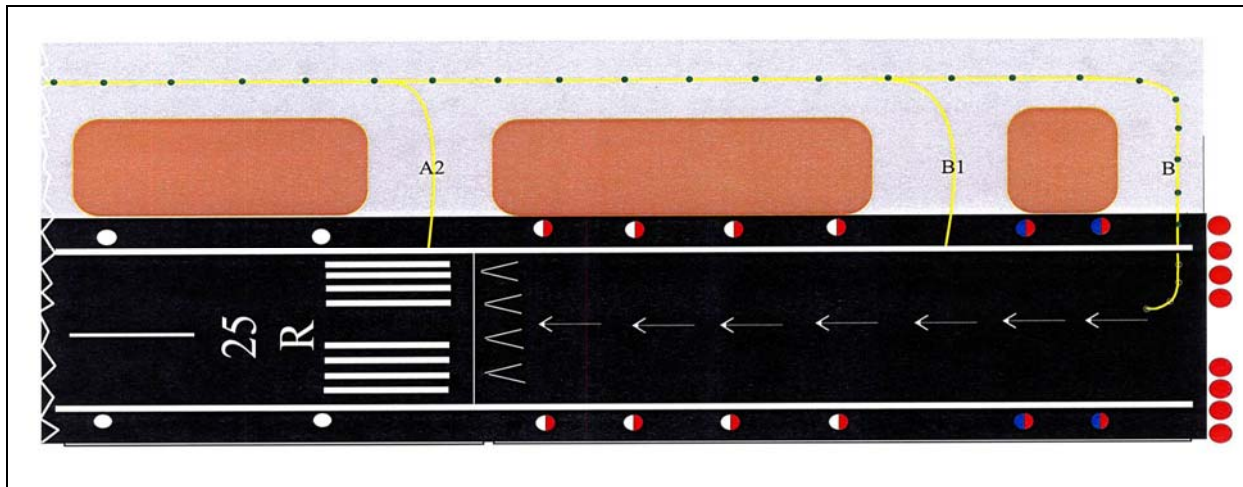
Figure 1. Runway 25R threshold markings

To provide good visual contrast with the runway, a white runway side stripe marking is painted along both sides of Runway 25R (see Figure 1). In accordance with Federal Aviation Administration Advisory Circular (AC) 150/5340-1J and International Civil Aviation Organization (ICAO) Annex 14, Volume 1, Aerodrome Design and Operations, the side stripe marking is a continuous line that is unbroken where the taxiways join the runway. In Canada, TP 312, Section 5.2.1.3, allows for the runway side stripe markings to be interrupted at an intersection of a runway and taxiway. In fact, all Canadian runways marked with side stripes have them interrupted at the intersection of their runways and taxiways.

Had the runway side stripe been interrupted at the runway and Taxiway B intersection, it could have prevented the misalignment. Since the flight crew was more familiar with Canadian airport markings, where side stripes are interrupted at the intersection between the taxiway and the runway merging point, they probably were not expecting to see a white runway side stripe marking.

The lead-in lines from Taxiways B1 and A2 may cause confusion because they lead directly to the runway edge line rather than to the runway centreline. In contrast, the Taxiway B centreline marking continues across the white runway side stripe marking until it merges with the runway centreline. During the day, this marking would provide a strong visual cue to the location of the runway centreline. However, in this occurrence, the taxiway centreline lead-in lights did not catch the flight crew's attention, resulting in a lack of visual guidance toward the runway centreline. The pilot may also have misinterpreted the runway edge line as the runway centreline.

The Las Vegas airport authority made modifications to the taxiway markings following the occurrence. At Taxiway B1, the radius of the taxiway centreline was extended past the runway edge line and now meets with the runway centreline in the displaced threshold arrow area. At Taxiway A2, the radius of the taxiway centreline that curves to the runway edge line was erased, and the taxiway centreline now extends to the threshold markings.

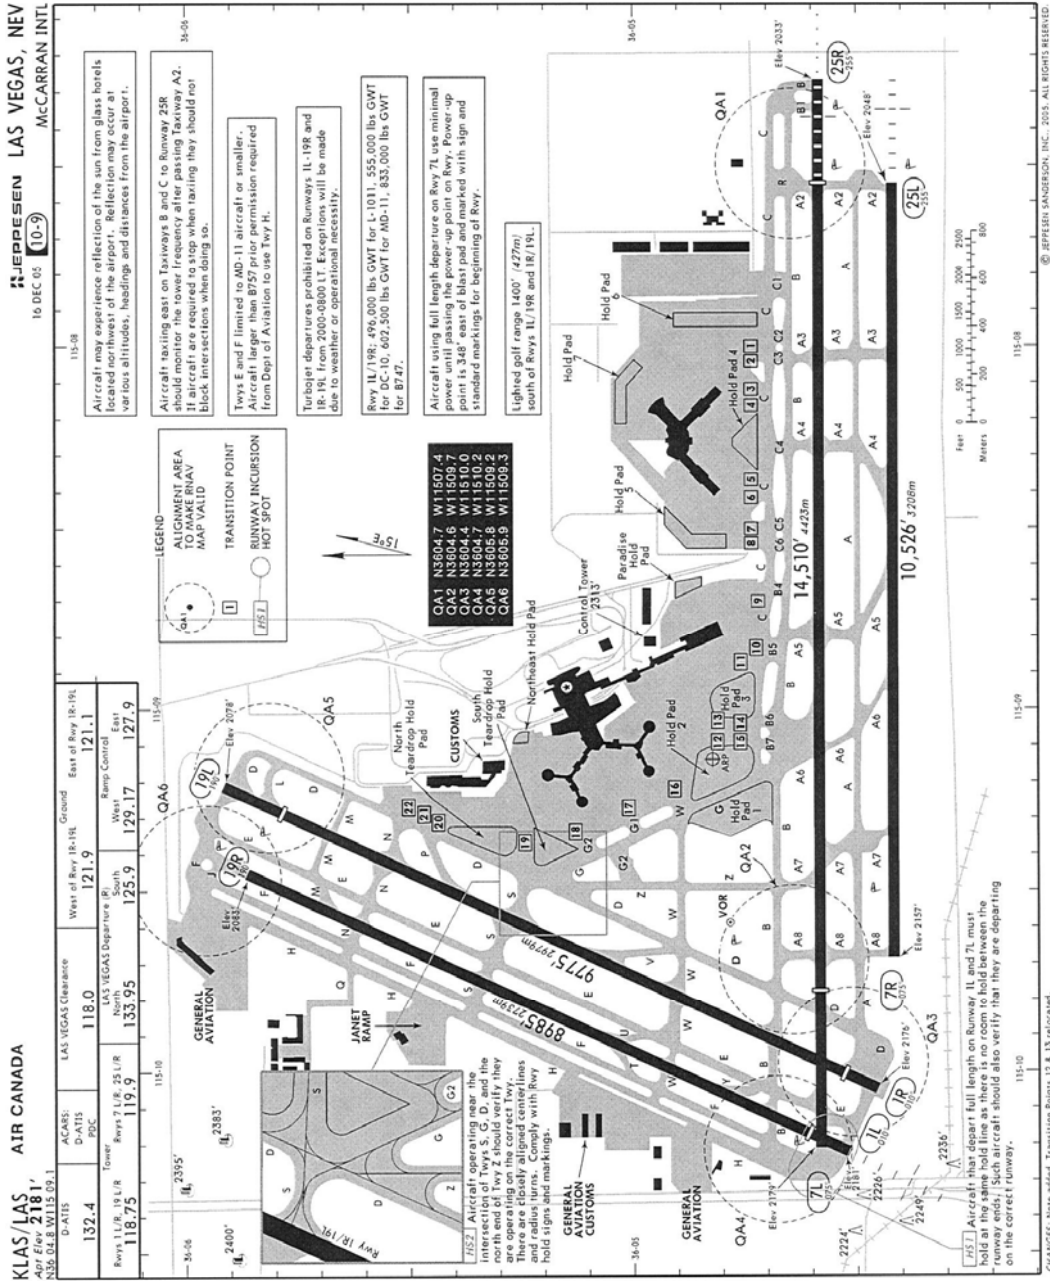
Appendix A – KLAS Aerodrome Map

KLAS is a busy airport with an average of 1468 aircraft operations per day. It has four runways: two parallel runways on the south side of the terminal buildings and two on the west side (see Appendix A). The surface of Runway 25R was dry at the time of the occurrence. The runway is 14 510 feet long by 150 feet wide and has a displaced threshold of 1397 feet. It has asphalt runway shoulders capable of supporting an aircraft if it runs off the side of the runway.

The displaced threshold area is fed via Taxiways B and B1 (see Appendix A). Taxiway A2 feeds Runway 25R in the threshold marking area. On Taxiway B, the one used during this occurrence, the taxiway centreline and the green centreline lights continue past the runway hold position along the curved taxiway centreline, across the white runway side stripe marking until it merges with the runway centreline marked by the displaced threshold arrows. At Taxiways B1 and A2, the taxiway centrelines continue past the runway hold position and curve onto the runway edge line. The green taxiway centreline lights for Taxiways A2 and B1 also continue past the runway hold position and stop at the runway edge line but do so in a straight line.
