AVIATION INVESTIGATION REPORT

A06O0104

IN-FLIGHT SEPARATION OF FLAP TAB

**EXPRESS NET AIRLINES
AIRBUS A300 B4-203 N372PC
TORONTO, ONTARIO
01 MAY 2006**

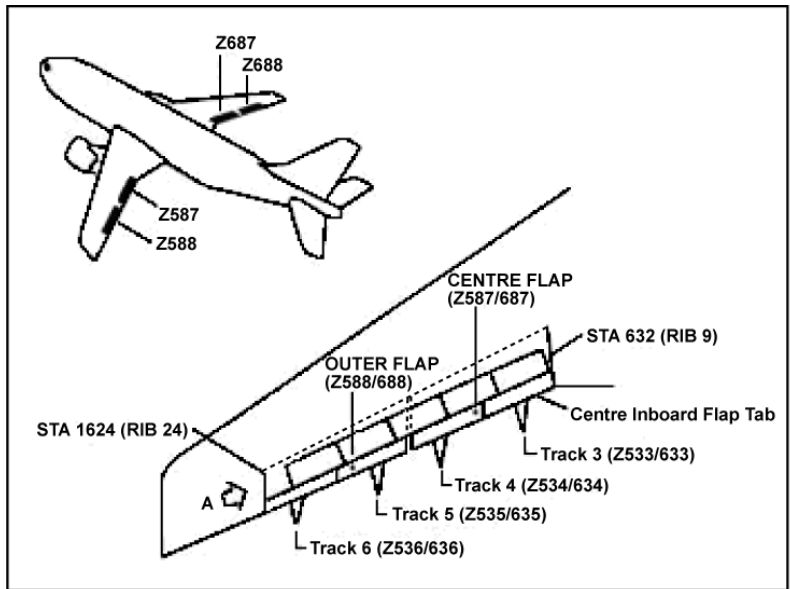
The left centre inboard flap tab is part of the trailing edge flap system (Figure 1). The flap tab is approximately 2.8 m (112 inches) long, 0.6 m (27 inches) wide and weighs approximately 16 kg (35 pounds). The main structural attachment, referred to as the flap tab hinge bracket (hinge bracket), was located mid span on the bottom of the flap tab near the leading edge. The hinge bracket is characterized as a solid lever that transitions to a box section for attachment to the inside of the flap tab.

Figure 1. Overview of aircraft showing centre inboard flap tab position

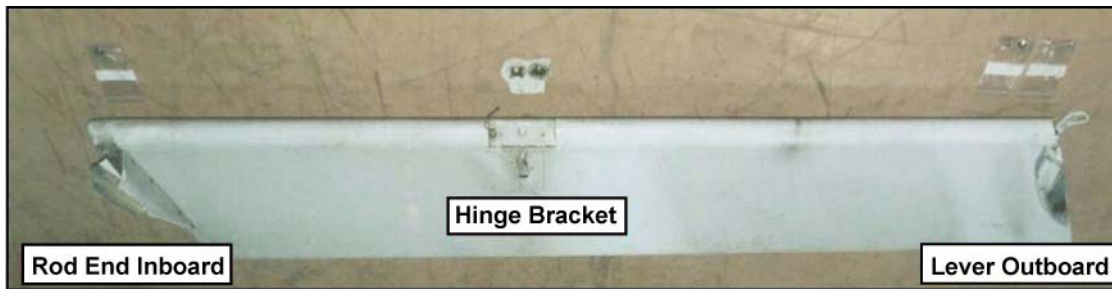
flap tab bottom skin, immediately around the hinge bracket, was covered by a doubler plate. The hinge bracket failed just below the bottom level of the doubler plate in line with the flap tab skin. As well, the flap tab was supported on the inboard end by a rod link and on the outboard end by a lever assembly (**Photo 1**). The inboard rod link was bent and had failed in overload. The outboard lever assembly was bent and the attachment ball bearing had pulled out of the ball bearing mount.

Photo 1. Flap tab

The inboard rod link had failed in overload, and the outboard lever had bent and the ball bearing connecting the lever to the flap pulled out of the lever. The lever from the right outboard flap tab had excessive wear in the bushings and the wear was more pronounced than that of the left lever.

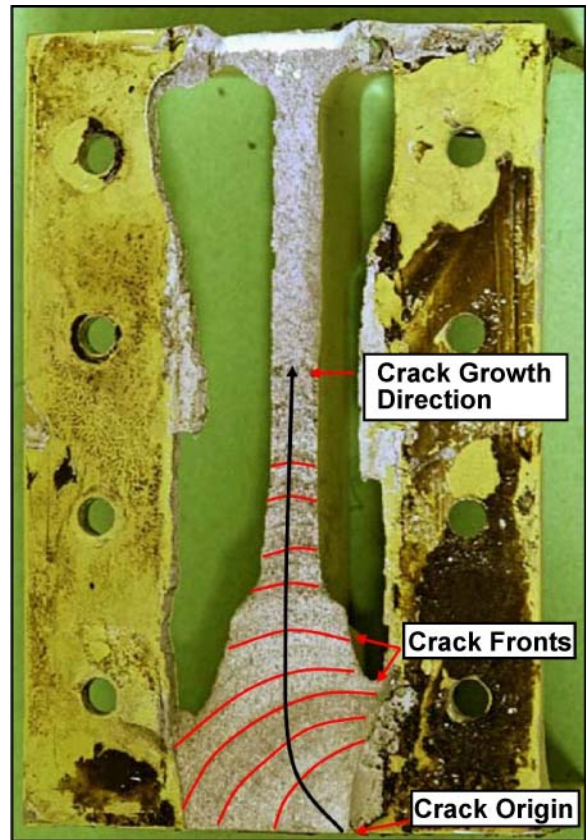
Microscopic examination of the hinge bracket after removal from the flap tab showed that a fatigue crack initiated due to impact damage, measuring approximately 0.5 mm in depth. The impact damage was located at the outboard side of the flap tab hinge bracket in the contour radius at the transition hinge to flange. The fatigue crack propagated over 70 per cent of the cross-sectional area of the hinge bracket (Photo 2). The weakened hinge bracket, unable to sustain the increased aerodynamic flight loads with the flaps extended, failed as the crack length attained critical dimensions. The impact damage, at the origin of the crack, occurred in a location that is protected once the hinge bracket is installed.

Photo 2. Hinge bracket fatigue pattern

There were no abnormalities noted in the previous recorded flights or service history that indicated any problems with the hinge bracket before the incident. The hinge bracket failed due to low cycle fatigue, which originated at the site of the identified impact damage. The impact damage created a stress riser, which developed into a fatigue crack over the operating life of the hinge bracket. The impact damage was located in an area that is protected once the bracket is installed. It is likely that the hinge bracket was damaged before or during installation and, given the relatively small size of the damage, was likely not noticed at that time. After installation, it would not have been possible to see the damage, and detection of the crack during subsequent inspections would have been very difficult.

1. Hinge bracket damage, which occurred either before or during installation, created a stress riser for a low cycle fatigue crack to develop and progress over the life of the part.
2. The hinge bracket failed after the flaps were selected to the 25° setting while on approach to the Toronto/Lester B. Pearson International Airport. This allowed the flap tab to separate from the aircraft and strike a parked vehicle.

Airbus is developing a repetitive inspection program (planned Inspection Service Bulletin [ISB] 57-0250) for the hinge bracket, and based on the results of that inspection program, will consider further modifications to the hinge bracket.
