**AVIATION INVESTIGATION REPORT
A06W0041**

AIRFRAME FAILURE AND COLLISION WITH TERRAIN

**RUPERT'S LAND OPERATIONS INC.
McDONNELL DOUGLAS MD600N C-FTAZ
ZAMA LAKE, ALBERTA, 25 nm NW
21 MARCH 2006**

Report Number A06W0041

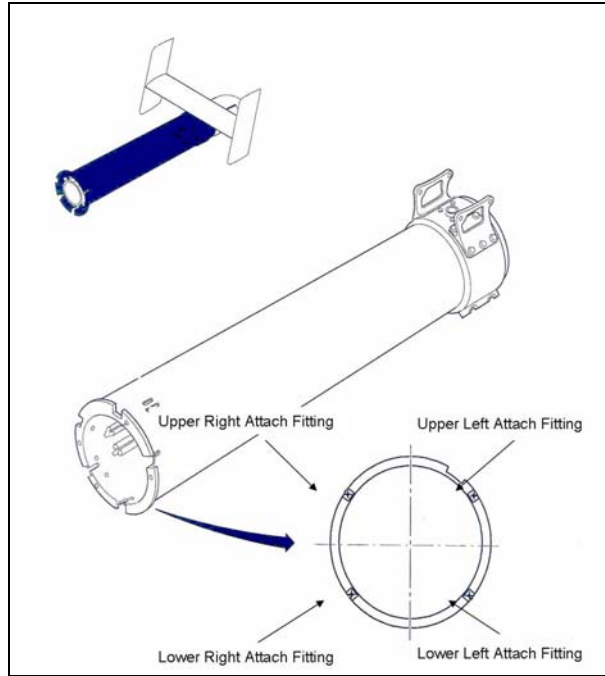
Figure 2. Tail boom assembly (copyright 1999-2006 by MD Helicopters Inc.)

The tail boom of the helicopter was attached to the fuselage at four locations by two, 5/16-inch-diameter bolts at the upper right and lower left positions and two, 3/8-inch-diameter bolts at the upper left and lower right positions (see Figure 2).

The forward flange of the tail boom was bolted against the aft surface of the aft fuselage ring frame. The bolts were attached from the aft side of the forward flange of the tail boom. Each bolt head was lock wired to the radius block following tightening to final torque. The bolt was secured by a fastener assembly, comprised of a locknut (see Figure 3) attached to a retainer plate and riveted inside an attach fitting.

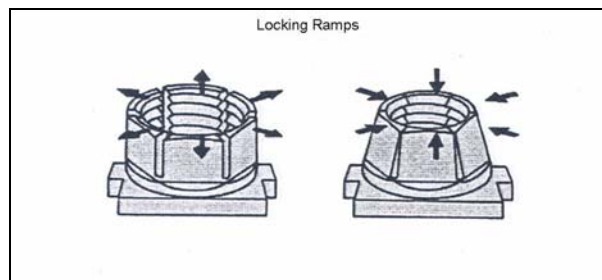
Figure 3. Tridair flatbeam locknut

The upper left attachment bolt had pulled through the locknut. The threads of both the bolt and the locknut show damage consistent with a shearing motion. The upper left attachment bolt was fully engaged and extended through the nut by three to four threads. The locknut has six flexible beams (Figure 3 locking ramps) that provide the locking function as the bolt is tightened. One of the six beams was broken off, and a second beam was cracked but still attached; it broke off when slight finger pressure was applied. A third beam had several small

cracks emanating from the inner surface. Cracking was evident in all three beams emanating from the roots of the internal threads, initiating and leading from the corners formed by the intersection of the threads with the vertical cut slots. The TSB Engineering Laboratory confirmed the cracking was due to fatigue. The exposed surfaces of the cracks had rub markings, which destroyed any fine detail of the nature of the fatigue.

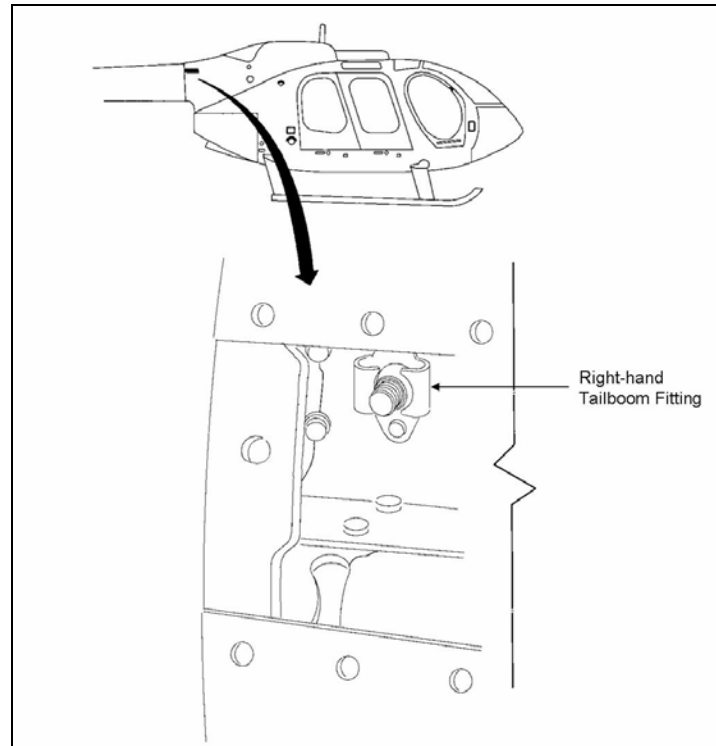
Figure 4. Tail boom attach fitting and angle (copyright 1999-2001 by MD Helicopters Inc.)

The upper right attach fitting (see Figure 4) had separated due to the failure of the fitting. This in turn caused the failure of the attaching section of the fuselage ring frame. Of the two brackets that attach the fitting to the frame, one was missing and the second had fractured through one of the attaching rivet holes.

The fracture surfaces of the fitting appeared fresh and had a bright, crystalline appearance, with the exception of the crack surfaces between the two inboard rivet holes, which were coated with a black deposit. The deposit was determined to be fretted material. The complete failure of the bathtub fitting was consistent with the fatigue cracking through more than 95 per cent of the cross section of the fitting. The failure of the fitting resulted in the transfer of load to the aft ring structure, causing a section of the ring structure to separate during the final failure sequence.

Fatigue cracking of the upper right attach fitting occurred, resulting in the transfer of loads to the aft ring structure and remaining three tail boom attach fittings. The resulting onset of fatigue in the locknut flexible beam elements of the upper left attach fitting, which compromised the strength of the fastener, allowed the upper left bolt to pull out of the locknut. Failure of the two upper attach fittings caused overload and separation of the lower two attach fittings. This resulted in the detachment of the tail boom and loss of aircraft control. Safe recovery following this type of structural failure would be unlikely.

1. The attach fitting at the upper right attachment point of the tail boom failed in fatigue. The transfer of loads to the adjacent aft ring structure resulted in the cascading failure of the remaining three tail boom attach fittings and separation of the tail boom from the fuselage.
2. Aircraft control was lost following separation of the tail boom. Safe recovery following this type of structural failure was unlikely.

On 13 April 2006, McDonnell Douglas Helicopters Inc. (MDHI) issued SB600N-043 requiring a borescope inspection of all four attach fittings. Within 25 hours of receipt of the bulletin, the attach fittings are to be replaced. On 13 April 2006, MDHI issued Technical Bulletin TB600N-007R1 regarding modification of the fuselage aft section and tail boom to strengthen the tail boom attach fittings and upper longerons.

On 27 April 2006, the Federal Aviation Administration (FAA) issued Airworthiness Directive (AD) AD2006-08-12. This AD requires that additional inspection holes be created in the aft fuselage skin panels, and that inspection of the upper and lower tail boom attach fittings, the upper longerons, and angle and nut plates for cracks be accomplished. It also requires, within a specified time, replacing the aluminum upper right tail boom attach fitting with steel fittings, painting the inspection area, and replacing existing nut plates.
