**AVIATION INVESTIGATION REPORT
A07C0114**

POWER LOSS - COLLISION WITH WATER

**EXPEDITION HELICOPTERS INC.
EUROCOPTER AS 350 B-2 C-FLUK
BERNICK LAKE, SASKATCHEWAN
01 JULY 2007**

Report Number A07C0114

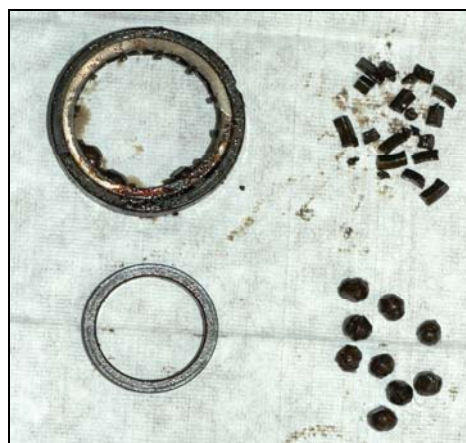
Photo 3. No. 3 bearing components disassembled
