**AVIATION INVESTIGATION REPORT  
A07C0151**

**HARD LANDING - FUEL LEAK AND FIRE**

**SUNDANCE BALLOONS INTERNATIONAL  
FIREFLY 12B (HOT AIR BALLOON) C-FNVM  
WINNIPEG, MANITOBA, 15 nm NE  
11 AUGUST 2007**

Report Number A07C0151

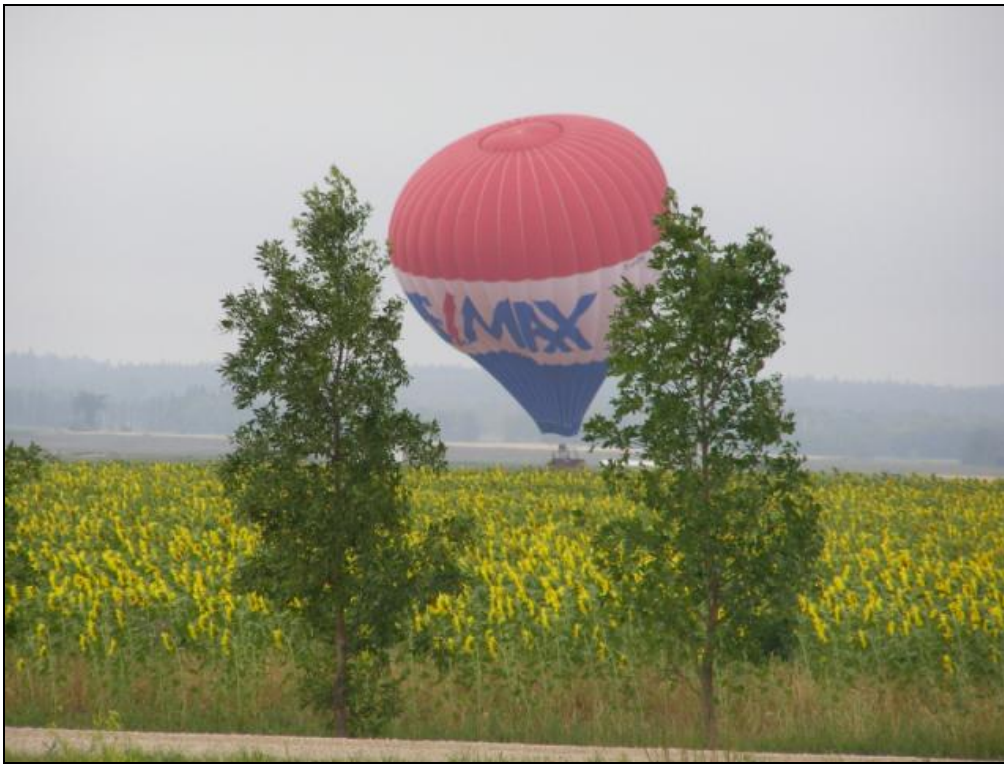
After leaving the outskirts of the city, the pilot attempted to land several times in different fields but chose to overshoot because of the wind speed and unfavourable ground conditions or obstacles. On the final landing attempt, at approximately 0855, the balloon descended at about a 45° angle, hit hard, and skipped several times. The impacts were severe enough to dislodge one of the burner frame support uprights. The upright came loose and was later found along the landing trail. A photograph taken during the landing showed the parachute still in the sealed position (see Photo 1). The pilot's efforts to reposition the parachute were observed to pull in the fabric of the envelope in the parachute area, though subsequent examination found the rigging to be correctly attached. The basket was dragged on its side for about 700 feet, coming to rest in a partially-inverted position. The passengers fell on top of each other as the basket overturned. The manifold of one burner was broken by the impact with the ground. The fuel had not been shut off before landing and the pilot was unable to reach any valves while the basket was being dragged across the ground. A propane leak occurred and the propane was ignited by the burner pilot lights. An intense fire broke out with the passengers and pilot beneath the basket. All escaped or were pulled from beneath the basket.

**Photo 1.** C-FNVM landing with parachute valve closed

The rigging of C-FNVM was examined and no failures were found. Information provided indicated that the parachute valve of the FireFly 12B balloon envelope does not dump the air quickly after a landing in high winds, increasing the likelihood of a dragged landing.

The pilot attempted to deflate the balloon envelope quickly and was unable to do so effectively even though the rigging was functional, resulting in a dragged landing of some 700 feet. The extended drag distance increased the risk of injury to the passengers and damage to the basket. The wind speed at the accident site could not be measured, but was likely between the wind speed of 15 knots recorded at the Winnipeg Airport and the 19-knot wind speed that was recorded near the accident site. Therefore, the company operations manual wind speed of 15 knots was too high to ensure a short drag distance while deflating the envelope after landing.
