**AVIATION INVESTIGATION REPORT
A07O0190**

GUY-WIRE STRIKE DURING LANDING

**HYDRO ONE NETWORKS INC.
AEROSPATIALE AS 350 B2 (HELICOPTER) C-GOHY
MOOSONEE, ONTARIO, 26 nm SW
20 JULY 2007**

Report Number A07O0190

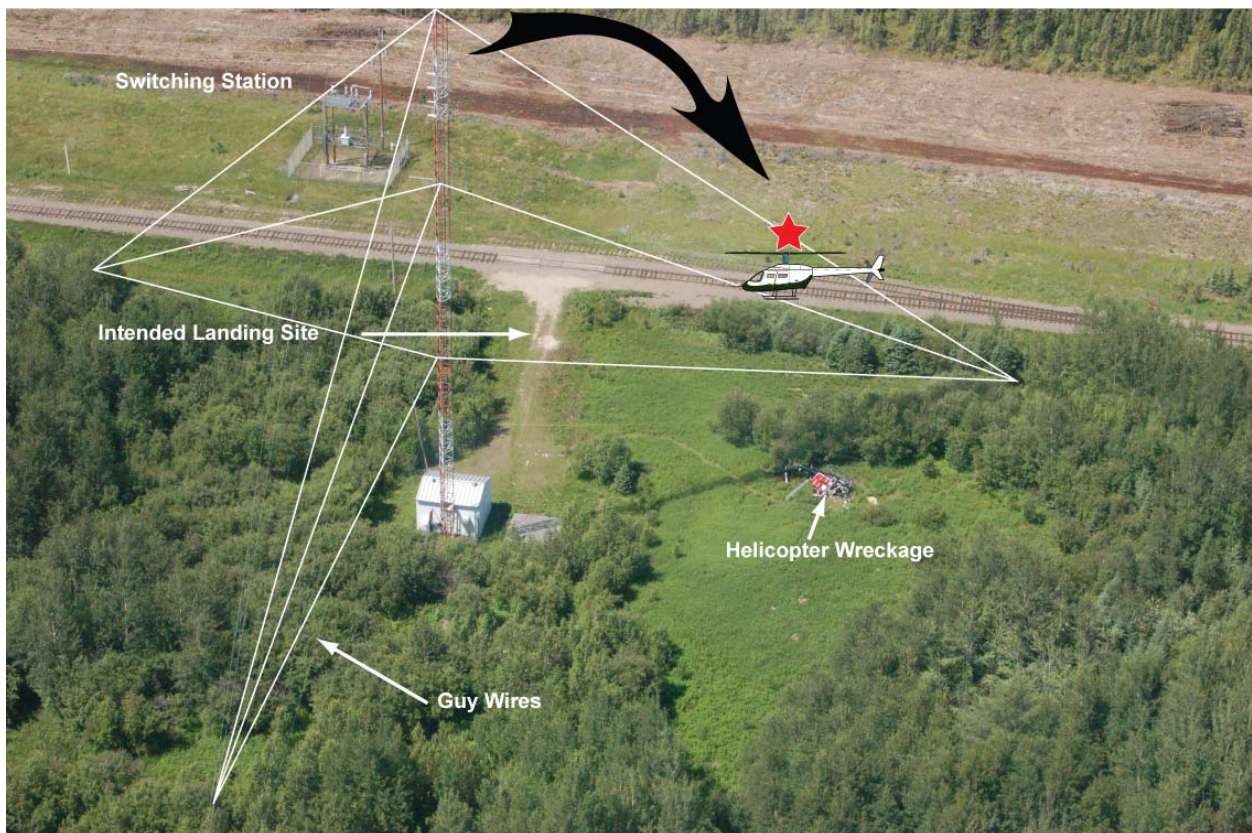
Photo 1. Accident site

The pilot had initially intended to land the helicopter on a wide clearing near the switching station (see Photo 1). While hovering to land, the pilot assessed that the ground was too soft to support the helicopter. The only other suitable area was the driveway near the communications tower. It was more confined with mature brush lining the sides, but wide enough to accommodate the helicopter.

The pilot was occupying the front right control position. As he approached the landing site, he rotated the helicopter such that it was flying in a left sideways manner towards the driveway site. Although this allowed the pilot to maintain forward visual contact with the driveway where the helicopter was to land, his view in the direction of flight was restricted by the cabin structure and the passenger sitting in the left forward seat. Once over the driveway, the intention was to rotate the helicopter until the tail rotor faced the communications tower. As the helicopter was moving closer to the driveway, the main rotor blades struck the guy wires.

The communications tower was approximately 300 feet high, and was supported by guy wires that were attached around the tower at approximately 120 degrees of spacing and at three equidistant points up the height of the tower. The guy wires consisted of steel multi-strands and were approximately one inch in diameter. Each guy wire in Photo 1 consists of two separate wires in close proximity. The helicopter main rotor blades struck the two top guy wires at a height of approximately 100 feet above the ground. The guy wires were pulled from their attachments on the ground but remained attached to the top of the tower.

During the impact sequence, one of the guy wires became entangled with the helicopter and remained entangled even after the helicopter struck the ground. The impact with the ground in an inverted position partially crushed the top of the cabin structure, with the most crush damage in the cockpit area. This trapped the pilot and hampered the evacuation of the two passengers.

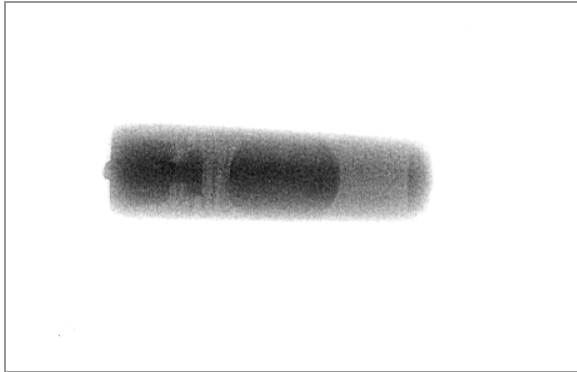
The G-switch, part number 2014-1-000, was manufactured by Select Controls Inc. It is a single-axis, ball and spring-type switch, with the ball and spring contained within a casing (see Photos 2 and 3). The ELT is activated when G-forces are sufficient for the ball to compress the spring and touch a contact inside the front of the casing. Examination showed that the ball was seized in the midway position within the casing and had partially compressed the spring. Attempts to shake the ball loose were unsuccessful.

Photo 2. X-Ray of switch as removed from ELT

The ELT did not activate even though impact forces exceeded the threshold of the G-switch. The type of G-switch used in this ELT was a single-axis, ball and spring-type switch. This type of switch will automatically activate the ELT only if a component of the impact force is in the same direction as the orientation of the switch.

During examination of the switch, black powder residue was found and the switch was seized within its casing; thus electrical contact was never established and the ELT failed to activate. The ELT was properly attached and located in the cockpit of the helicopter as per current regulations, but the accident impact forces were in a direction that may not have activated the G-switch even if it had been serviceable. The failure of the ELT did not affect the rescue of the three injured persons because of the availability of phone service at the communications tower.

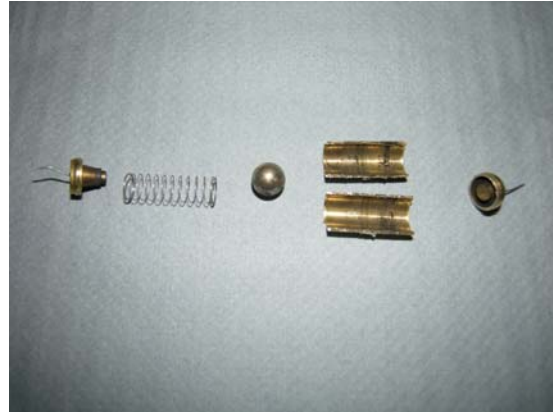
The switch was cut open and found to be contaminated with a black powder substance. Select Controls Inc. is aware that the G-switch may stick due to the deterioration of the gold plating within the casing, which creates a powder residue that prevents the ball from moving full travel. Select Controls Inc. recommends replacing the switch or increasing the switch testing frequency if the ELT has been in service more than five years and replacing the switch after ten years in service.

Photo 3. G-Switch split open

1. The single-axis, ball and spring G-switch in the emergency locator transmitter (ELT) meets current specifications, but it is not effective when the impact forces are at angles that are substantially different to switch orientation.
2. The ELT failed to activate on impact as a result of a faulty internal G-switch. The internal parts of the switch are susceptible to deterioration over time and can prevent switch operation and ELT activation.

Transport Canada will contact both Narco and ACK Technologies Inc. to seek their publication of a Component Maintenance Manual amendment that would mirror the Select Controls Inc. recommendation.
