**AVIATION INVESTIGATION REPORT
A07O0314**

IN-FLIGHT ENGINE FAILURE

**ROYAL CANADIAN MOUNTED POLICE
AEROSPATIALE AS 350 B3 (HELICOPTER) C-FRPQ
STONEY POINT, ONTARIO
23 NOVEMBER 2007**

Report Number A07O0314

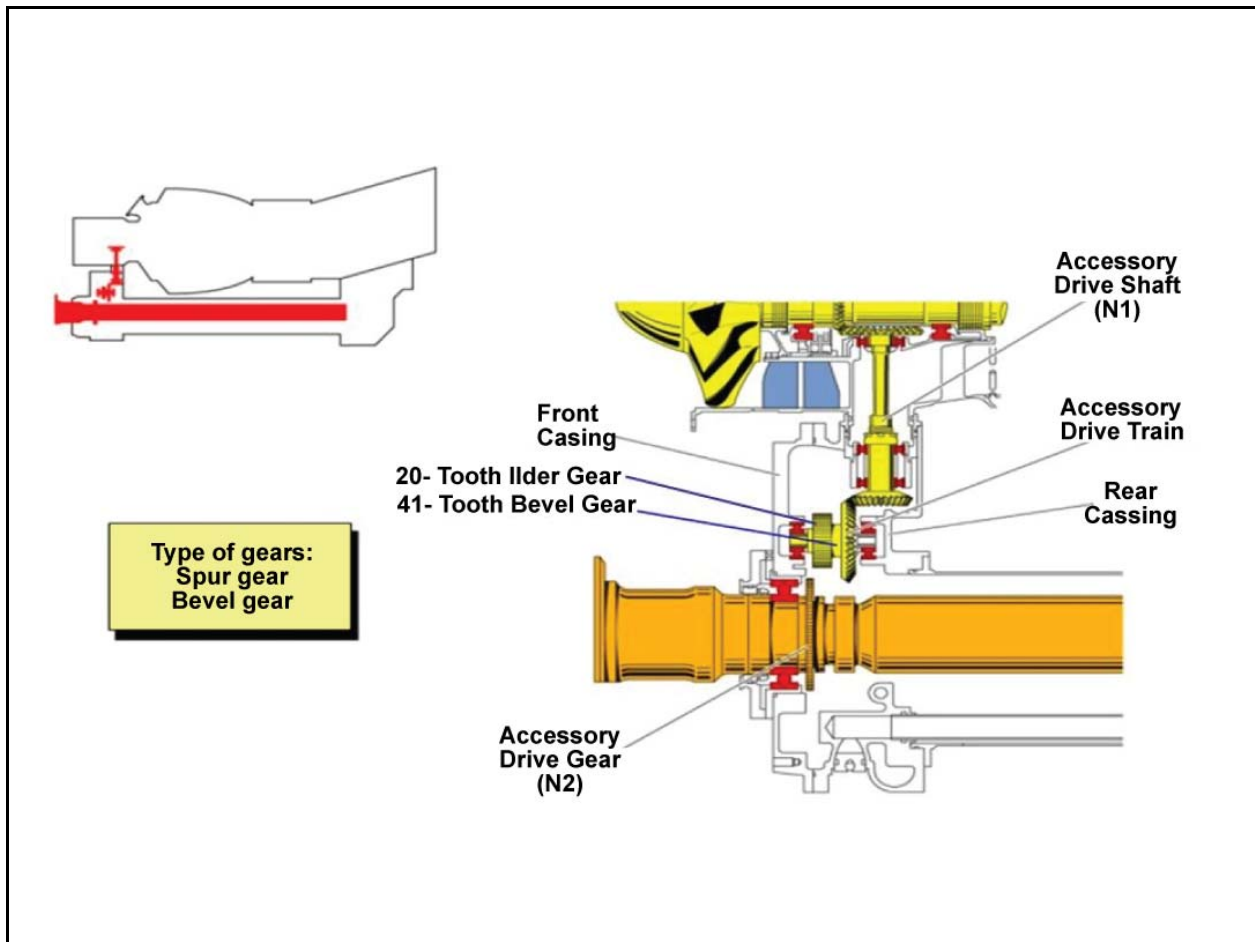
Figure 1. Accessory gearbox

An examination of the engine determined that the 41-tooth bevel gear (part number 0292127330) had fractured due to high-cycle fatigue cracking. The gear was installed during engine manufacture and had accumulated a total of 1644 hours since new. Metallurgical examination (TSB Laboratory report LP 005/2008) of the bevel gear revealed numerous fatigue cracks radiating from the roots of many of the gear teeth. Circumferential fatigue cracks were also observed in the rim of the gear. There were no relevant manufacturing flaws found in the gear that could contribute to the failure.

The 41-tooth bevel gear (see Figure 1) is located in the accessory gearbox module 1 (MO1) and has a 20-tooth idler gear mounted to its shaft. The MO1 is composed of the accessory gear box and the transmission shaft. The starter-generator output shaft is coupled to the compressor through a series of bevel gears that includes the 41-tooth gear. The 20-tooth idler gear drives all the accessories mounted to the MO1. During the starting sequence, the starter-generator drives both gears, which in turn drive the compressor and accessories. Conversely, once the engine is running, the compressor drives the 41-tooth bevel gear which, in turn, drives the accessories and starter-generator. Failure of the 41-tooth bevel gear will decouple the engine from the accessories and result in an uncommanded engine shut down. Once the engine is shut down, it can not be restarted.

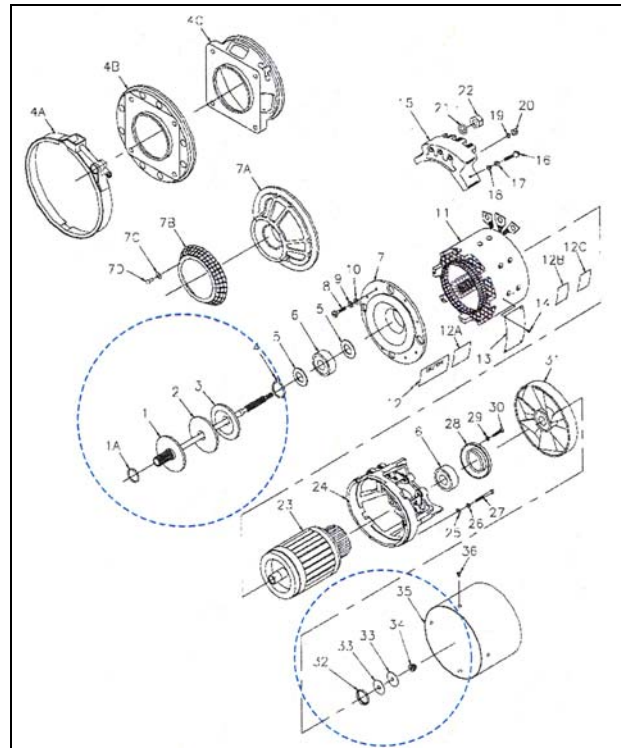
Figure 2. Exploded view of starter-generator

The starter-generator design incorporates a dampening system. Dampening systems are state-of-the-art features in starter-generator design (for APC: USA spec. MIL TDL 6162) and are systematically taken into account during the design of all starter-generators. For the APC starter-generator, this is comprised of a pair of damper plates on each side of a friction plate at one end of the rotor shaft. At the other (cooling fan) end of the shaft, a retainer spring, a set of Belleville springs, and a drive shaft nut are fitted (see Figure 2). With the drive shaft nut correctly tightened, the appropriate pressure is applied to the damper plates and friction disc.

- A check of the dampening system showed that the Belleville springs were excessively compressed, preventing the dampening system from functioning properly.
- The Belleville springs as visible from the outside appeared to be concave.
- The shaft was noted to be off-centred.

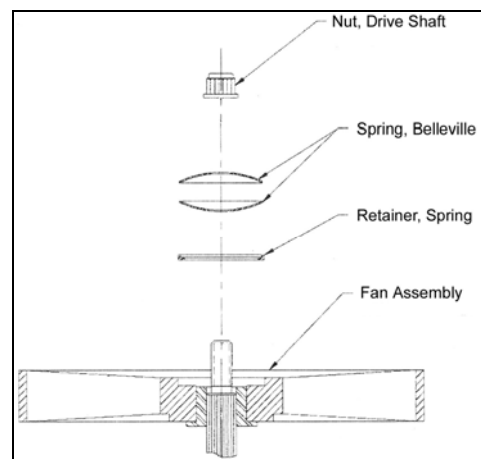
Figure 3. Belleville spring installation

It was also demonstrated during testing that the APC overhaul procedure to assemble and adjust the dampening system by tightening the nut was imprecise and did not ensure a proper functioning dampening system as it was only possible to see the outermost Belleville spring: "With a suitable holding tool, hold drive shaft and install drive shaft nut, and gently tighten until the drive shaft nut and springs bottom gently against fan. Then back off the drive shaft nut, $\frac{3}{4}$ of a turn."

The overhaul of APC starter-generators was undertaken by various service centres prior to the takeover of that company by Unison Industries in 2005. Since that time, only two maintenance centres are authorized to carry out overhaul of the APC starter-generators. Unison industries indicate that the procedure for installing and adjusting the Belleville springs in the factory inverts the top washer and bottoms-out the assembly (metal-to-metal) before being backed-off to allow the necessary free-play in the system (see Figure 3). The top washer takes a set after the first cycle, but subsequent cycles repeat a consistent hysteresis loop. Therefore, the force is quite predictable.
