**AVIATION INVESTIGATION REPORT  
A07P0123**

**REDUCTION GEARBOX FAILURE/ENGINE POWER LOSS**

**PACIFIC WESTERN HELICOPTERS  
BELL 212 (HELICOPTER) C-GPWX  
PRINCE GEORGE, BRITISH COLUMBIA  
26 APRIL 2007**

Report Number A07P0123

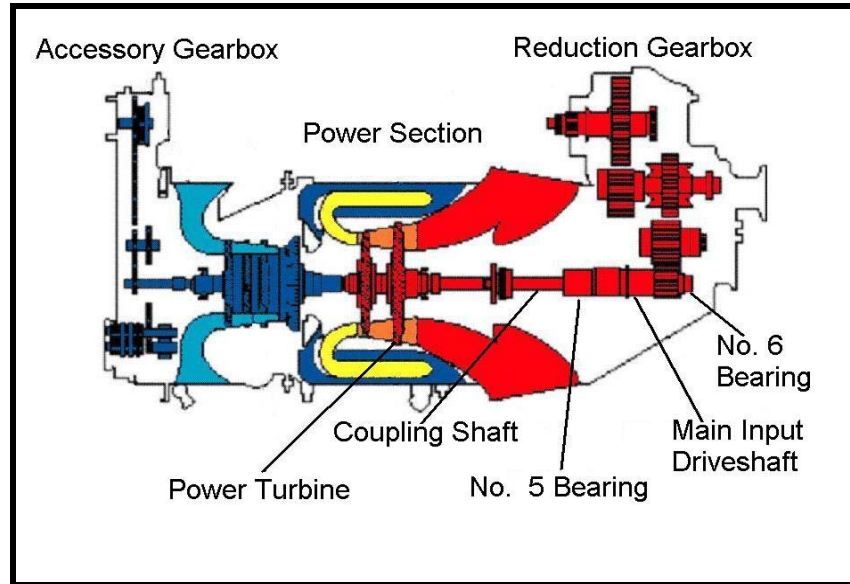
Post-occurrence examination of the RGB revealed that the rolling elements (balls) and raceways of the number five bearing (part number 3021467, serial numbers F619A and F619B) installed on the number one main input driveshaft had deteriorated, allowing the main input driveshaft to move aft until the coupling shaft decoupled from the PT. The PT subsequently oversped, the PT bearing support failed, and the PT blades contacted the shroud. All of the PT blades suffered severe tip damage and several blades broke off near their platform.

Figure 1. PT6T-3B engine, side view
