AVIATION INVESTIGATION REPORT
A07Q0014

FUEL STARVATION

PROPAIR INC.
DHC-2 BEAVER C-GUGQ
LA GRANDE-4, QUEBEC, 25 nm N
21 JANUARY 2007

Report Number A07Q0014

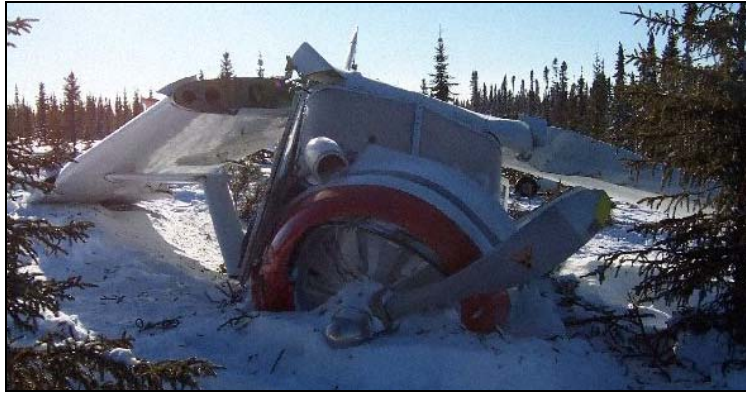
After the accident, the wing tips were touching the ground; as a result, the remaining fuel ran to the outboard part⁴ of the tanks. These fuel tanks contained less fuel than the unusable fuel quantity. Because the fuel filter broke in the accident, the contents of the belly fuel tank (auxiliary tank) drained out onto the ground.

Photo 1. View of the position of the wings

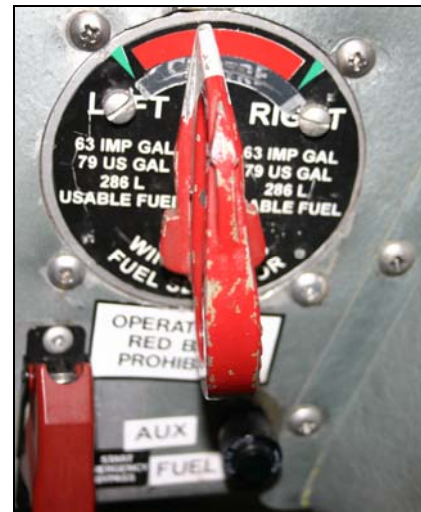
Photo 2. Wing tank selector

During winter operation, being able to select one wing tank or the other was not assured because the secondary cable would freeze. Because of this problem, the company pilots had adopted the practice of placing the wing tank selector in the middle position, as was the case during the occurrence flight. This position partially opened both valves and had shown over the course of several hundred hours of operation that it could provide an adequate flow of fuel to the engine. As this procedure did not conform to the flight manual supplement, the operator should have objected and ensured that the pilots operated the aircraft in accordance with the amended flight manual.

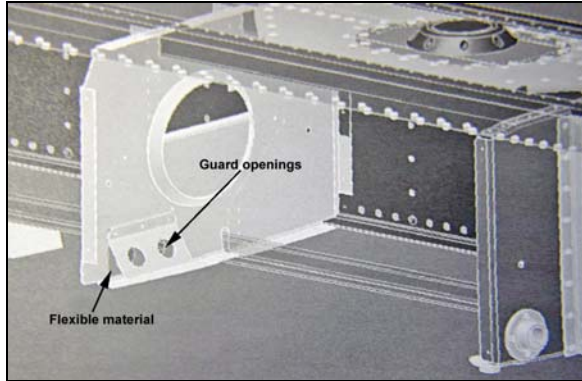
The flow of fuel between the wings should have stopped in the first compartment of each tank where the fuel supply outlet was located (see Appendix A). These compartments are equipped with a flapper valve to stop the fuel from returning to the outboard compartments. The flapper was made of a flexible material similar to neoprene. It was riveted to the outboard bulkhead, behind a guard (part number MW14-99) that restricted its movement and kept it in proper position. The investigation revealed that the guards were not fabricated in accordance with the drawings (see Figure 1); two round openings about one inch in diameter were not drilled (see

Figure 1. View of the drawing⁷

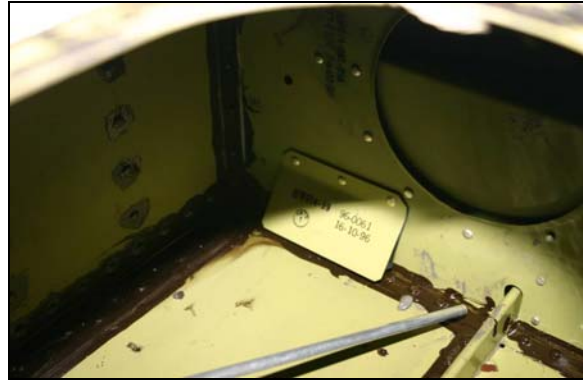
Photo 3). Normally, the openings allowed the fuel to put pressure on the flapper and help keep it closed. Without the openings, the fuel could flow around the guard and lift the side of the flapper. Also, the bulkhead is installed at a right angle to the wing. Considering the 2° dihedral angle and that the flapper is only maintained against the bulkhead by gravity, proper sealing was not assured. As a result, fuel could return toward the outboard compartments.

Photo 3. Guard for the flapper valve as installed

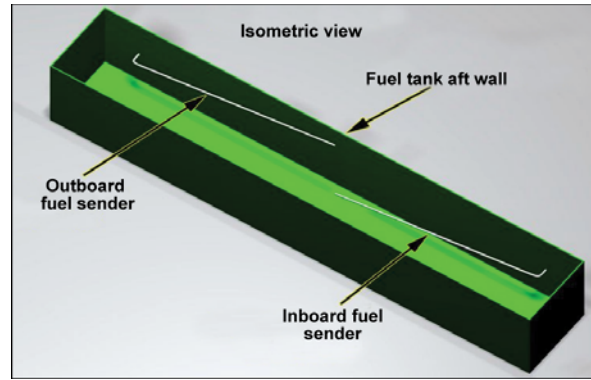
Figure 2. Orientation of the fuel senders in the wing tanks

AWT drawing MF001-005 rev IR specified that the fuel senders had to be bent into an inverted U-shape. However, as per Westach, the model number specified at the AWT drawing cannot be bent into an inverted U-shape. It can only be bent near its anchorage at an angle up to 90°. Consequently, the shape of the fuel senders was in accordance with Westach instructions but the AWT drawing was not. The drawing also wrongly quoted part number WS34T13 for the triple fuel indicator. That part number is not known to Westach. The only indicator recommended for use with their fuel sender is indicator part number A3T13-IV, which was found installed in the aircraft.

The probe of the outboard fuel sender in the left tank had rotated in its base to an almost horizontal position until its tip contacted a bulkhead. Several friction marks on the bulkhead indicated that the probe had moved before the accident. Since the fuel sender was immersed until the tank level reached about half, the signal transmitted to the fuel level gauge was for a full tank.

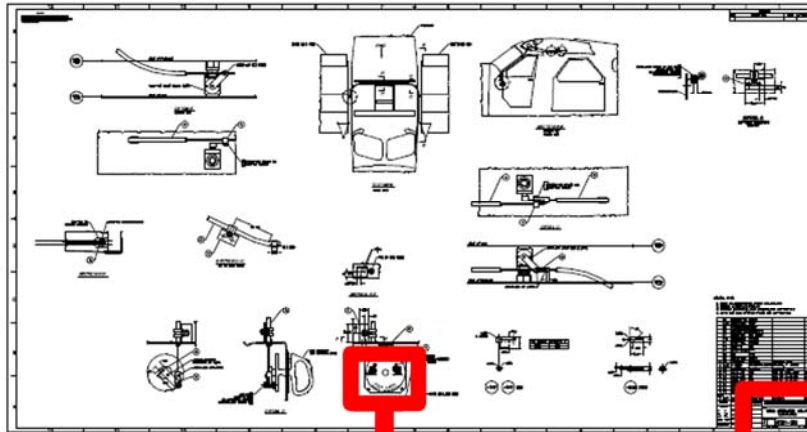
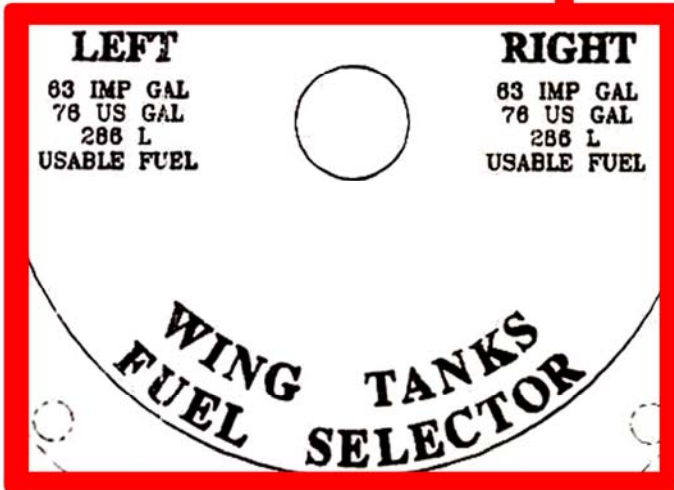
Appendix B – Drawing MF001-003

- the bending of the fuel senders;
- the absence of perforations in the flapper valve guards;
- the wing fuel selector placard did not conform to drawing MF001-003 (Rev IR);
- the error in the flight manual supplement about the cruise flaps position; and
- the description of the fuel system.
