**AVIATION INVESTIGATION REPORT
A07W0003**

LOSS OF CONTROL - MARGINAL WEATHER

**ARCTIC SUNWEST CHARTERS
CESSNA A185F C-GSDJ
YELLOWKNIFE, NORTHWEST TERRITORIES, 53 nm SE
03 JANUARY 2007**

Report Number A07W0003

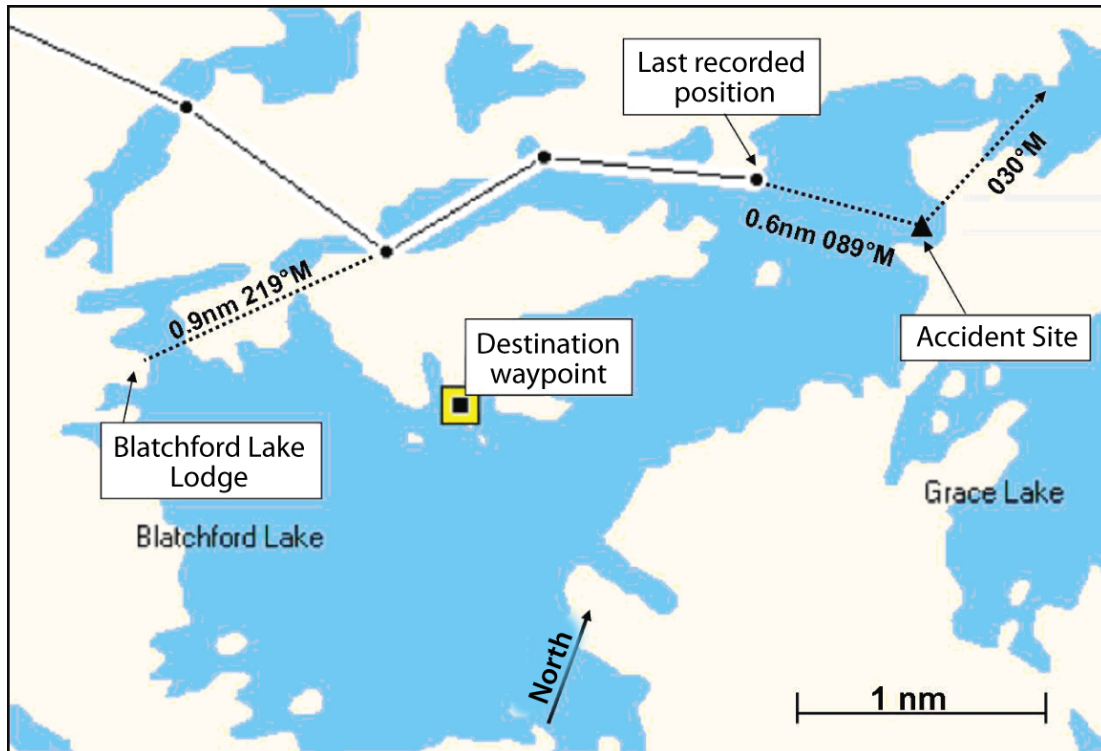
Figure 1. Map of area

Slight deviations left and right from the direct track were recorded while en route to the destination waypoint, with the aircraft arriving at the north shore of Blatchford Lake approximately 0.9 nm east of the lodge. The aircraft then took up a northeasterly heading (away from the lodge) and slowed to 78 knots. There was one more track point recorded 0.6 nm west of the accident site on a track of 071° magnetic (M), with a ground speed of 90 knots, before the unit ceased recording (see Figure 1). The aircraft was in a left turn when it began to shake just before a sudden descent and impact.
