AVIATION INVESTIGATION REPORT

A08O0036

COLLISION WITH TREES ON APPROACH

BOEING 727-260 C-GUJC

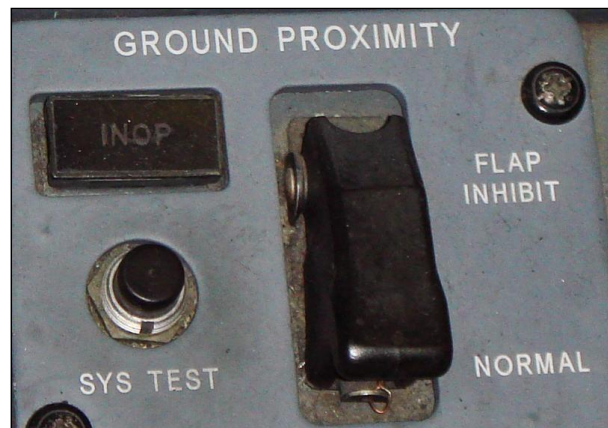
The EGPWS control panel is labelled “Ground Proximity” and the inoperative indication is labelled “INOP” (see Photo 1). There were no indications to the crew that an EGPWS was installed.

Photo 1. EGPWS control panel

Pulling of the radio altimeter circuit breaker after the take-off from CYMX led to a loss of the basic modes of the EGPWS. It also caused the illumination of the INOP light on the ground proximity control panel in front of the pilots, leading the flight crew to believe that the GPWS was inoperative.

The inoperative radio altimeter led to a loss of the basic modes of the EGPWS and the illumination of the "INOP" light on the control panel in front of the pilots. With an inoperative radio altimeter, a GPWS would become inoperative. However, an EGPWS loses only the basic modes that rely on radio altitude and continues to provide RFCF and TLAA caution and/or warning alert to the crew. The result was that, despite the failed radio altimeter, the EGPWS

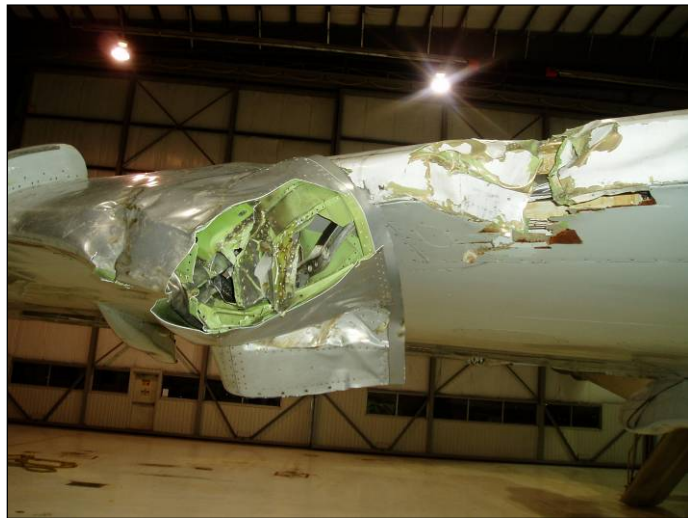
The aircraft was substantially damaged following the impact with the trees (see Photo 2). Several light scratches were found on the underside of the aircraft, running from forward of the wing root to the tailskid. Most of the damage was concentrated on the right side of the aircraft, with substantial damage to the right leading edge flaps and slats. There was no evidence of damage to the wing’s front spar. The right main gear door was damaged and the right anti-skid wiring harness was severed from the brake assembly.

Photo 2. Aircraft damage – leading edge, right wing

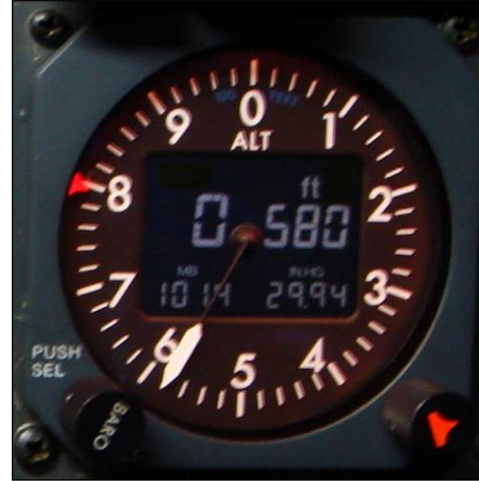
The pressure altimeter installed on this aircraft has two controls (see Photo 3). The left baro set knob is used to set the barometric pressure in millibars or inches of mercury. The right altitude index set knob is used to set the orange altitude bug or cursor on the outer scale of the indicator (in Photo 3 at 800 feet). It is used to set critical target altitudes such as the MDA.

The white altitude pointer indicates altitude in hundreds of feet, subdivided into 20-foot increments, and each rotation of the pointer equals 1000 feet. The position of this white pointer in relation to the orange altimeter bug is used to determine that the aircraft is approaching a critical altitude such as the MDA. Use of this type of altitude bug, however, requires altitude awareness on the part of the crew, especially for target altitudes above 1000 feet asl.

Photo 3. Pressure altimeter

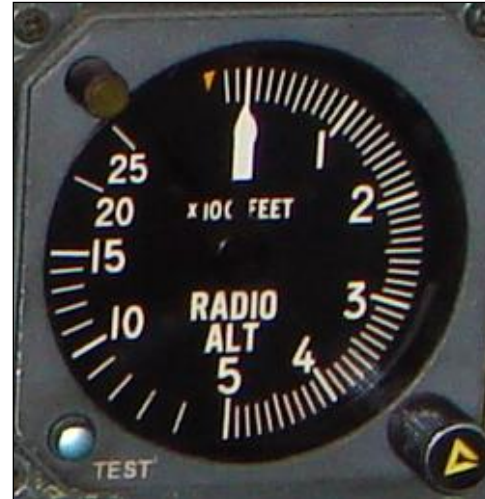
The radio altimeter (see Photo 4) displays the altitude of the aircraft above the ground. The white altitude pointer moves within a range of 0 feet to 2500 feet above the ground. The scale expands for indications below 500 feet above the ground to offer more precise readings and to increase low-altitude awareness.

Photo 4. Radio altimeter

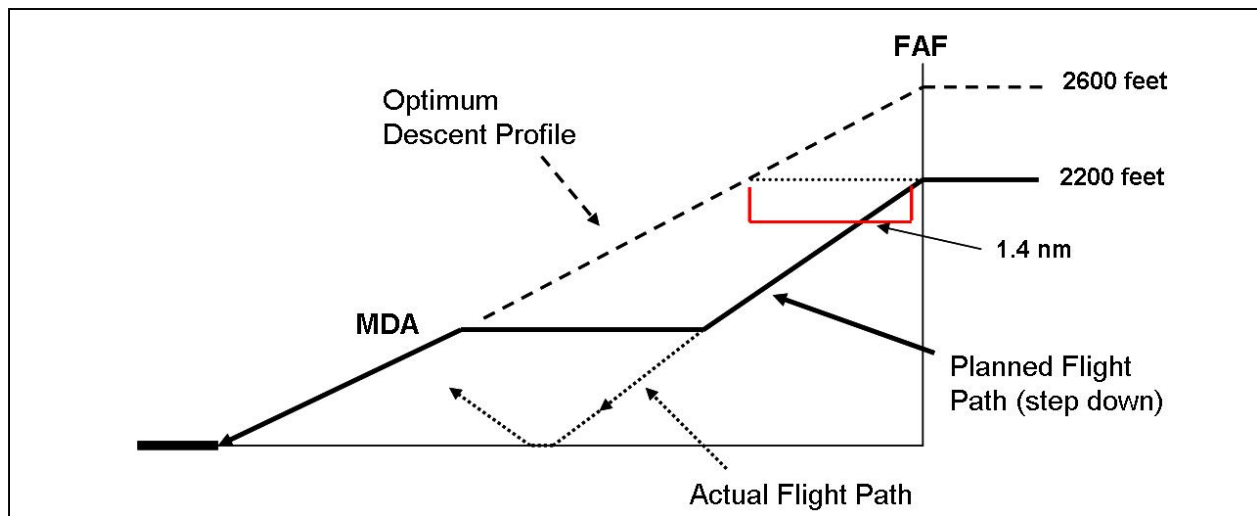
The Runway 30 threshold elevation at Hamilton is 767 feet asl and the FAF crossing altitude is 2200 feet asl. This equates to a descent profile of approximately 2.3 degrees, which, at a ground speed of 140 knots, results in a rate of descent of 565 feet per minute.

During the occurrence approach, a step-down technique was used. After crossing the FAF, the aircraft descended at approximately 1000 feet per minute.

Figure 1. Optimum descent profile, planned and actual approach paths

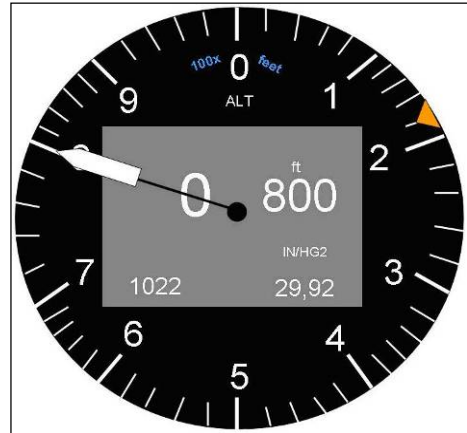
Misreading the altimeters would imply that, when they initiated their level-off, all three crew members did not notice that the white altitude pointer was at 800 feet, while the altimeter bug was set at 1180 feet (see Figure 2). It is unlikely that the crew misread the altimeter because the 800-foot position and the 1180-foot position are in opposite quadrants of the altimeter.

Figure 2. Pressure altimeter at 800 feet with the altimeter bug at 1180 feet

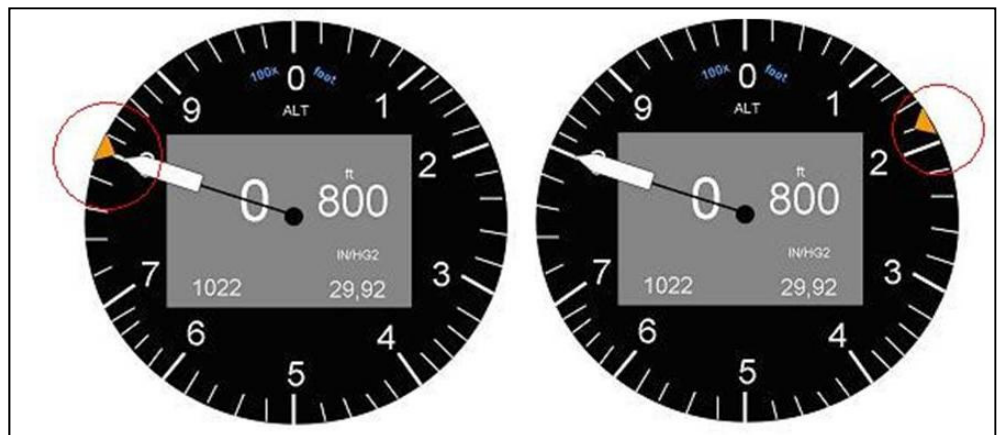
Post-flight examination of the altimeters found the PNF's altimeter bug set at 800 feet. Therefore, when the "minimums" callout was made by the PNF at MDA, the white altitude pointer had to be aligned with the altimeter bug

(see Figure 3, left side). **Figure 3.** Pressure Altimeter Index Positions

It could not be determined what the PF's bug was set to on the first approach. However, it is likely that it was the same as the PNF's (800 feet) as there was no indication in the FDR data that the aircraft levelled off at MDA (1180 feet). On the second approach, the crew was likely monitoring the altitude more closely using the digital altitude readout instead of the pointer and bugs. The more-experienced PNF coached the PF throughout the level off. However, the PF was slow to adjust power in response to calls from the PNF to level off and the aircraft descended 100 feet below MDA. One of the crew members (possibly the PNF) pulled back on the control column despite the fact that autopilot was engaged. Both the PF's and PNF's altimeter bugs were likely still set at 800 feet because that was where the PNF's bug was found.
