AVIATION INVESTIGATION REPORT

A08O0333

RUNWAY OVERRUN

**JAZZ AIR LP (AIR CANADA JAZZ)
DE HAVILLAND DHC-8-100 C-GTBP
NORTH BAY JACK GARLAND AIRPORT, ONTARIO
14 DECEMBER 2008**

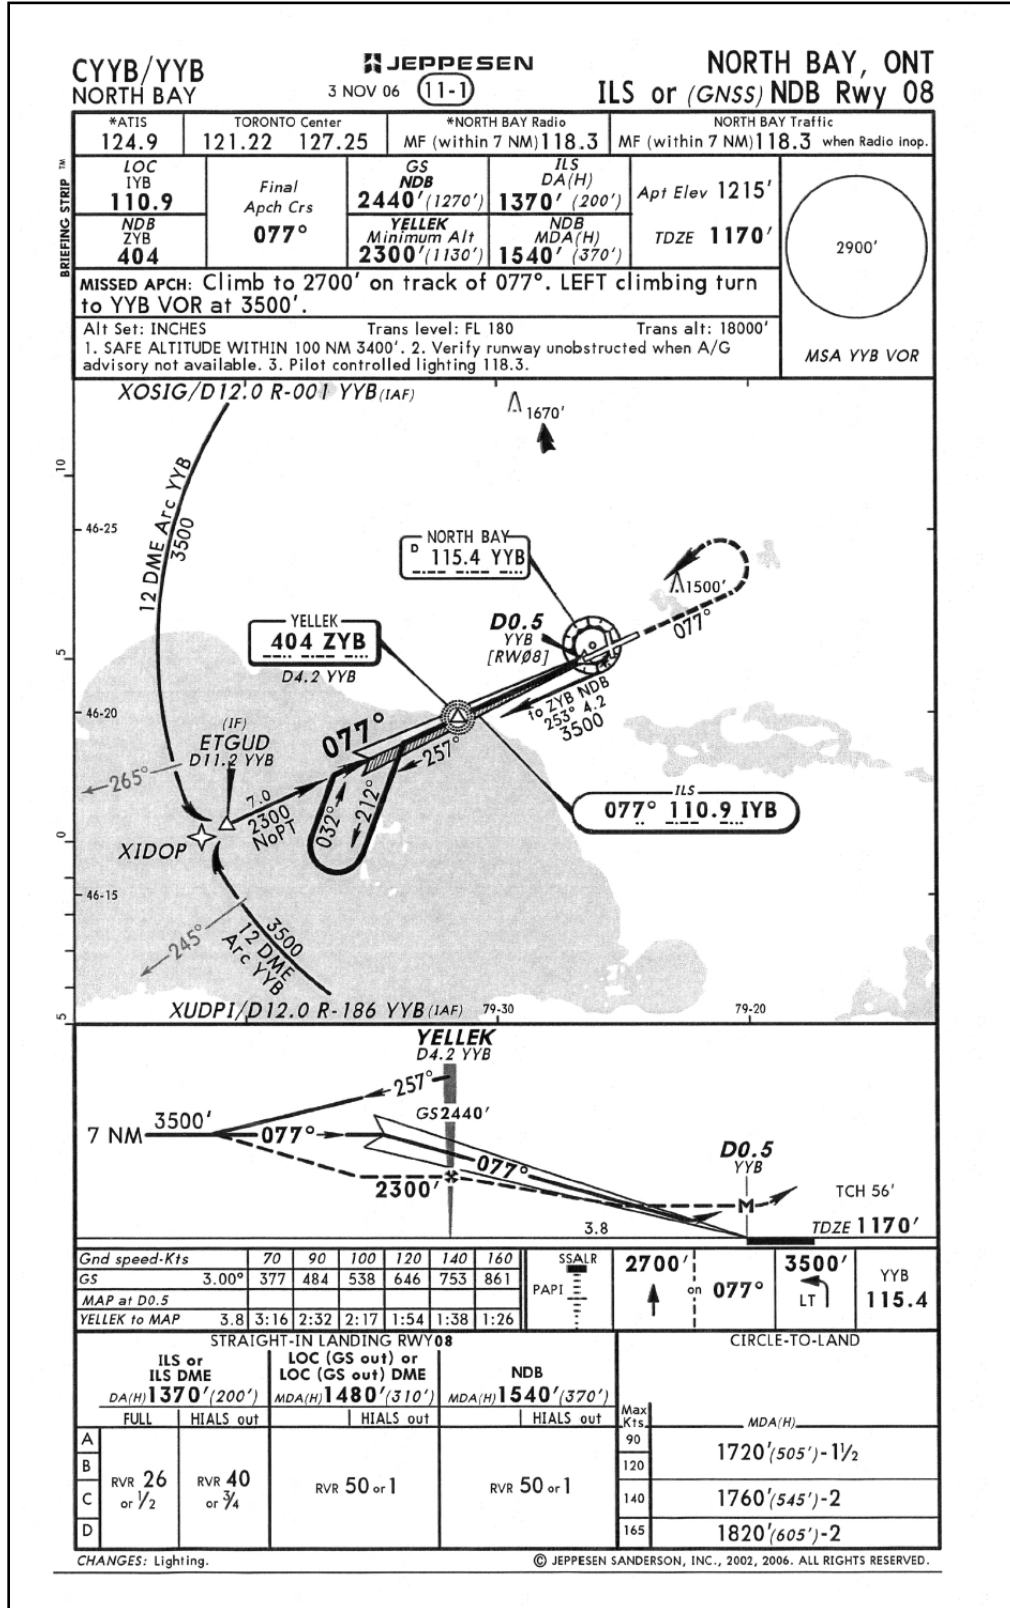
Appendix B – Jeppesen Approach Plate North Bay

Furthermore, the CAP approach plates do not show a rate of descent table or a final approach descent gradient as recommended by the ICAO. Therefore, flight crews in Canada may not have all the tools available to safely conduct a SCDA-style approach.

Since Canada does not follow the requirements and recommendations mentioned in ICAO Annex 4, and the guidelines in PANS-OPS, Jeppesen does not depict distance/altitude cross checks on its Canadian approach plates.

3. The profile view of the CAP approach plate does not show a rate of descent table or a final approach descent gradient as recommended by ICAO Annex 4. Without this information, there is a risk that situational awareness may decrease.

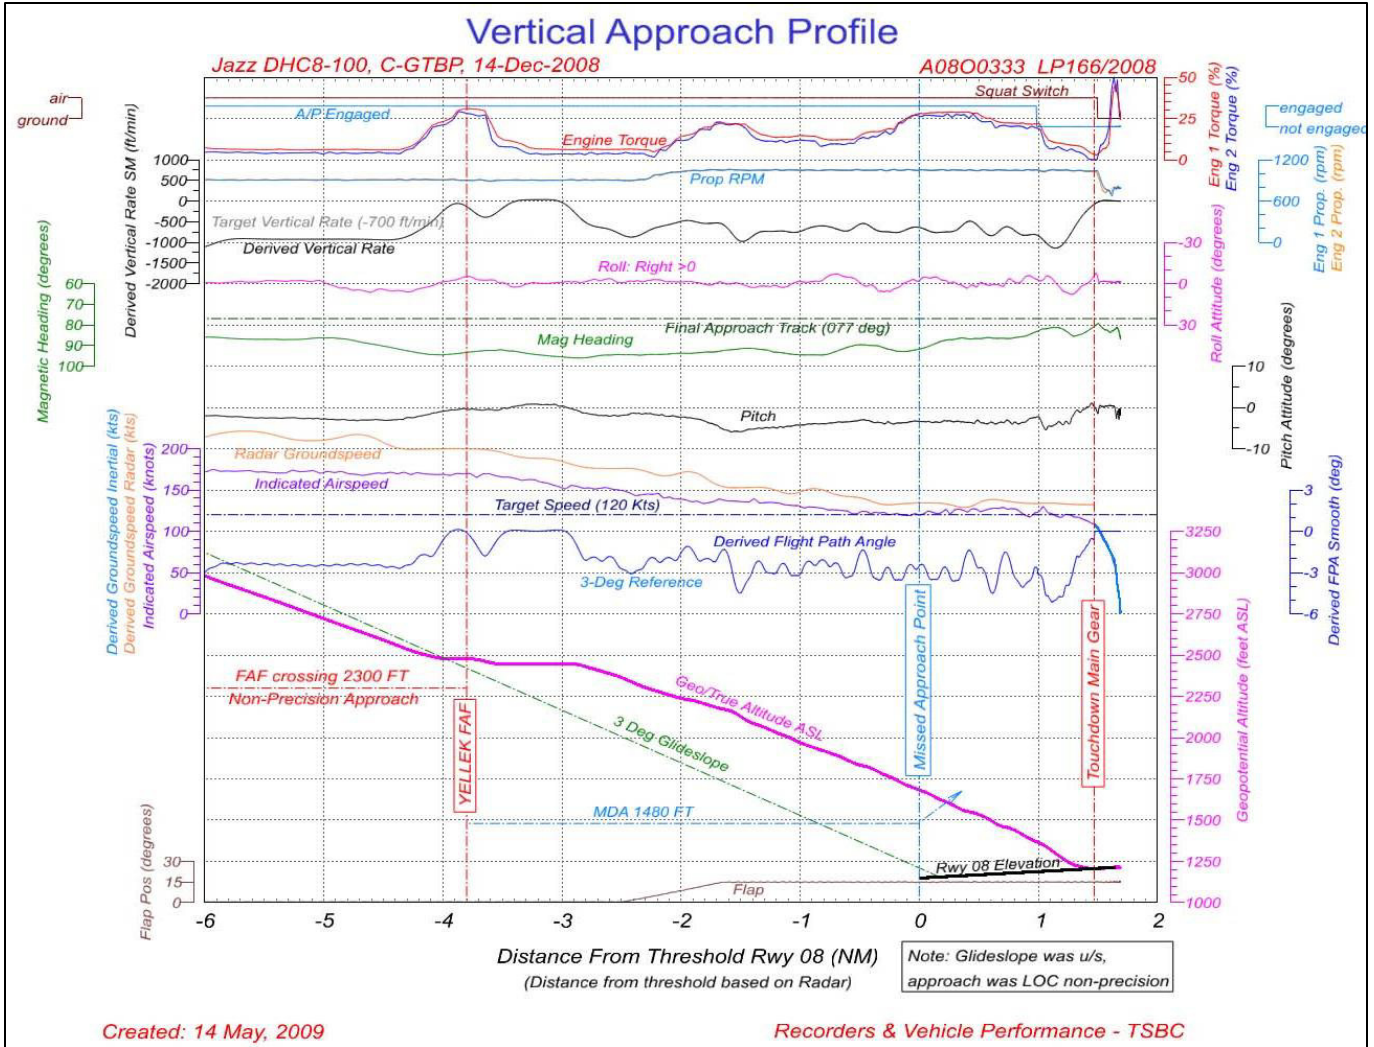
Appendix C – Vertical Approach Profile

The aircraft turned onto the final approach track in descent, levelling at 2500 feet 0.2 nautical miles (nm) before the FAF. It crossed the FAF at approximately 170 KIAS; the ground speed was 200 knots. At the FAF, the aircraft began to decelerate. It could not be determined whether the crew began timing the final approach over the FAF or not. The aircraft slowed to the flap and landing gear extension speeds and began its descent 1 nm past the FAF at a descent rate of approximately 700 fpm, displaced above the desired flight path. At 3.3 nm past the FAF, the aircraft reached its target airspeed of 120 KIAS (140 knots ground speed) configured for landing. The aircraft crossed the missed approach point (MAP) at an approximate altitude of 1700 feet, 220 feet above the MDA (see Appendix C). The flight crew members were not aware that they were above the desired flight path.
