**AVIATION INVESTIGATION REPORT  
A08P0244**

**LOSS OF CONTROL - COLLISION WITH TERRAIN**

**PRISM HELICOPTERS  
MD HELICOPTERS 369D (HUGHES 500), C-GZIO  
ALICE ARM, BRITISH COLUMBIA  
06 AUGUST 2008**

Report Number A08P0244

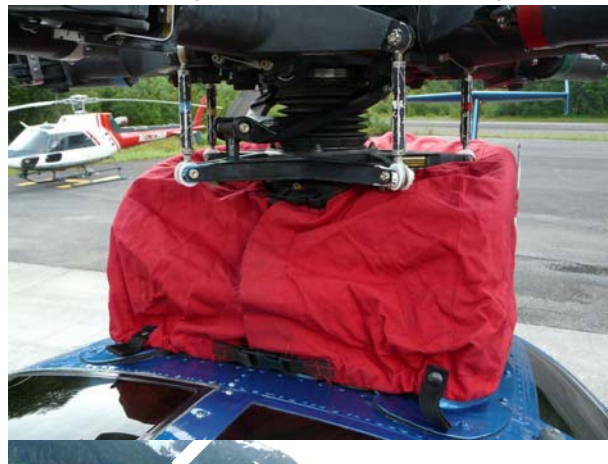
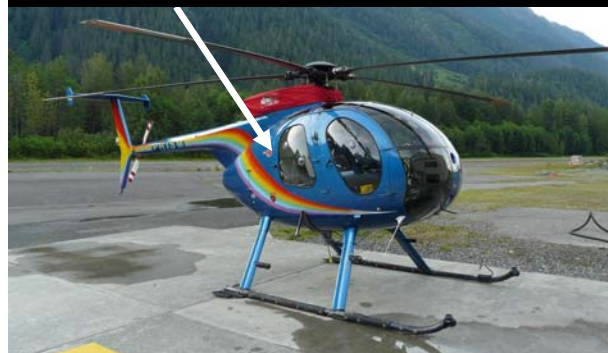
**Photo 1. Doghouse cover**

Records indicate that the helicopter was certified, equipped, and maintained in accordance with existing regulations and approved procedures. There was an apprentice aircraft maintenance engineer on-site to help with elementary tasks on the helicopter. He would normally look over the helicopter at the end of the day and secure it for the night. This included installing a synthetic heavy material cover (doghouse cover) over the engine intake and around the main rotor control system (see Photo 1) and tying the main rotor down.

The cover does not have any straps or physical barriers that fall at or below human eye level. Once the pilot gets into the helicopter, there are no visual cues of the cover's installation.

Prism Helicopters implemented procedures requiring that blade tie-downs be installed whenever the doghouse cover is installed. Also, the covers have been modified with tape/straps that hang down and are to be placed in the front doors.

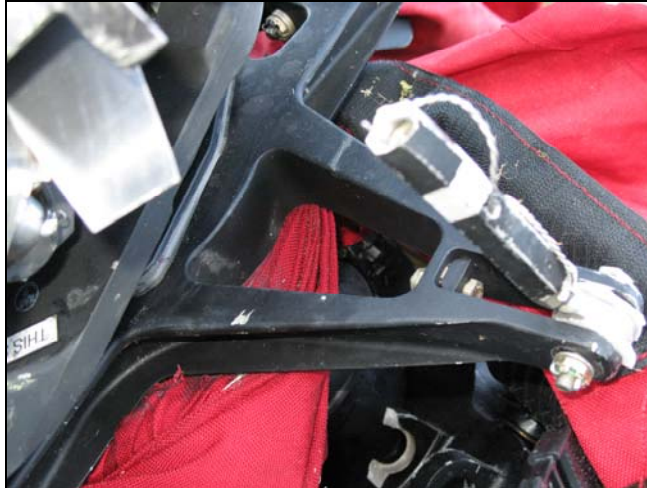
Examination of the helicopter wreckage at the accident site revealed the cover tightly wrapped around the main rotor control system, around the swashplate (see Photo 2). Nearly all the control linkages (pitch change rods) were broken and the damage was not consistent with that normally found from crash impact forces. Rotor blade damage was consistent with low rpm at impact. Tree damage/scars at the accident site were consistent with a vertical descent and no rotor rpm.

**Photo 2.** Doghouse cover wrapped between controls

It is clear that the removal of the cover was missed during flight preparation and that the cover damaged the main rotor controls while the rotor was turning. Also, rotor rpm was likely lost due to the binding effect that the cover had as it squeezed between the stationary and rotating components of the swashplate assembly. This rendered the helicopter uncontrollable after the takeoff, and it collided with terrain.

1. The doghouse cover was not removed before flight and it wrapped around the flight controls linkage, damaged the linkage, and rendered the helicopter uncontrollable.
2. The helicopter fell in an uncontrolled state, with reduced rotor rpm, until it collided with terrain.
3. Anomalies in the pilot's routine and the lack of physical barriers likely caused him to miss removing the cover before the flight.

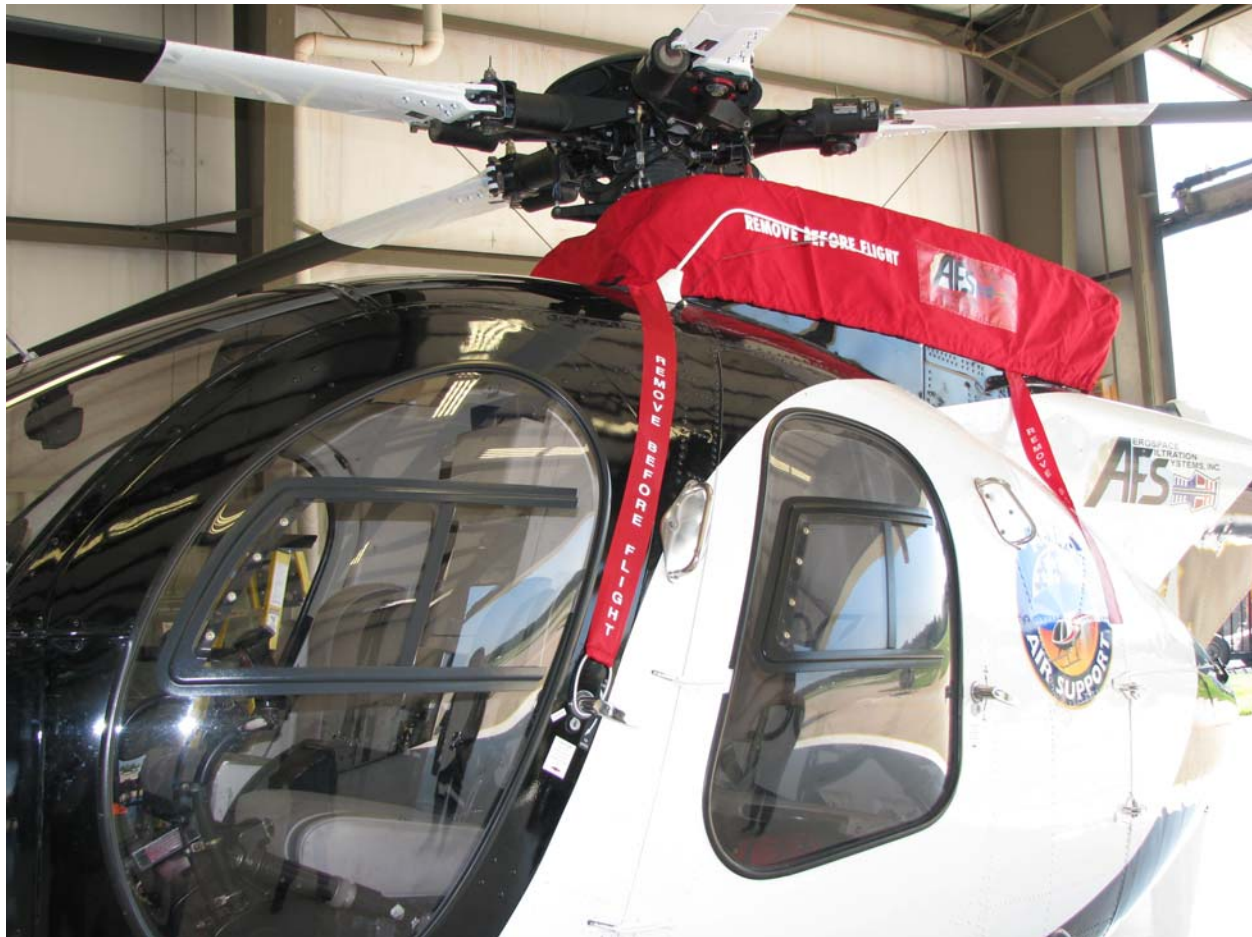
**Photo 3.** Modified doghouse cover

The manufacturer of the doghouse (Aerospace Filtration Systems Inc.) has taken safety action in modifying the cover (see Photo 3).
