## **AVIATION INVESTIGATION REPORT**

**A08W0096**

### **LOSS OF CONTROL AND COLLISION WITH TERRAIN**

**MDHI 369D C-GNMG**

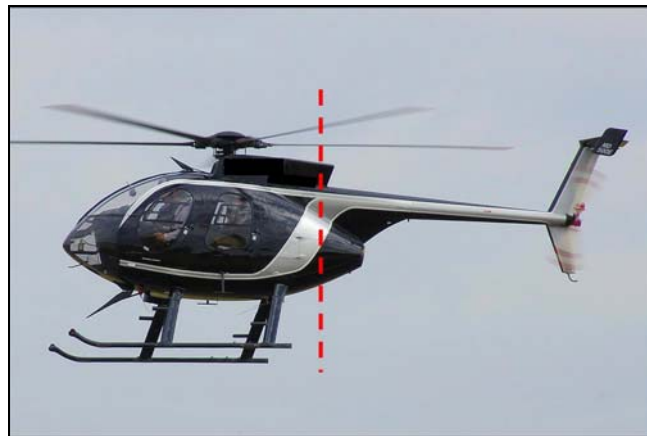
The tail section had not burned. There was no indication of tail rotor drive shaft rotation at the time of impact. A break occurred in the aft boom at Station 242, and the drive shaft and flight control tubes were bent approximately 90 degrees at that point. The skin had rotated counter-clockwise 270 degrees at the same location. The drive shaft did not show any indication of torsional load at this bend or anywhere else. The tail rotor blades had strike marks only on the sides, toward both the leading and trailing edges. There were no strike marks on the leading edges. The front sections of the tail rotor drive shaft and flight control tubes were completely melted from Station 137 forward (see Photo 1). The tail rotor drive and flight controls were continuous forward to this burn point. The tail rotor controls were examined to the extent possible and no other disconnected controls were found. All the tail rotor components indicated no signs of failure before or at impact. There were no indications of flailing of the tail rotor drive shaft at any location.

**Photo 1.** Approximate location of Station 137

The tail rotor drive shaft inspection/check in Section 63-15-10 of the Maintenance Manual, revision 20,<sup>2</sup> details a twist inspection of the tail rotor drive shaft only from the aft coupling at the tail rotor transmission forward to Station 137.5. There is no requirement to inspect forward of this point to the main transmission output quill coupling.

Damage to the aircraft indicated virtually no rotation of the tail rotor at the time of ground contact, but there was evidence of low-power main rotor rotation. The engine was producing power but this power was not being transferred to the tail rotor. It was most likely that the tail rotor drive shaft failed at the forward section, but evidence to confirm this was lost in the post-crash fire. Failure of the tail rotor drive shaft would result in an uncommanded rotation of the helicopter around the vertical axis. The helicopter response to changes in throttle setting corresponds to what would be expected for a loss of tail rotor drive. There was insufficient altitude to effect recovery before ground impact.

The operator initiated a special inspection and measuring process on the forward section of selected tail rotor drive shafts operating in its fleet for this model of helicopter, in addition to the requirements of the Maintenance Manual inspection criteria.
