AVIATION INVESTIGATION REPORT

A09A0036

LOSS OF CONTROL – COLLISION WITH TERRAIN

BRITTEN-NORMAN ISLANDER (BN.2A-27) C-FJJR

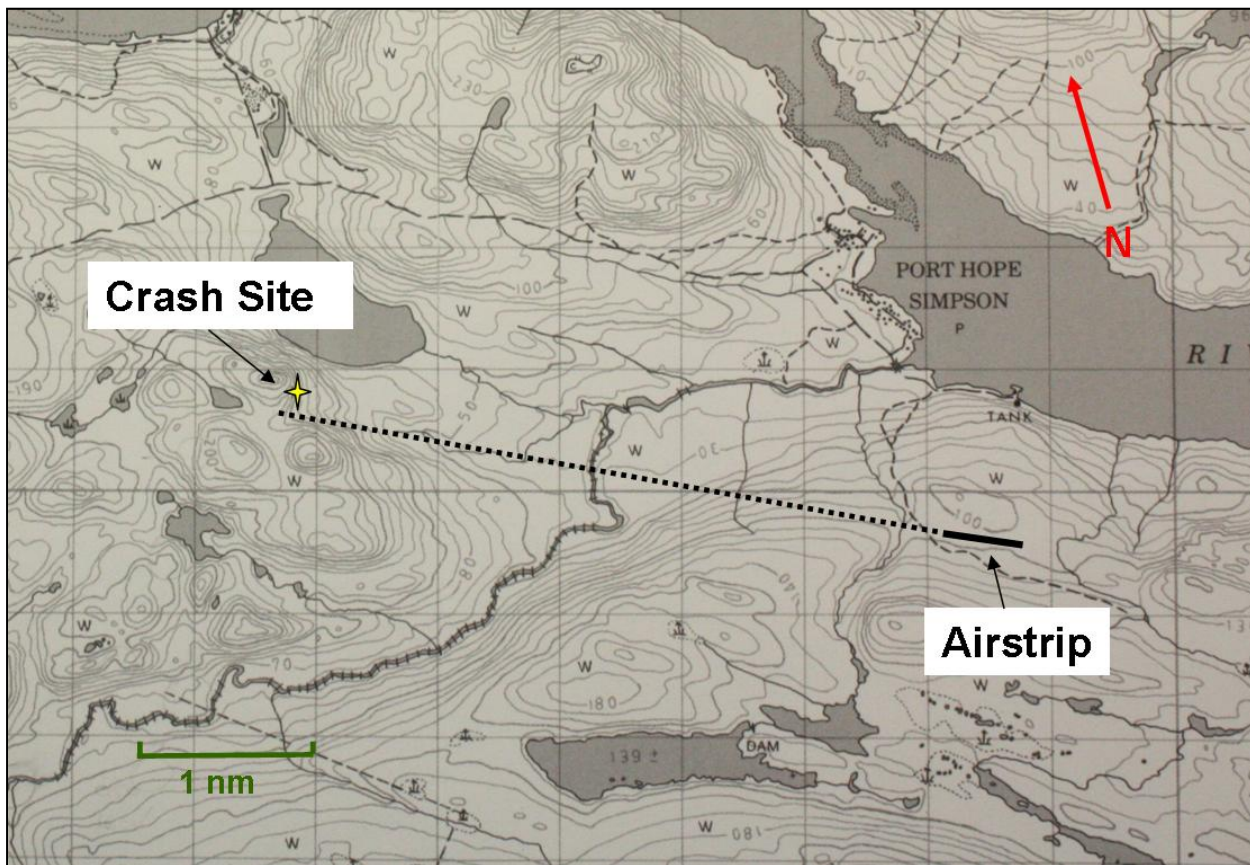
Figure 2. Location of the crash site relative to the airstrip

Around 0730, the fog started to clear and smoke was visible to the west of the airport on the side of a hill. At 0930, a Canadian Rangers team was dispatched to locate the aircraft. It took less than two hours to find the crash site. The wreckage was located about four nm west of the airfield, just north of the extended centreline for Runway 12 (see Figure 2).

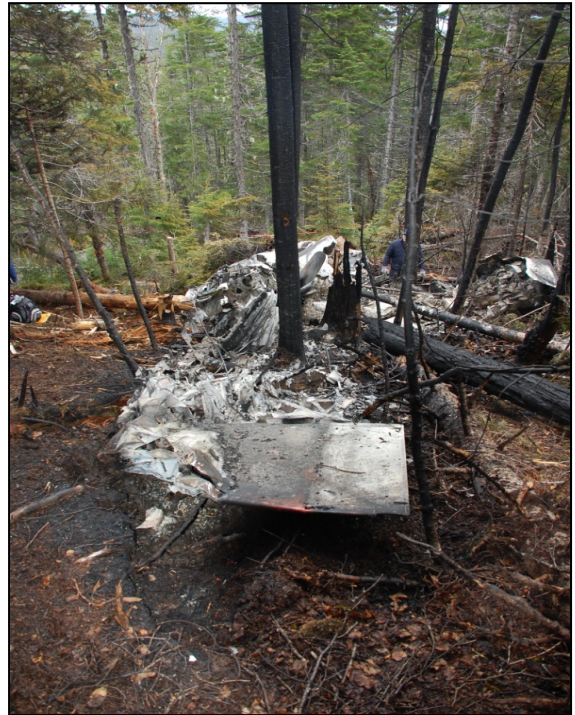
Photo 2. Crash site looking downhill from left wingtip.

There was no evidence of tree strikes in the area of the crash site. The aircraft impacted the ground in a near-vertical attitude with no rotation about the longitudinal axis. The fuselage and wings were extensively damaged by impact forces and a post-crash fire (see Photo 2). The fuselage was oriented in a northerly direction parallel to the hillside. The wreckage was located on the east side of a heavily wooded hill at approximately 490 feet asl.

There was no indication of pre-impact structural failure or failure of the flight control system. The damage noted on the propeller and spinner of both engines was consistent with rotation at the time of impact. There was no indication of a pre-existing condition that would have prevented the engines from performing normally.
