AVIATION INVESTIGATION REPORT

A09C0114

IN-FLIGHT COLLISION

Glad Air Spray
Pezetel M18B Dromader, C-GEZV and
Air Tractor AT-401, C-GBDF
Gladstone, Manitoba
13 July 2009

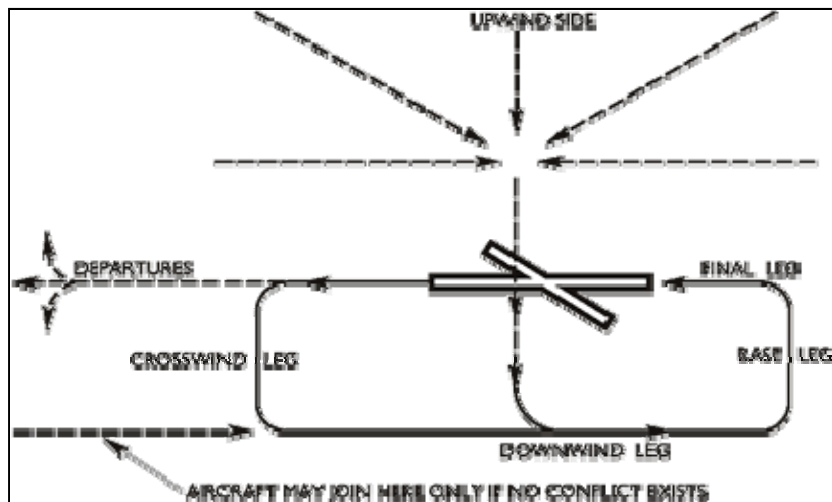
Figure 1. Standard Left-Hand Circuit Pattern

The *Canadian Aviation Regulations (CARs)*⁴ specify that before landing at an aerodrome, the pilot of an aircraft shall conform to or avoid the pattern of traffic formed by other aircraft in operation there, give way to any aircraft at a lower altitude that is also approaching the aerodrome for the purpose of landing, and make all turns to the left when operating within the aerodrome traffic circuit, except where right turns are specified. Transport Canada *Aeronautical Information Manual*, section RAC 4.5.2, Traffic Circuit Procedures - Uncontrolled Aerodromes, states the following:

Unless otherwise specified or required by the applicable distance from cloud criteria, aircraft should approach the traffic circuit from the upwind side. Alternatively, once the pilot has ascertained without any doubt that there will be no conflict with other traffic entering the circuit or traffic established within the circuit, the pilot may also join the circuit on the downwind leg [Figure 1]. When joining from the upwind side, plan the descent to cross the runway in level flight at 1000 feet above aerodrome elevation or the published circuit altitude. Maintain that altitude until further descent is required for landing.

The Dromader pilot joined the circuit for Runway 18 on a right base leg, contrary to the recommended aerodrome traffic procedure. This compromised his opportunity to observe other traffic in the area and join the circuit without conflict with other traffic.

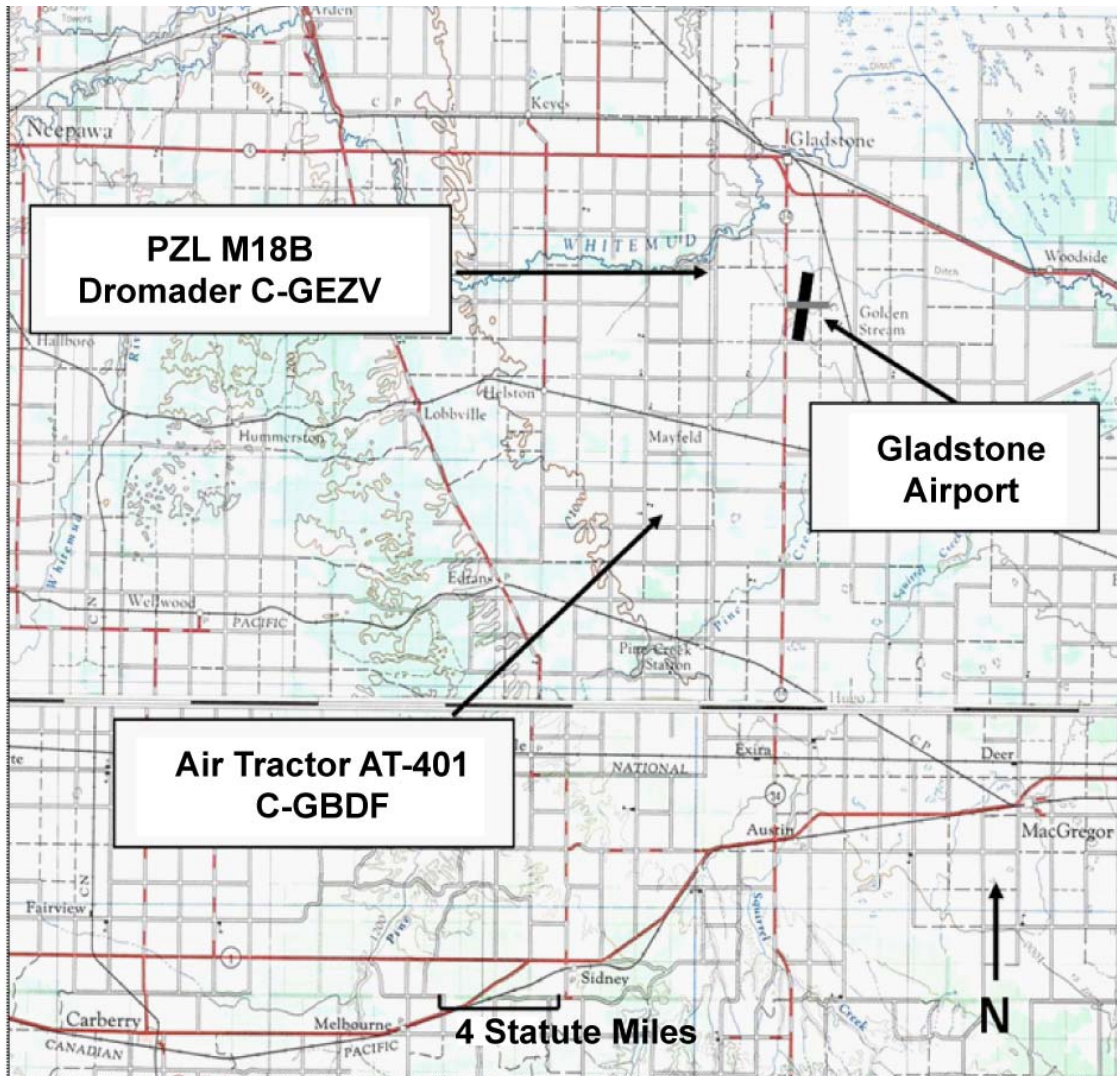
Appendix A - Accident Aircraft Initial Flight Paths

The Air Tractor had been operating near Carberry, Manitoba, earlier in the day. It remained at Carberry mid-day, and then completed a flight as winds subsided in the early evening. Returning to Gladstone, the Air Tractor approached the aerodrome from the southwest, crossed just south of Runway 18/36, and joined the circuit on a left downwind leg for Runway 18, at about 500 feet above ground level (agl).¹ The Dromader approached from the west and joined the circuit directly on a descending right base leg, also for Runway 18, starting at about 1000 feet agl. Both aircraft turned onto final approach for Runway 18 and proceeded towards the runway. The aircraft collided on short final, with the Dromader positioned slightly above the Air Tractor.² Neither pilot saw the other aircraft until the collision.

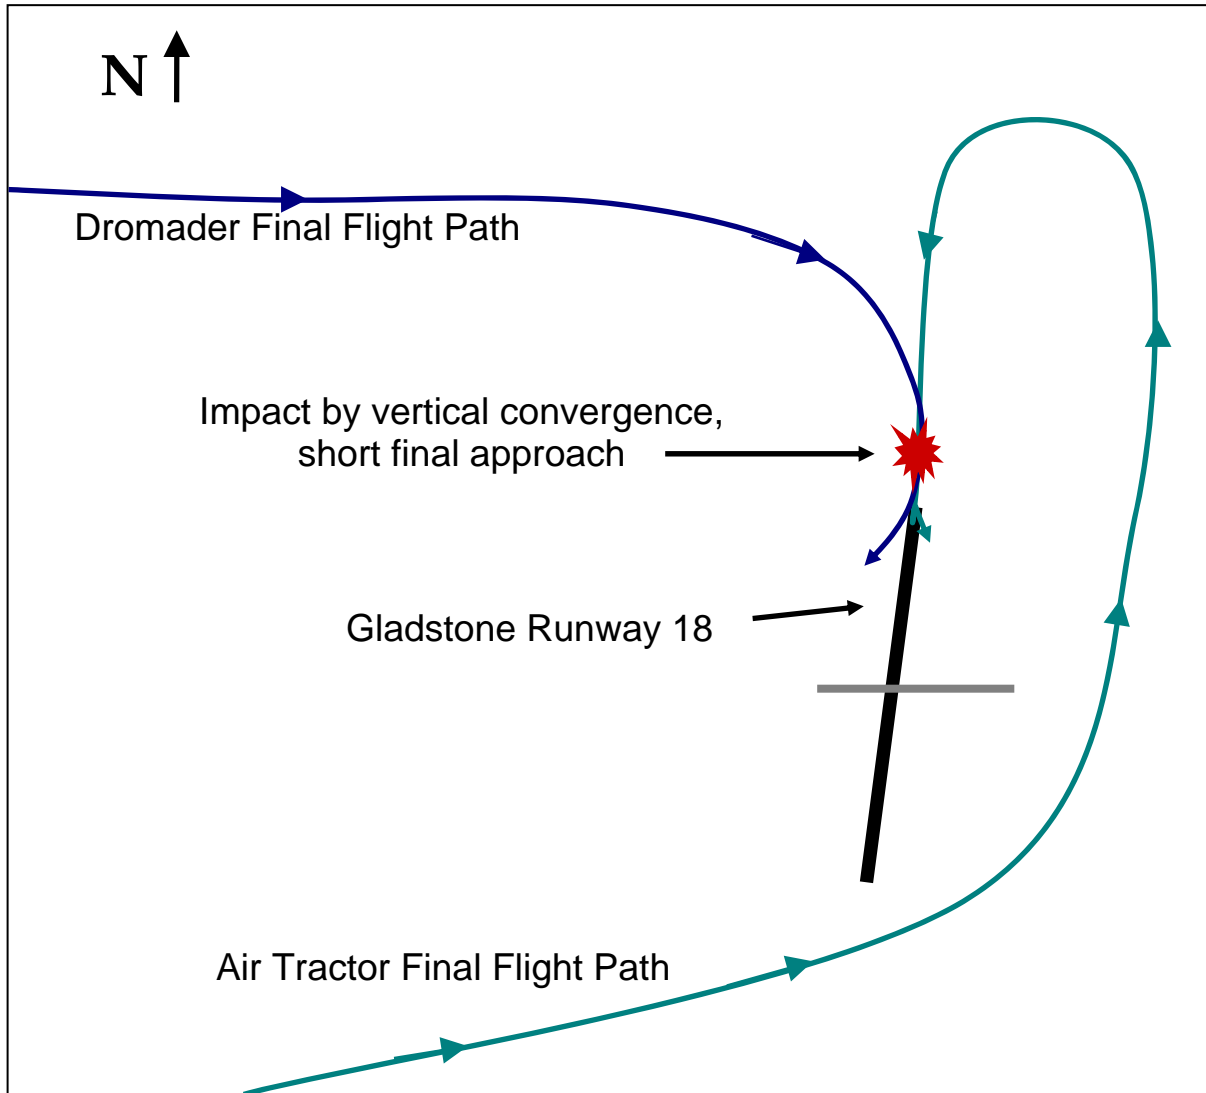
Appendix B – Accident Aircraft Final Flight Paths

The Dromader's nose was large enough to obscure its pilot's view of a significant area ahead of and underneath the Dromader. In the right turn onto final approach, the area which was obscured likely kept pace with the flight path of the Air Tractor while the two aircraft lined up on final approach. Although both aircraft were substantial in size, were painted in conspicuous colours, and the weather was favourable, the relative positions of the aircraft would have made each difficult for the other pilot to detect. The pilot of the Dromader would have had to make clearing turns to observe the area under the aircraft's nose, and because the pilot believed there was no local traffic, no such turns were made. After the Dromader turned onto final approach, its flight path converged with that of the Air Tractor. As it descended, it struck the Air Tractor and both aircraft descended to the ground out of control.

3. The Dromader's nose likely obscured an area which kept pace with the Air Tractor flight path while the two aircraft converged on final approach. The Dromader pilot did not make clearing turns to observe the area under his aircraft's nose and this made it difficult for him to see the Air Tractor's approach and avoid the impending conflict.
4. On final approach, the Dromader's flight path converged horizontally and then vertically with that of the Air Tractor, until the Dromader struck the Air Tractor and both aircraft descended out of control to the ground.
5. The non-use of landing lights and lack of radio communication contributed to the pilots' reduced awareness of traffic in the area.
6. The Air Tractor pilot's arms and hands were not protected, which likely increased the extent of the injuries resulting from the post-crash fire.
