AVIATION INVESTIGATION REPORT

A09O0217

CONTROLLED FLIGHT INTO TERRAIN

PIPER PA-28R-180, C-FURX

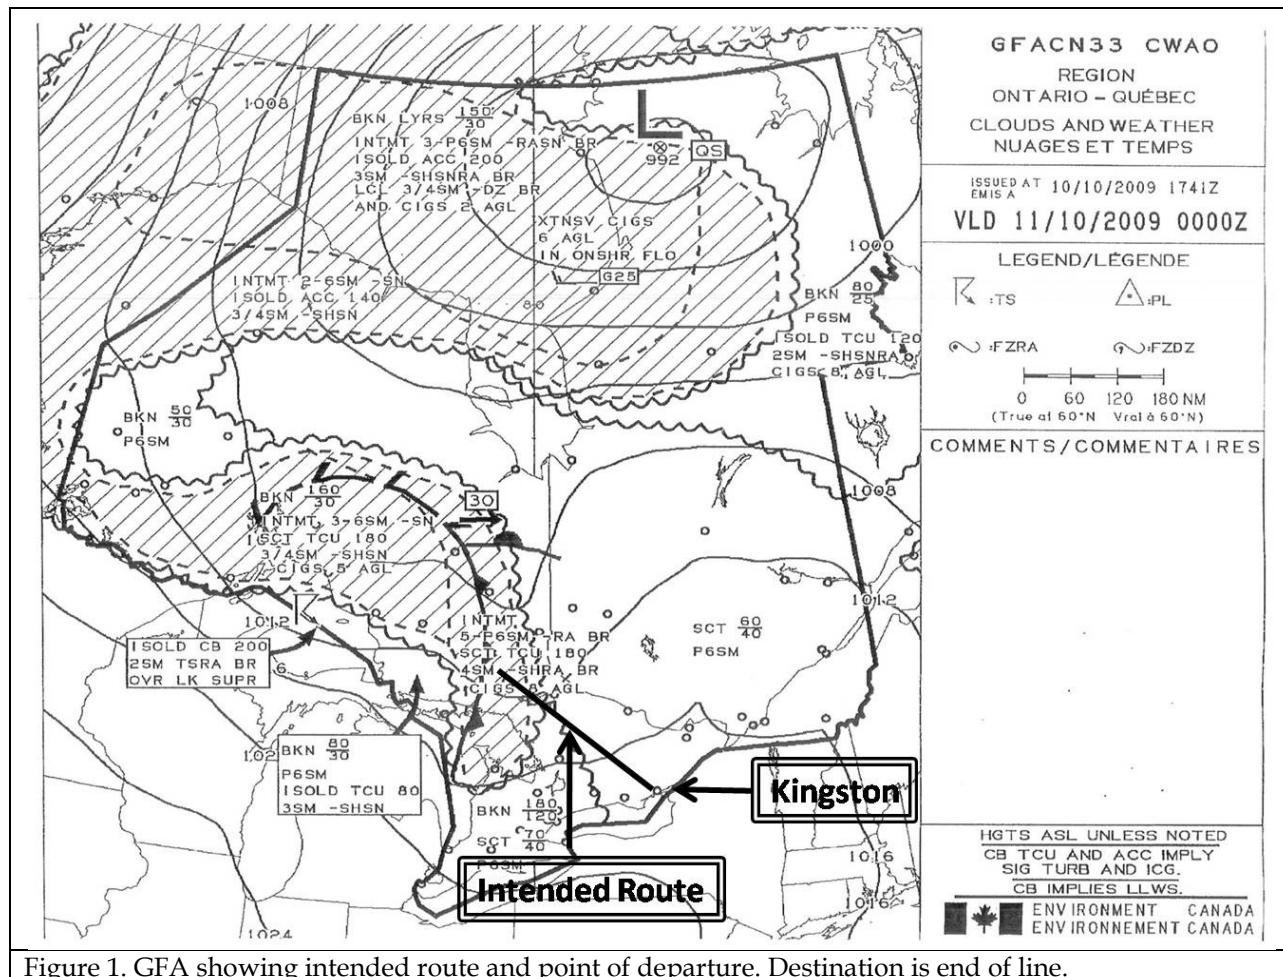
A cold front stretching from east of Sault Ste. Marie northward to Timmins was the major meteorological influence.

Figure 1. GFA showing intended route and point of departure. Destination is end of line.

The cold front was moving east at 30 knots, doubling in speed from the previous GFA. It was estimated to arrive in the Sudbury area at about the same time as the flight. The cold front had passed Sault Ste. Marie earlier. The ceiling was recorded as 800 feet agl, with a visibility of 3 sm in snow showers.

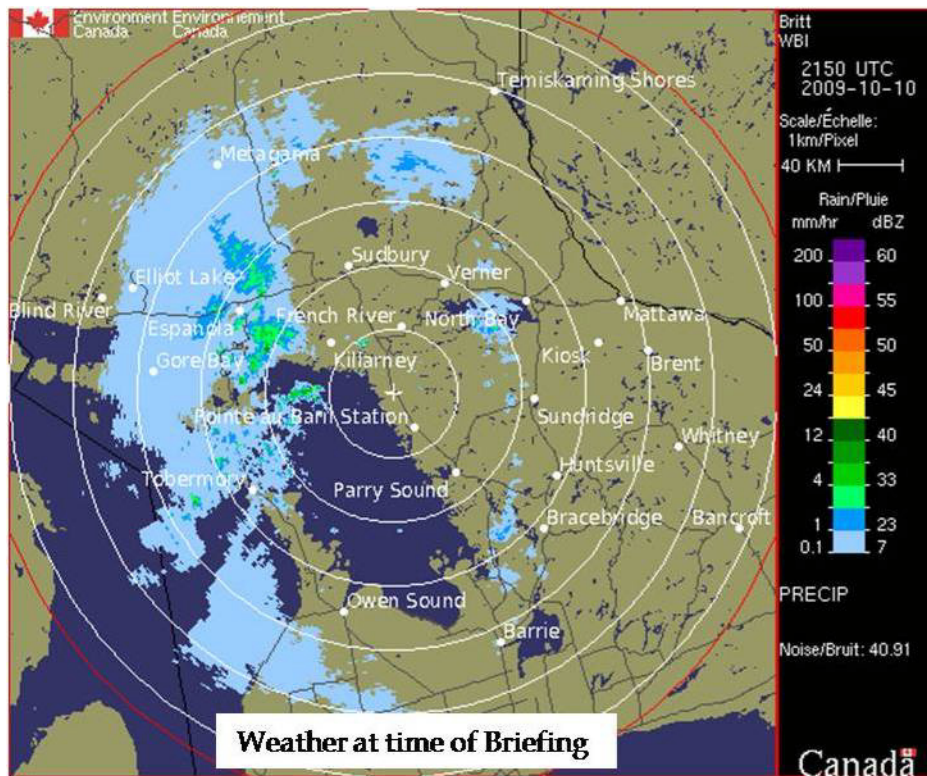
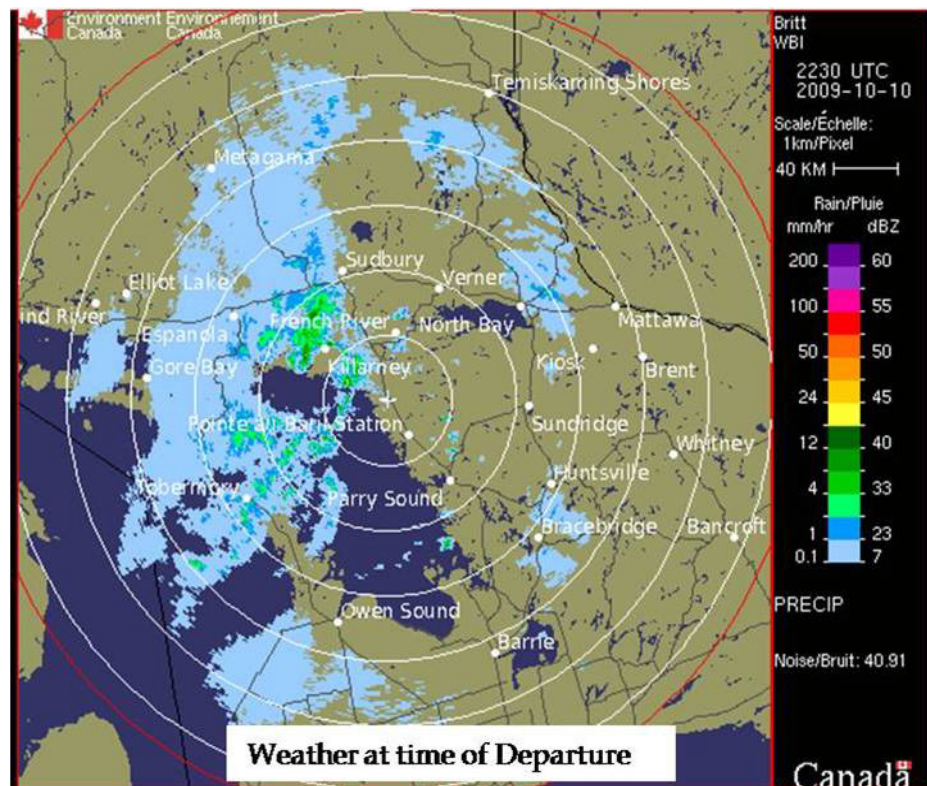
Appendix A - Weather Radar Before and at Departure

Originally shaped as a line from north to south, the weather system was moving from west to east. It covered an area from Southwest Ontario to north of Sudbury (see Appendix A.) The heaviest concentration of precipitation was at the front, where there were no weather reporting stations. A mixture of rain, snow and strong winds were also present. As it moved east, the front began to change shape and appeared to be more convex. This meant that, at the outer tips, the weather was not as severe and any available weather reports were not indicative of the actual weather likely encountered by the pilot (see Appendix B).
