**AVIATION INVESTIGATION REPORT
A09Q0131**

LOSS OF CONTROL AND COLLISION WITH CABLES

**ESTROM F-28C HELICOPTER C-GVQQ
MONT-LAURIER, QUEBEC
05 AUGUST 2009**

Report Number A09Q0131

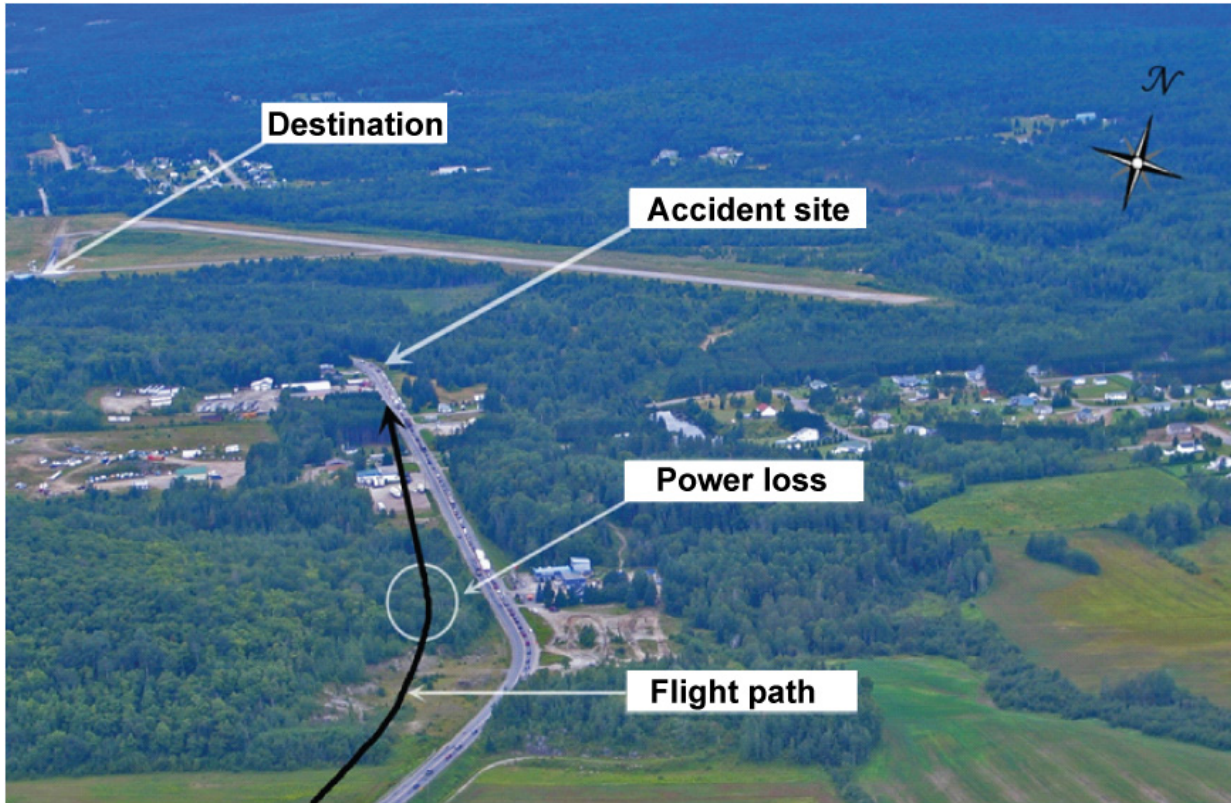
Photo 1. Return path to Mont-Laurier Airport.

At approximately 0910, on the return flight to the airport, the cameraman stopped shooting video about 2 km from the landing site at the airport. At this point, the helicopter was at a height of about 250 agl and travelling 75 mph (see Photo 1). A few seconds later, the helicopter experienced a loss of power and backfiring when it was 1.6 km from the landing site. Approximately 14 seconds after the power loss, the helicopter flew over a garage parking lot at a height of about 150 feet agl, then over a wooden area, and finally positioned itself above highway 117. The helicopter was fishtailing during the descent⁸. Once the helicopter was over the highway, descent was arrested at about 20 feet agl with a horizontal trajectory along the highway, but the helicopter was yawed to the right. Roughly 32 seconds elapsed from the power loss to the time the helicopter flew above the highway.

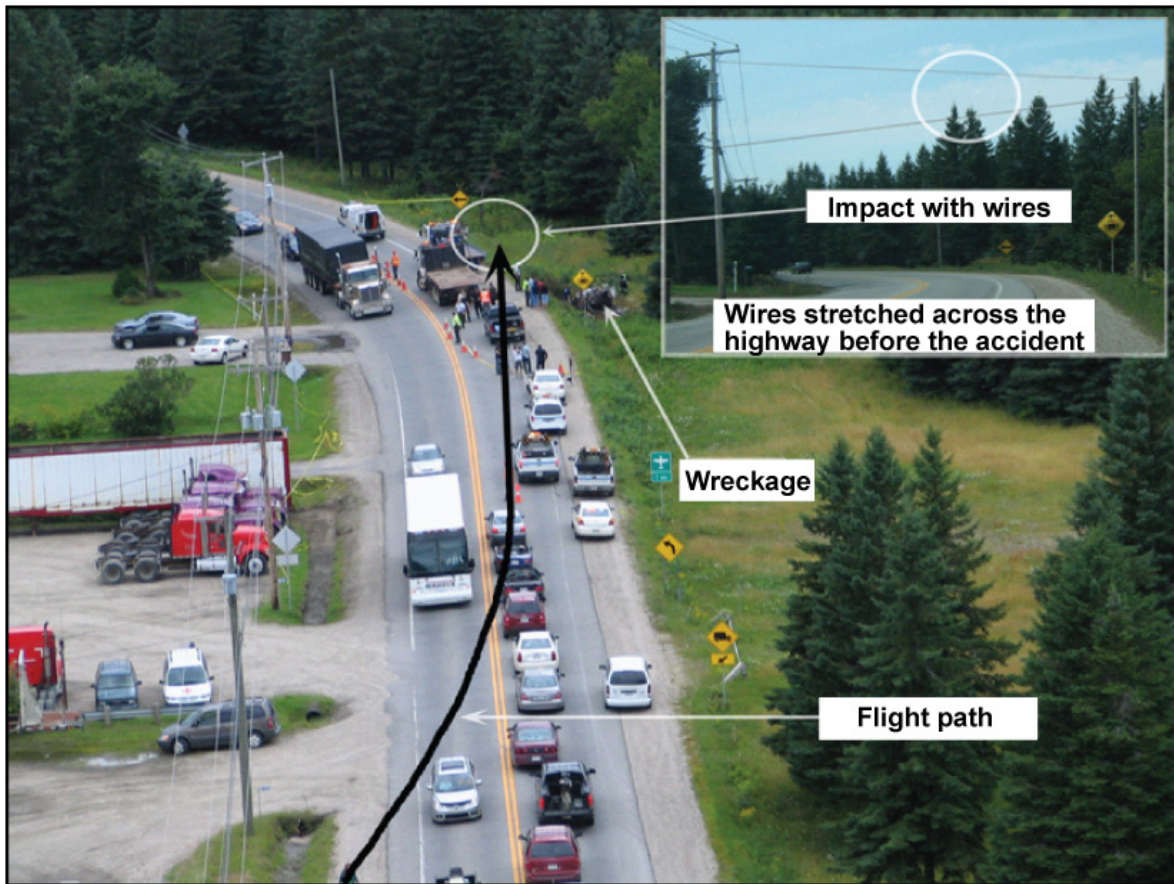
Photo 2. Accident site.

Before the pilot was able to arrest the sideways motion of the helicopter along the road, it struck the cables spanning the road at a height between 21 and 26 feet agl. The cables wound around the main rotor mast. The helicopter crashed on the pavement and rolled over on its right side into the ditch (see Photo 2).

When the helicopter rolled over, gasoline spilled onto the engine hot parts and ignited immediately. The persons who arrived at the site a few seconds after the accident were unable to control the flames that engulfed the helicopter, and therefore could not rescue the occupants.

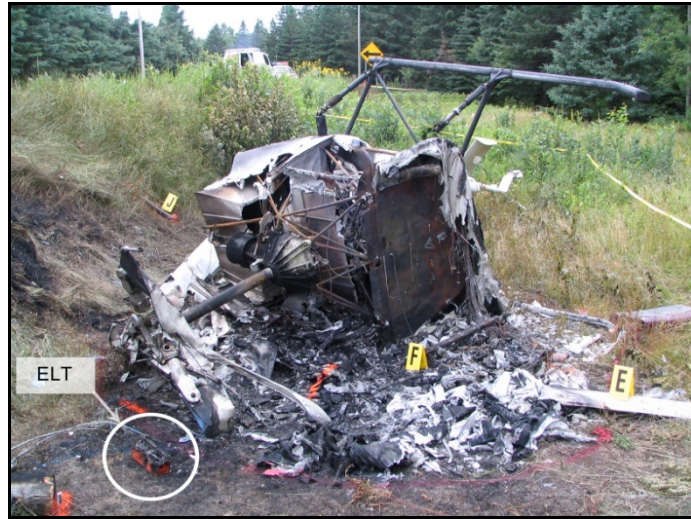
The aircraft was equipped with a Narco 10 emergency locator transmitter (ELT), serial number A17809. The selector was found on ARM; however, the ELT was found separated from its mount and antenna (see Photo 3). The Rescue Coordination Centre was not advised of any ELT signals being received at the time of the accident.

Photo 3. Helicopter wreckage and ELT.

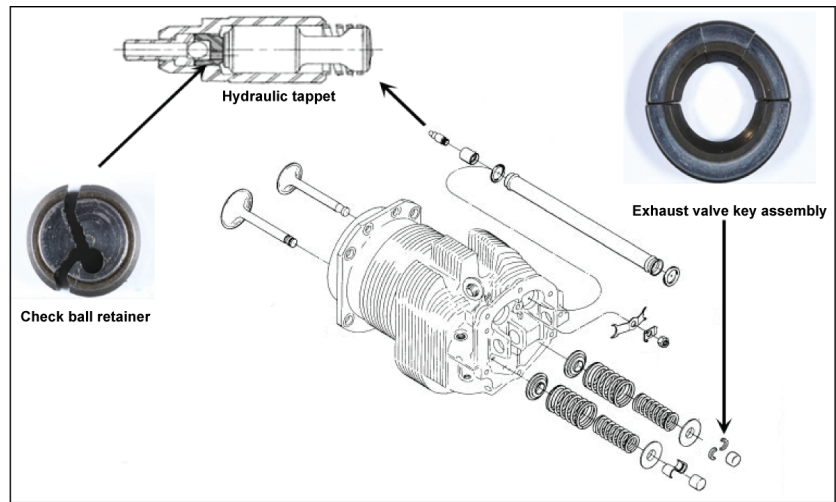
Teardown of the engine revealed no external anomalies. The four cylinders were in good condition and no carbon fowling was found on the valves that could have caused them to seize. However, a detailed examination of the No. 4 cylinder revealed that the exhaust valve key assembly²³ and the check ball retainer in the exhaust valve hydraulic tappet²⁴ were broken.

Figure 1. Engine cylinder and parts.

The exhaust valve key assembly consists of two symmetrical, semi-circular halves, one of which had failed in two places. A scanning electron microscope examination showed that these fractures were present before the occurrence. It was not possible to determine the initial cause of these fractures, but the key assembly had remained in its installed position. The exhaust valve key assembly is an integral part of the cylinder that was replaced in 2003.

The check ball retainer in the exhaust valve hydraulic tappet had a pre-existing defect in the form of cracks on the exterior surface which acted as a precursor for the eventual fracture of the retainer. The fracture advanced intergranularly, consistent with material embrittlement, most likely due to impurities in the material used to make the part. The check ball retainer is an integral part of the engine, and there was no indication in the technical records that it was replaced since the 1982 overhaul.

The fractures in the exhaust valve key assembly did not affect valve operation, since the key assembly remained in its installed position. The fracture of the check ball retainer in the exhaust valve hydraulic tappet, however, allowed the tappet to become spongy or collapse and allow the clearances to increase in the valve operating assembly. These increased clearances caused the valve to open late and close early, creating conditions conducive to backfiring and reduced power.

1. Fracture of the check ball retainer in the hydraulic tappet caused the malfunction of the No. 4 cylinder exhaust valve.
2. The malfunction of the No. 4 cylinder exhaust valve caused backfiring and partial loss of engine power. As a result, the aircraft could not maintain cruise altitude.
