AVIATION INVESTIGATION REPORT

A09Q0190

COLLISION WITH CABLE

ROBINSON R44 II RAVEN (HELICOPTER) C-GJMP

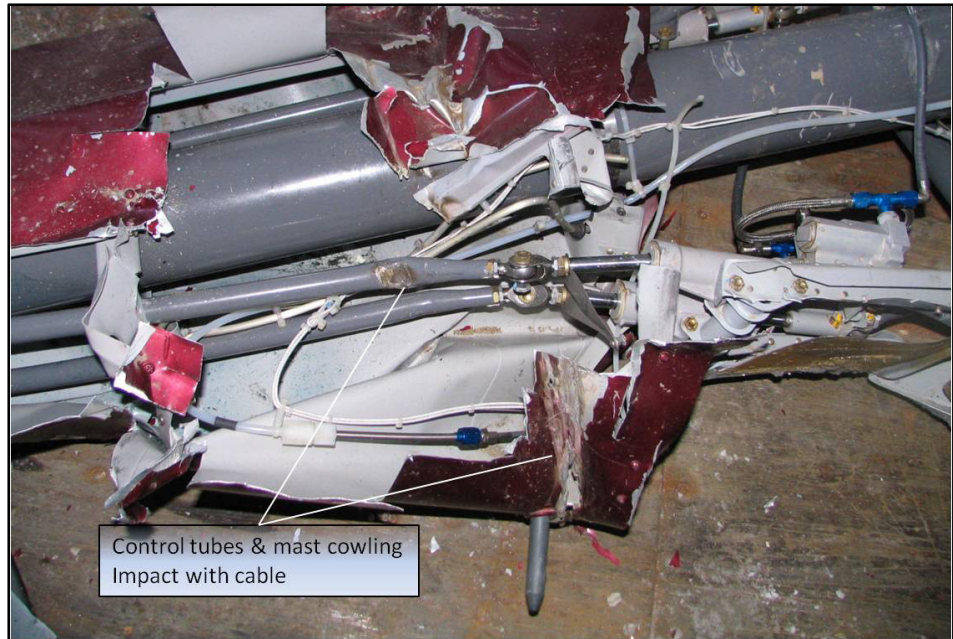
Photo 1. Cable marking on control tubes

Collision with the ground wire was evident at the left bottom of the mast fairing area just below the pitot tube. No wire markings were evident on the right side of the mast fairing. The collective and cyclic control tubes running vertically alongside the rotor mast were bent and showed marks from impact with the wire (see Photo 1). The bending of the control tubes rendered the collective and cyclic controls partially inoperable, likely allowing the pilot limited control of the helicopter during the descent towards the river.

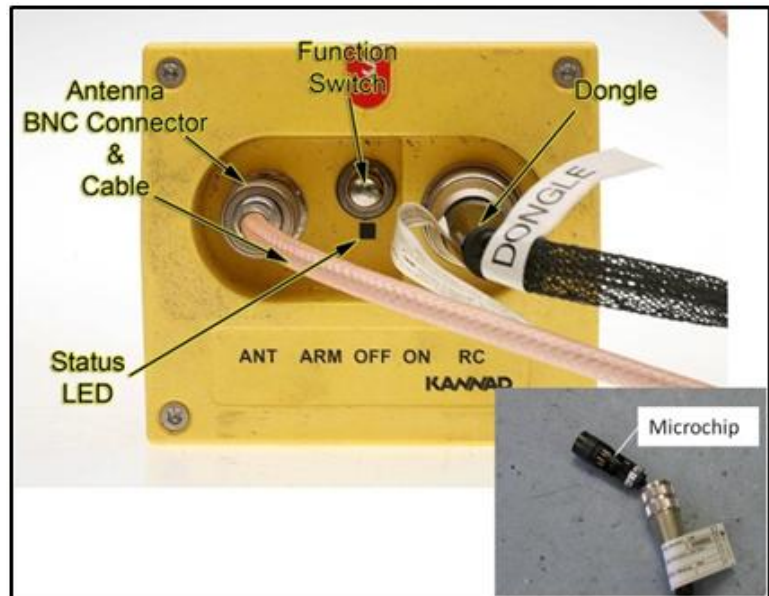
It was also determined that the occurrence ELT was transmitting on the Test User Protocol, a country code of 227 (France) and an ID code of S1386932 instead of transmitting in the 'Normal' mode, country code of 316 (Canada) and the correct ID code of C05D84. It was found that the dongle had not been programmed to reflect the current owner's information. By default a dongle which has not been re-programmed with this information restores the ELT to that which was programmed in the dongle when the ELT was initially installed in the aircraft before it left the manufacturer: that is a Test User Protocol with country code 227 (France) and ID code S1386932.

Photo 3. ELT and programmable dongle

After the ELT unit was tested in January of 2009 it was placed back in the aircraft, connected to the dongle and the function switch was placed from the OFF to the ARM position, the ELT was reprogrammed with the out of factory dongle information (i.e. Test User Protocol). Had the dongle been programmed with the proper identification information, the ELT would have been configured to transmit the correct information. Had a self-test been performed at this point, the faulty programming would have been detected.

On 12 July 2010, the TSB sent, *Aviation Safety Information Letter A09Q0190-D1-L1, Awareness – 406 MHz ELT Inappropriate Transmission Mode due to Programmable Dongle Information*, to Transport

Canada. This letter highlighted the importance of informing aircraft operators, owners, maintainers and avionics facilities of the purpose of the programmable dongle.
