AVIATION INVESTIGATION REPORT

A09W0037

RISK OF COLLISION

06 MARCH 2009

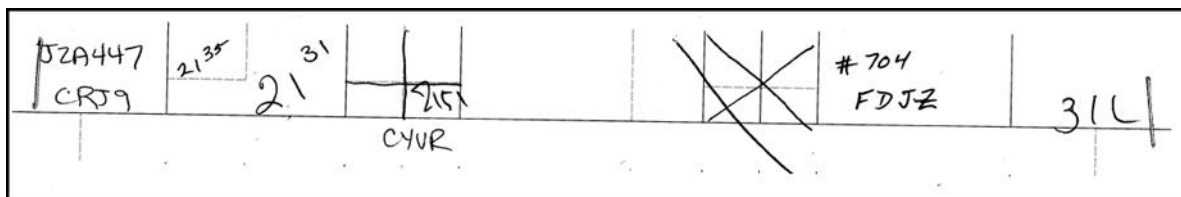
Tower Data Strip for JZA447 Completed by Whitehorse Tower Controllers

The flight progress strips at the Whitehorse tower are completed by hand by tower controllers, as information is received from Edmonton ACC. The flight progress strip for JZA447 displayed nine pieces of information in seven boxes. The ETA recorded on the flight strip was not referenced, and was not required by ATC MANOPS to be referenced, to a fix. The information on the flight strip identified the flight number and type of aircraft, and provided sufficient information to determine the expected order of arrival for JZA447. While ATC MANOPS 493.2 requires estimates to be updated if the estimates vary by three minutes or more, the original ETA for JZA447 was not updated at any time before the aircraft landed. The relieving tower controller considered ETAs recorded on tower flight strips to be inaccurate, and as a consequence did not rely on them to manage arriving aircraft. Tower controllers at Whitehorse occasionally used the wake turbulence clock,¹¹ which could be set to activate in a specific number of minutes, to augment their sense of timing or “internal clock.”
