**AVIATION INVESTIGATION REPORT**  
**A09W0105**

**COLLISION WITH TERRAIN**

**BEEHCRAFT V35B BONANZA C-GWUW**  
**CASTOR, ALBERTA, 13 nm NE**  
**15 JUNE 2009**

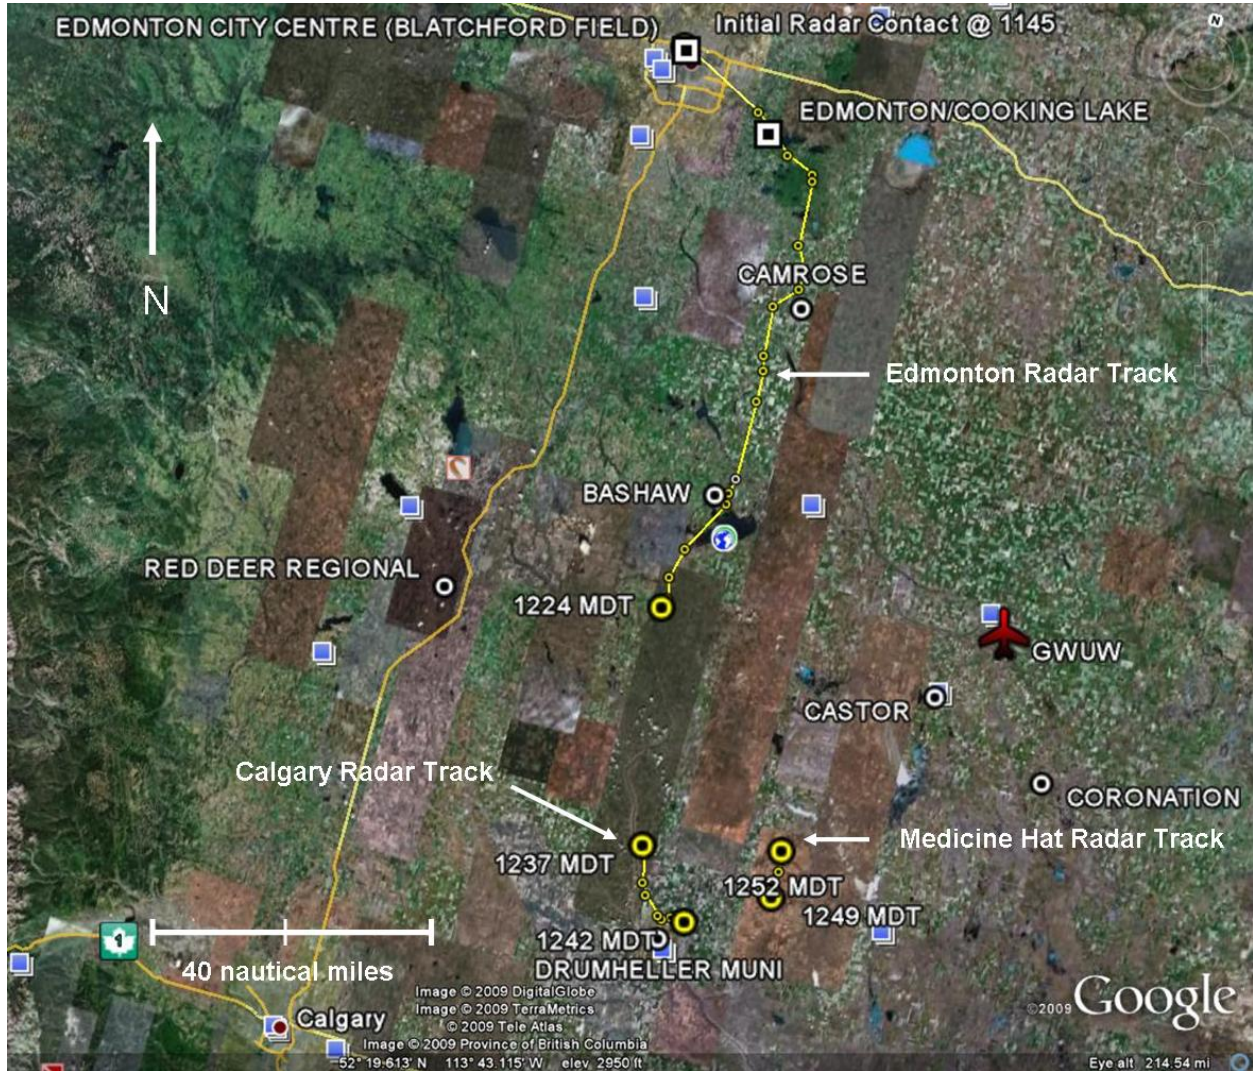
# Appendix A – Radar Track of C-GWUW

The aircraft departed from the Edmonton City Centre Airport at 1147<sup>1</sup> and was observed on the NAV CANADA Edmonton radar, departing Runway 30 (see Appendix A – Radar Track of C-GWUW). The aircraft remained on Edmonton radar until 1225. The flight path detailed by the radar was in a southerly direction through Camrose and past Bashaw, Alberta. Altitudes were recorded from approximately 4000 feet above sea level (asl) to 4600 feet asl. At 1237, Calgary radar picked up the aircraft in the vicinity of Drumheller, Alberta and maintained radar contact until 1243. The track recorded indicated a left turn towards the northeast. The aircraft appeared on the Medicine Hat, Alberta, radar from 1249 until 1252, approximately 42 nautical miles (nm) southwest of the accident site. The aircraft was flying at a ground speed of approximately 160 knots at 4400 feet asl, about 1500 feet above ground level (agl) at this time.
