AVIATION INVESTIGATION REPORT
A10A0085

COLLISION WITH WATER

CESSNA 414A, C-GENG
SYDNEY, NOVA SCOTIA, 13 nm EAST-NORTHEAST
05 AUGUST 2010

Report Number A10A0085

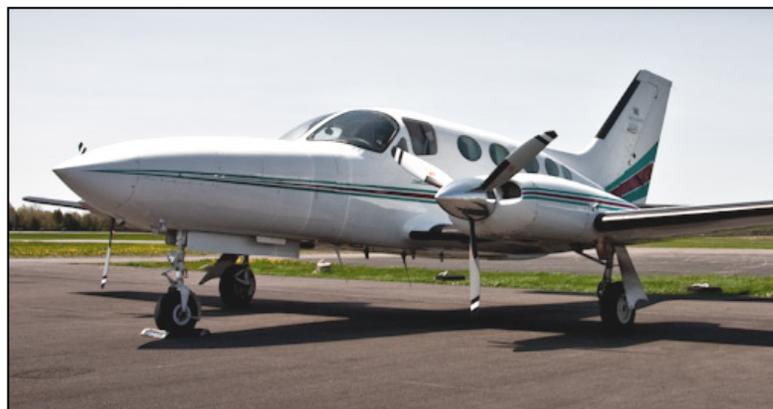
Photo 1. Occurrence Aircraft

The Cessna 414A is a pressurized low-wing twin-engine aircraft with retractable tricycle landing gear (see Photo 1). The occurrence aircraft had a RAM Series IV conversion, which included upgraded engine performance and wing-mounted vortex generators, to increase the performance and useful load of the aircraft. The aircraft was equipped and certified for IFR operation.

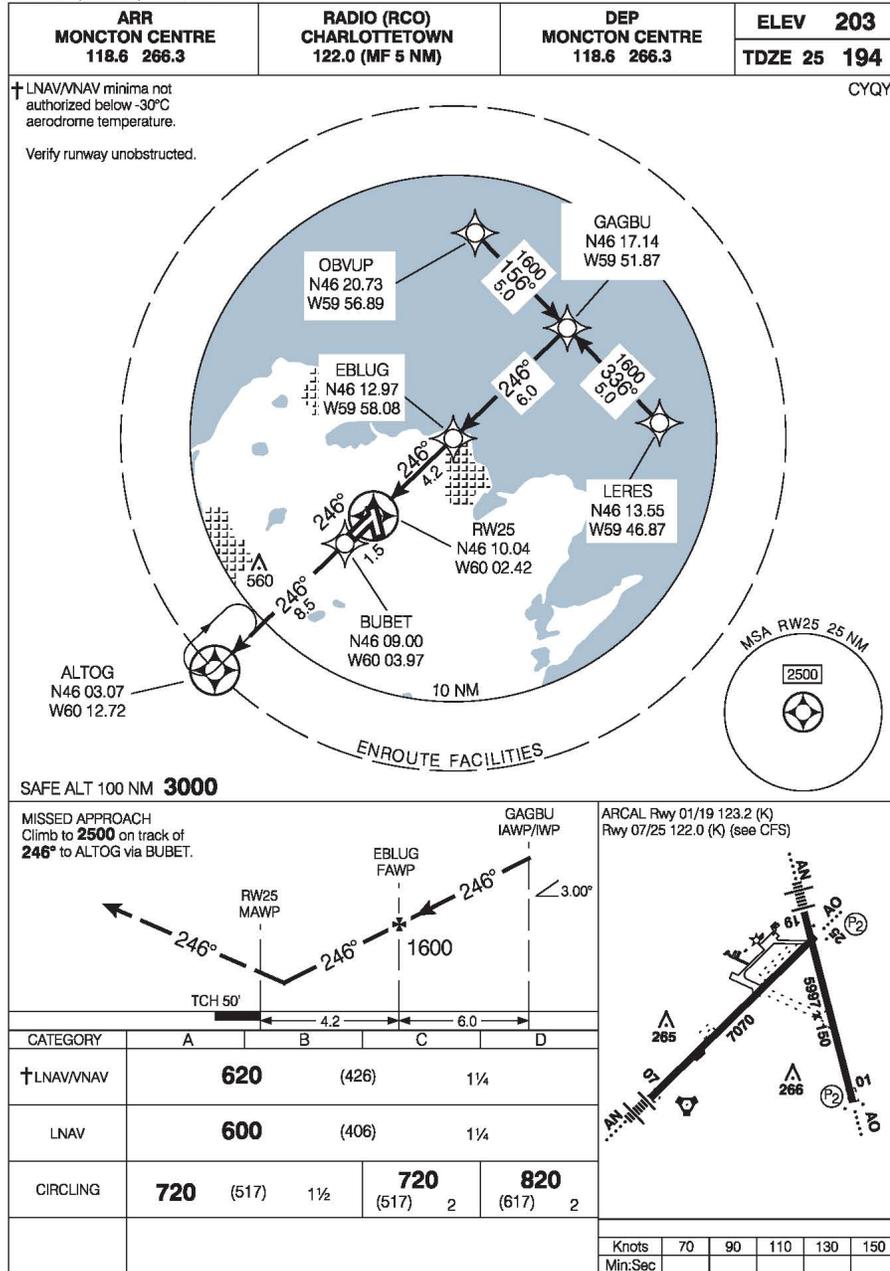
Appendix A – RNAV Runway 25 Approach

Following the familiarization training, the PIC and owner departed the Toronto/Buttonville Municipal Airport at 1930³ (1830 local time) on an instrument flight rules (IFR) flight to Sydney. All historic technical logs and other aircraft documents were placed on board the occurrence aircraft before the departure from Buttonville. The flight continued uneventfully until nearing the Sydney J.A. Douglas McCurdy Airport. The aircraft was maintaining 4000 feet above sea level (asl) and was cleared by Moncton Area Control Centre (ACC) for the RNAV (GNSS)⁴ Runway 25 approach via the OBVUP initial waypoint (see Appendix A).

The aircraft track nearing OBVUP created a sharp closing angle on the OBVUP-GAGBU track. As the aircraft neared the OBVUP waypoint, the course track bar on the GPS would have moved very quickly toward the GAGBU waypoint. Due to the maximum rate of turn that an autopilot system allows, the aircraft would have flown through the OBVUP-GAGBU track before regaining course. To prevent this, a pilot would have to manually take control and initiate a steep turn. In an attempt to intercept the OBVUP-GAGBU course, an inexperienced pilot may try to follow the track bar using an increasingly steep bank angle. If this steep bank angle is left uncorrected, a spiral dive will result.
