**AVIATION INVESTIGATION REPORT
A10A0122**

**CONTROLLED FLIGHT INTO TERRAIN
AERO PENINSULE LTEE (DBA AIR OPTIMA)
CESSNA 310R, C-GABL
POKEMOUCHE, NEW BRUNSWICK
14 DECEMBER 2010**

Report Number A10A0122

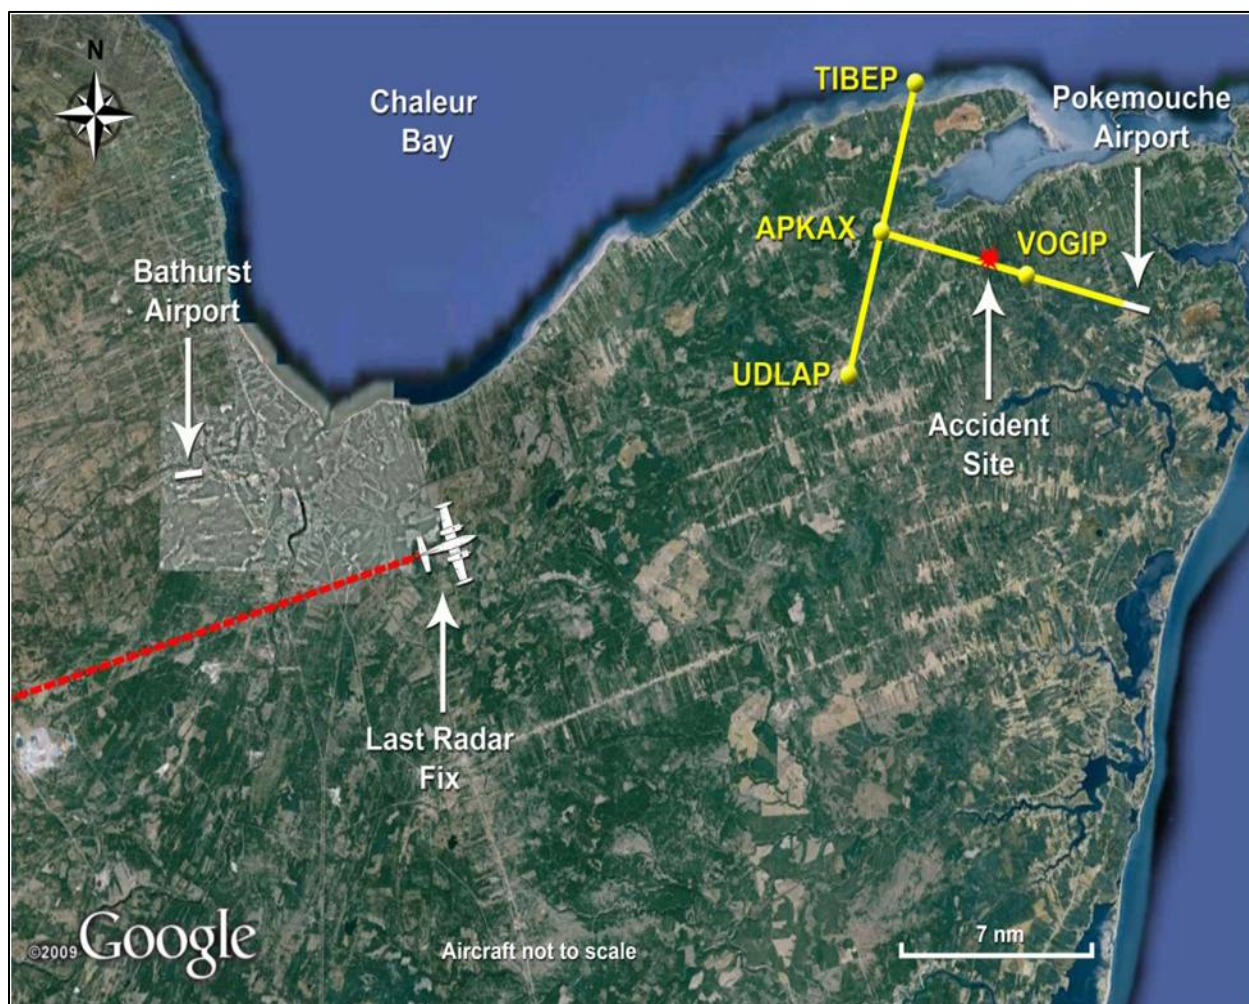
Figure 1. Aircraft flight path to Pokemouche Airport (CDA4)

At 2139:09, the aircraft started a normal descent. At 2146:04, approximately 26 nautical miles (nm) from CDA4, the aircraft descended below radar coverage at an altitude of 4400 feet asl.

The aircraft was located approximately 5.5 nm west-northwest of CDA4, aligned with the final approach segment of the RNAV instrument approach to Runway 13. The aircraft began striking the tops of the trees approximately 70 feet above ground. The tree strike damage and wreckage trail indicate that initial contact with the trees occurred with the wings level in a shallow descent. As the aircraft's forward speed decreased, impact strikes to the right wing caused the aircraft to roll to the right as it continued to descend. The right wing tip fuel tank was found lodged in a tree 235 feet from the main wreckage. The right engine cowl and right aileron were located 153 and 120 feet respectively from the main wreckage. The aircraft struck the ground inverted, approximately 589 feet from the point of initial impact with the trees, and was destroyed by the impact and an intense post-crash fire.

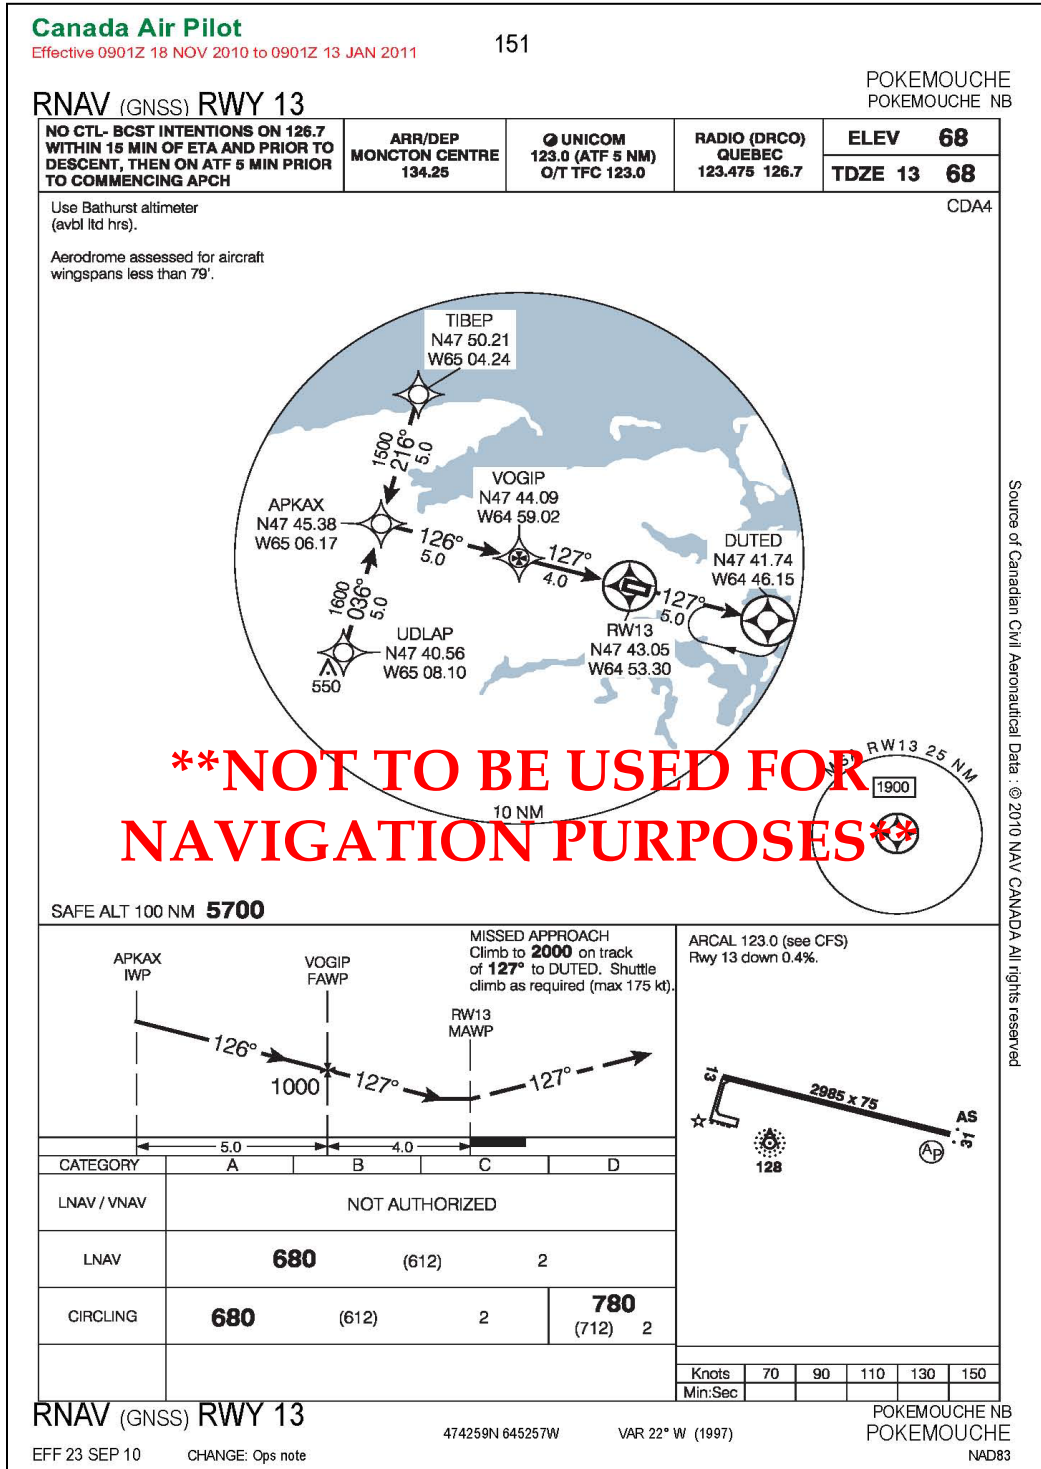
Appendix B – Pokemouche Airport Instrument Approach Chart

CDA4 is a registered aerodrome, located in uncontrolled airspace at an elevation of 68 feet above sea level (asl). The only published approach for Runway 13 is an RNAV (GNSS) approach (see Appendix B). The minimum safe altitude within 25 nm of the airport published on the approach chart is 1900 feet asl. Crossing the UDLAP initial entry point for the approach, an aircraft can descend to a minimum altitude of 1600 feet asl. From the aircraft's last recorded radar position, approximately 15 nm from UDLAP at an altitude of 4400 feet asl and a ground speed of 180 knots, a descent rate of approximately 500 feet per minute would be required to cross UDLAP at 1900 feet for the GPS approach. Once an aircraft reaches APKAX, it can descend to 1000 feet asl until 4 nm from the airport, at which point the final descent may be initiated. The highest terrain between APKAX and Runway 13 is 130 feet asl. There are 2 other published approaches for the Pokemouche Airport, a GPS and a non-directional beacon approach, both on Runway 31. The descent minimum on all 3 approaches is 680 feet asl.

This occurrence involved several of the most common factors associated with controlled flight into terrain (CFIT) accidents. In particular, it involved flight conditions that would make it nearly impossible to see the approaching terrain and it involved an instrument approach procedure with multiple step-down altitudes. As a result, each time that a descent is commenced, the pilot must remain vigilant to ensure that the aircraft does not descend below the appropriate minimum safe altitude, which during this portion of the approach was 1000 feet above sea level (asl). The combination of a non-precision instrument approach, conducted at night, with low ceilings and limited visibility significantly increases the risk of CFIT.
