**AVIATION INVESTIGATION REPORT  
A10C0214**

**ENGINE LOSS AND AUTOROTATIVE LANDING**

**FOREST HELICOPTERS INC.  
EUROCOPTER AS 350 B2 (HELICOPTER) C-FORS  
PICKLE LAKE, ONTARIO, 6 NM NE  
12 DECEMBER 2010**

Report Number A10C0214

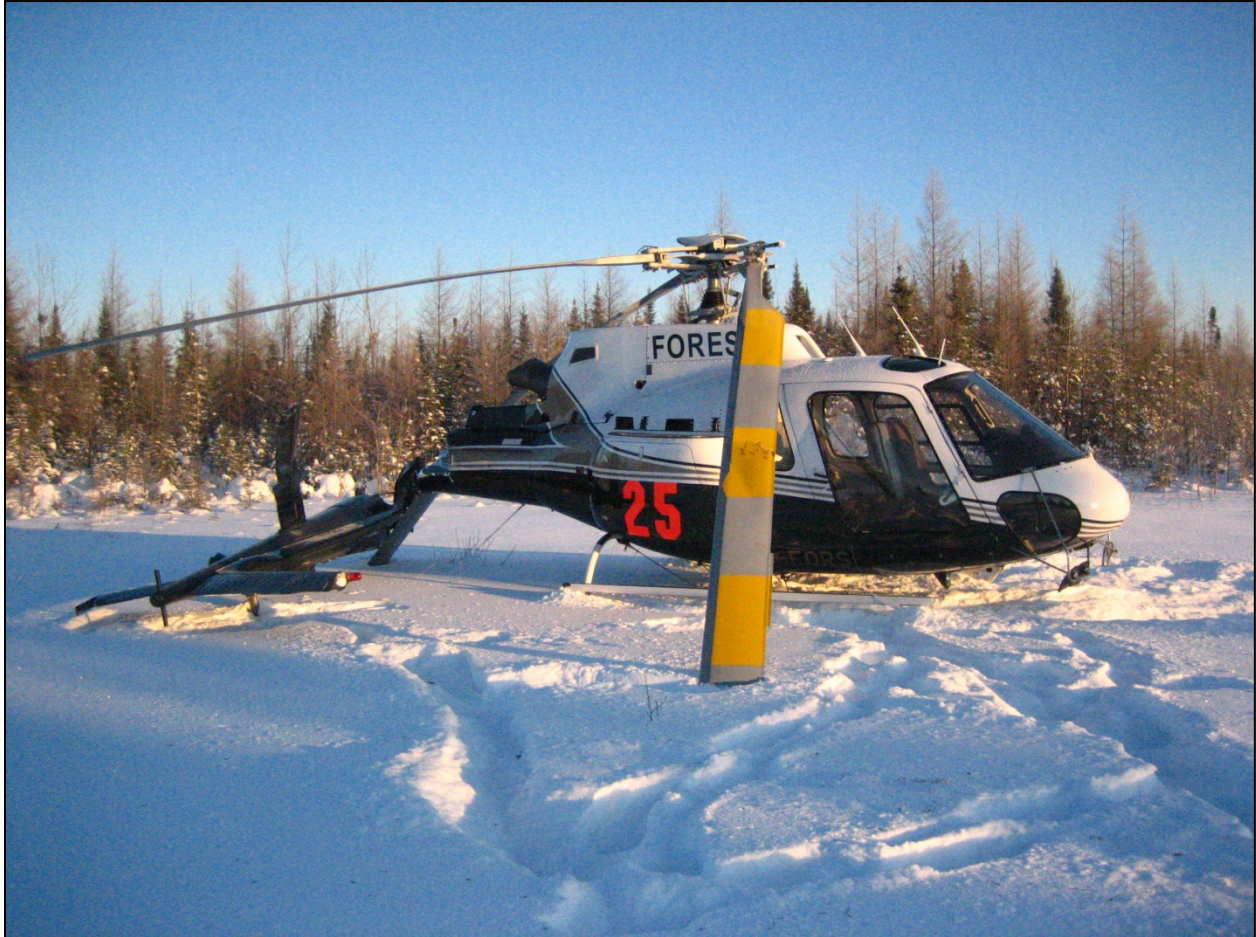
**Photo 1.** Occurrence Aircraft

The helicopter descended rapidly and just prior to ground contact, the pilot raised the nose of the helicopter to reduce forward speed and attempted to run the tail stinger on the ground to slow the descent and reduce the impact force. The helicopter struck the ground with some forward momentum. As a result of the impact, one of the main rotor blades struck and severed the tail boom (see Photo 1). The helicopter remained upright and slid forward approximately 60 feet before coming to rest. The emergency locator transmitter (ELT) did not activate as the deceleration forces were less than those required to activate its internal multi-axis g-switches.

The pilot, who was wearing a 4-point harness and helmet, was able to exit the aircraft uninjured. The Arriel 1D1 engine had stopped running by the time the helicopter made contact with the ground. The engine had been running continuously from initial start-up until it lost power. The total flight time was approximately 37 minutes. There were no abnormal engine or cockpit indications prior to the engine power loss.

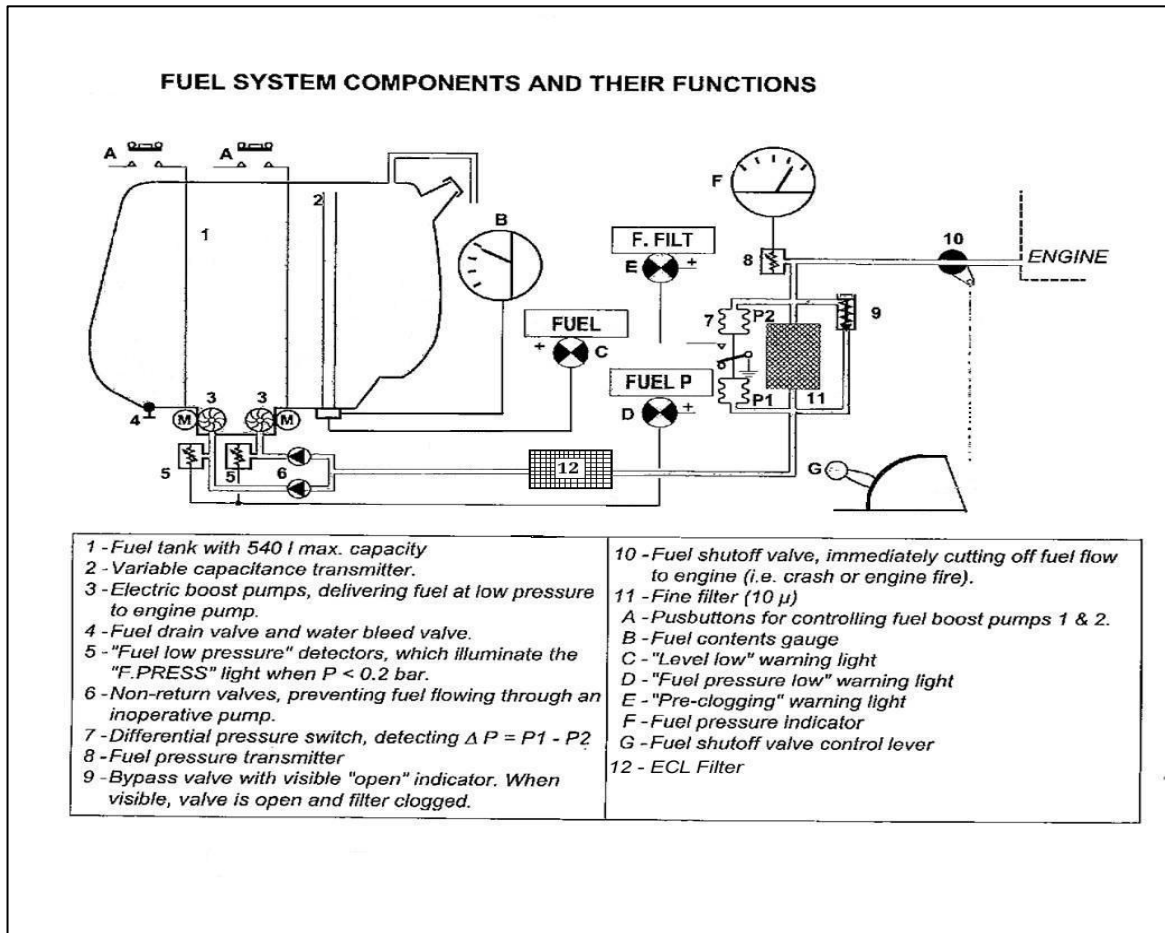
**Figure 1.** Fuel System

The airframe fuel filters were removed and reinstalled to simulate servicing of the fuel system. The boost pumps were turned on and the fuel system was bled in accordance with instructions contained in the *Aircraft Maintenance Manual* (MM), Section 28.00.00.302. The fuel flow was set to the purge flow rate and once the flow stabilized, the pumps were shut off. A large quantity of air that had not been bled out of the system during the purge event remained in the line, between the 2 fuel filters. The flow rate was increased to the cruise and maximum power settings and air slowly bled past the fuel filters. With rapid flow adjustments, larger quantities of air bled past the filters.

The test was carried out for 37 minutes to simulate the occurrence flight. At the end of the test, a small quantity of air was observed in the fuel line upstream of the Le Bozec airframe filter.

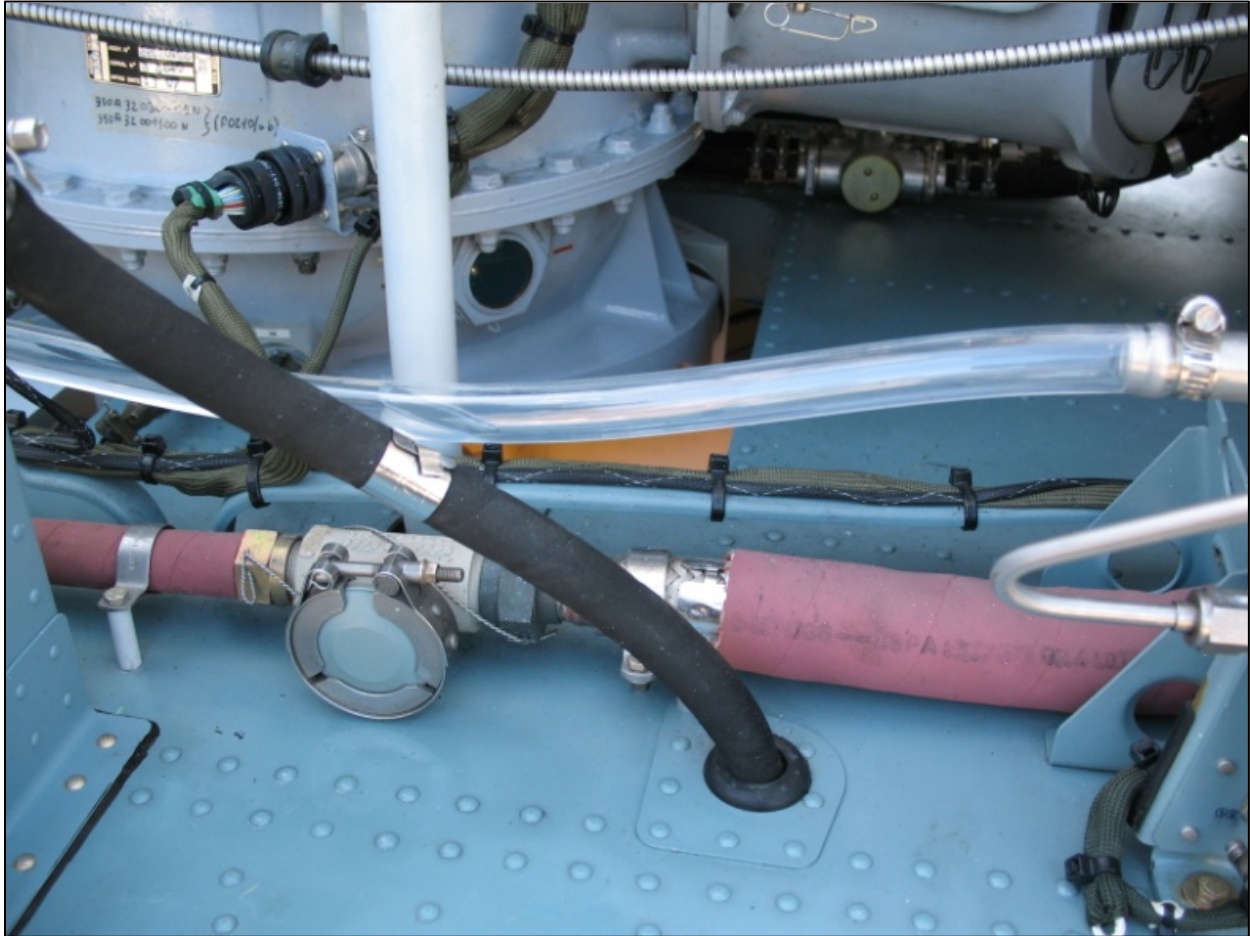
*Appendix A: Clear Tubing, Air in Fuel System*

With the boost pumps OFF, air was rapidly and sporadically drawn out of the ECL filter. This air entered the Le Bozec filter. Some minor engine surging occurred, but the engine continued to run. After approximately 2 minutes, the pumps were turned back ON and the engine regained smooth operation. The engine was run for another 3 minutes with the fuel flow control lever in the flight detent position. No abnormal indications were noted and flight would normally be initiated at this time. However, the engine was shutdown at that point. During the later stages of engine spool down, a small bubble of air appeared at the inlet of the Le Bozec filter. After the engine came to a complete stop, the fuel pumps were shut off. The bubble of air was then rapidly drawn back out of the Le Bozec filter inlet until approximately 8 inches of air was visible in the line (see Appendix A).
