**AVIATION INVESTIGATION REPORT
A10F0012**

RUNWAY EXCURSION

SKYSERVICE AIRLINES INC.

AIRBUS A320-232, C-FRAA

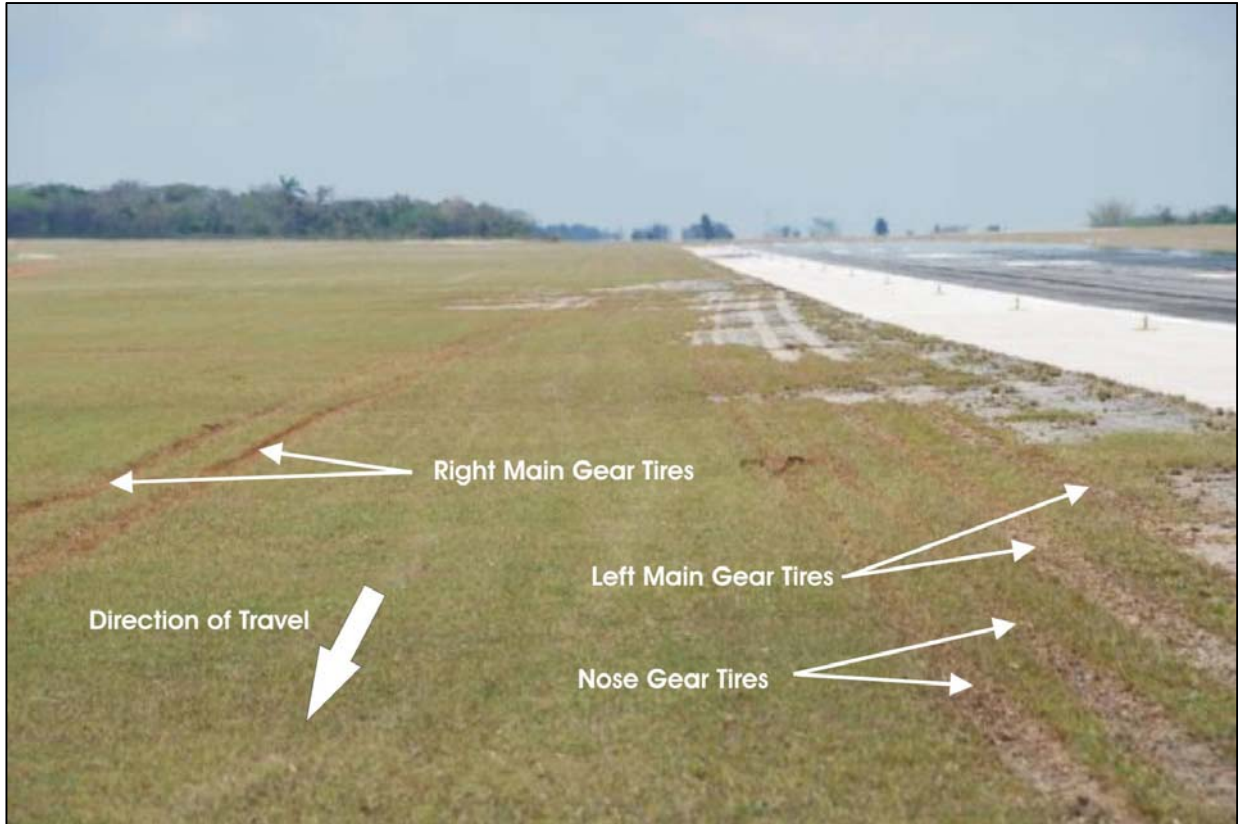
On touchdown, the spoilers deployed automatically and the thrust reversers were selected. As the aircraft tracked toward the right edge of the runway, the captain applied left rudder but the aircraft continued to drift to the right. The aircraft exited the runway approximately 1700 feet from the threshold at a speed of approximately 130 knots.

The aircraft then began tracking parallel to the runway with a 10° left crab for approximately 1745 feet. During that time, the engines began developing reverse thrust. At approximately 4300 feet from the threshold and at a speed of 40 knots, the aircraft re-entered the runway (see Photo 1).

Photo 1. Tire tracks off the runway

The aircraft paralleled the runway for a considerable distance with the heading crabbed to the left. It is likely that a combination of wet ground, reverse thrust, slope and wind (045° at 10 knots) resulted in the captain being unable to manoeuvre the aircraft back on the runway until the speed was reduced enough to allow for better tire traction. However, the extent to which any of the above factors contributed to the length of the excursion could not be established.

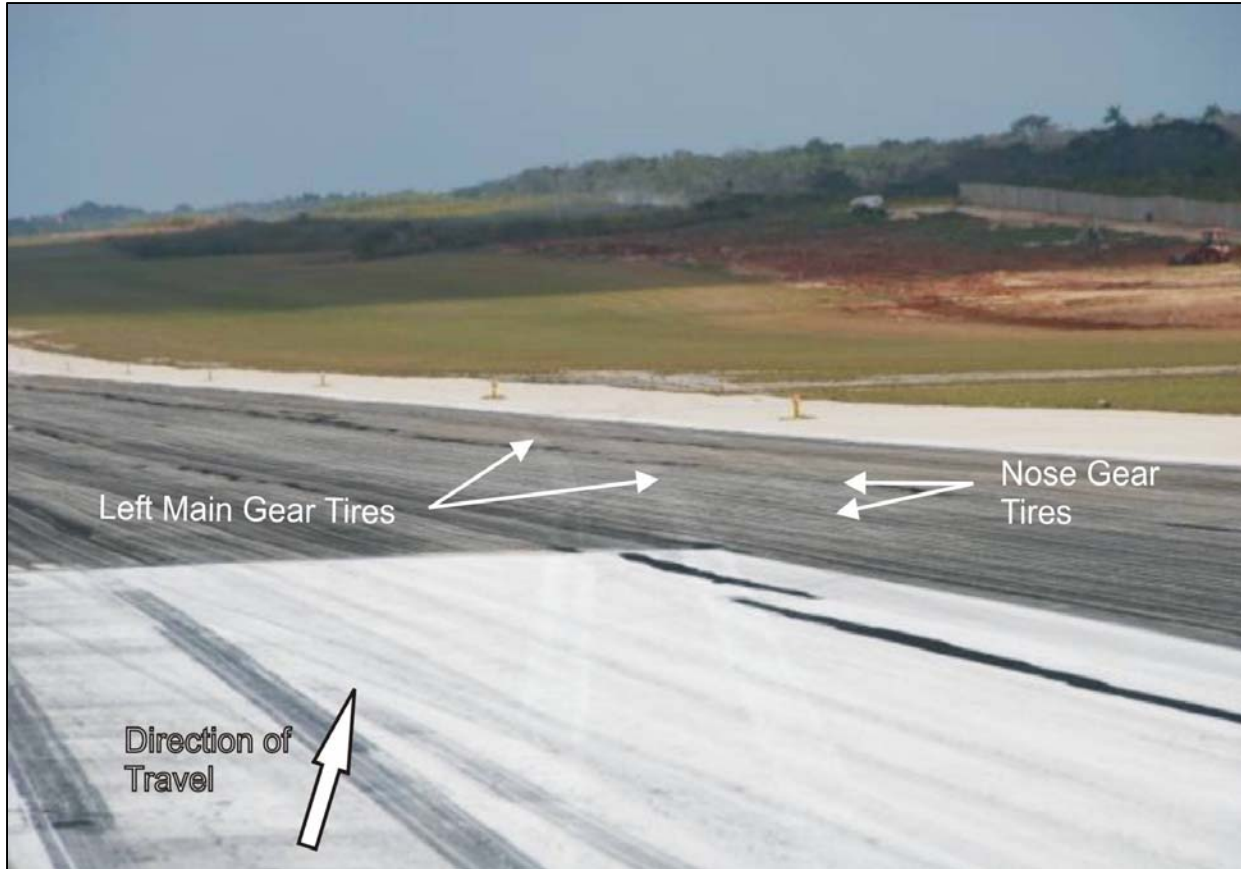
Photographs taken of the runway surface following the occurrence showed white 'steamed cleaned' tire tracks near the aircraft touchdown point (see Photo 3).

Photo 3. Tire tracks on the runway

Although no reverted rubber hydroplaning damage was present on the aircraft tires, the white streaks left by the tires are indicative of scouring action caused by some form of hydroplaning. As the aircraft touched down in an established right turn, the combination of momentum, low tire cornering forces due to the contaminated runway and some form of hydroplaning, caused the aircraft to drift until it left the runway.
